## Borescope Examination Report

| <b>Client Name:</b> | Daqing Drilling Company | <b>Location:</b> | Rig (DQ 1202) | <b>Job Number:</b> | QC-DQ-04-24-0138 |
| <b>Date of Examination:</b> | 03-05-2024 | <b>Date of Report:</b> | 03-05-2024 | <b>Certificate No:</b> | QC-DQ-04-24-0138-31-01 |

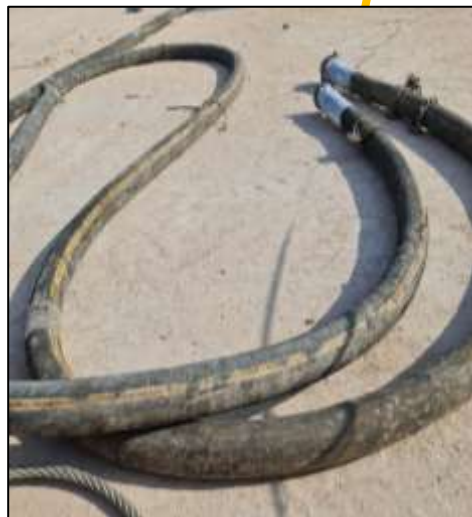
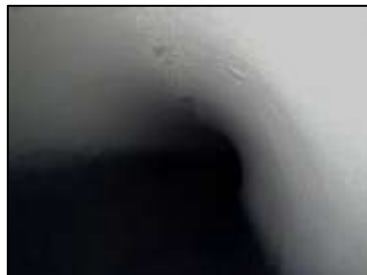
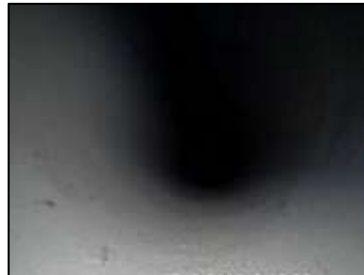
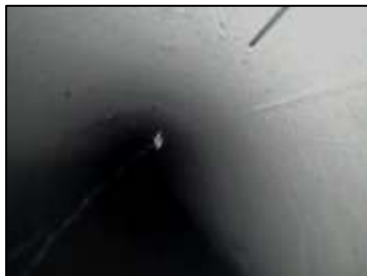
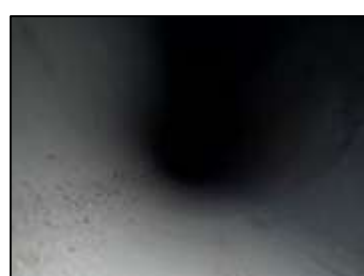
| 1026942 | ROTARY HOSE | 17-01-2023 | | Accepted | |

Check inside for any damage and wear and distortion by using Borescope camera. Visual carried out for the above description and found free of inside defects at the time of inspection

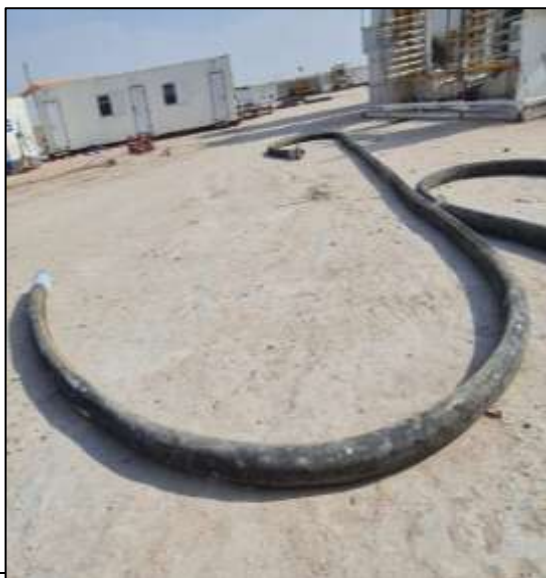
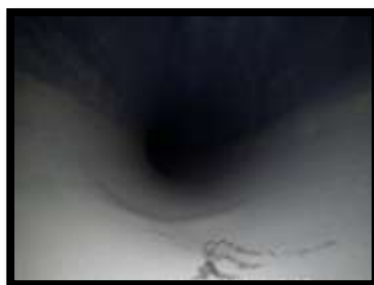
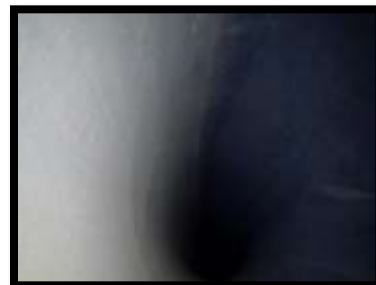
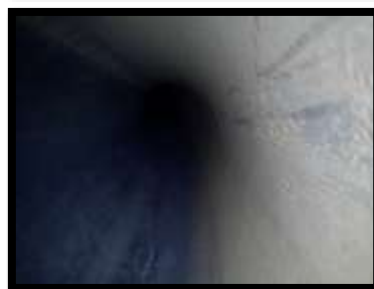
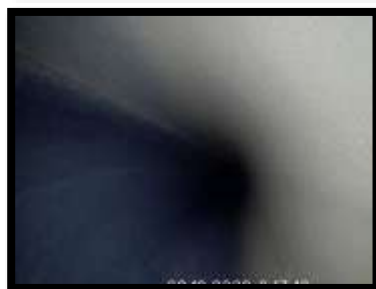
| 1026942 | ROTARY HOSE | | 17-01-2023 | | Accepted |

Check inside for any damage and wear and distortion by using Borescope camera. Visual carried out for the above description and found free of inside defects at the time of inspection

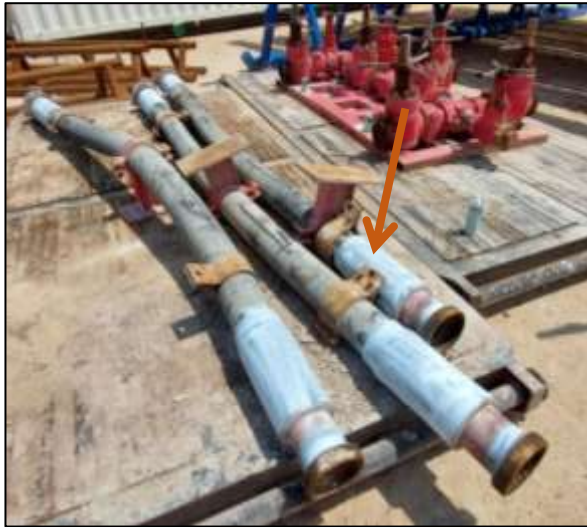
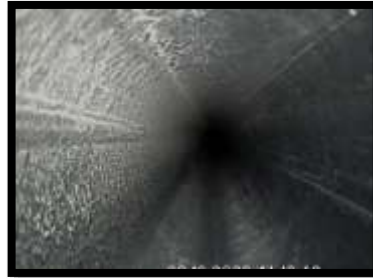
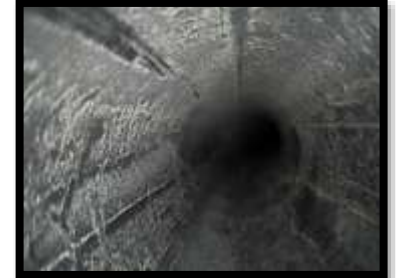
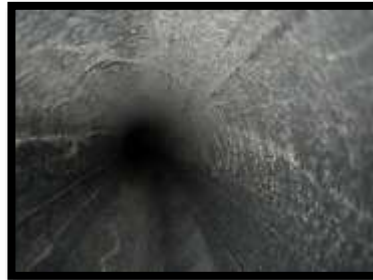
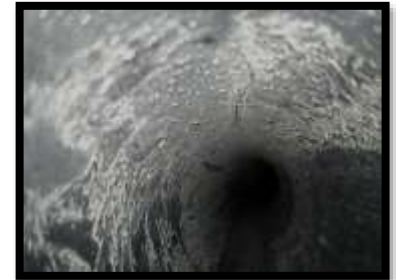
| 2020091444522 | MUD PUMP HOSE | | 17-01-2023 | | <b>Accepted</b> |

Check inside for any damage and wear and distortion by using Borescope camera. Visual carried out for the above description and found free of inside defects at the time of inspection

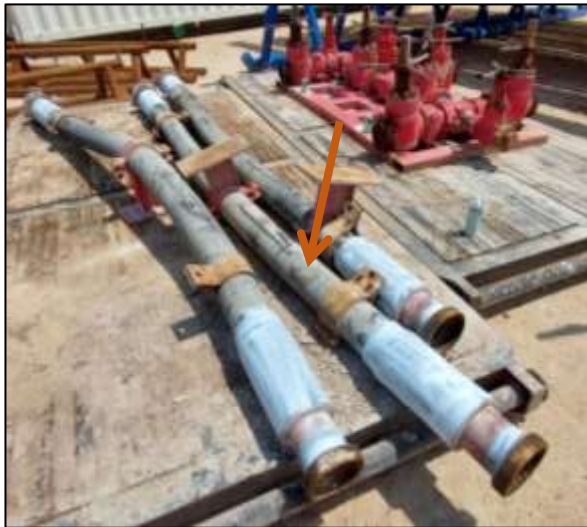
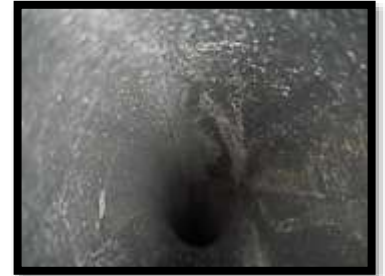
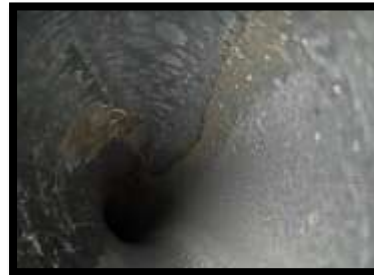
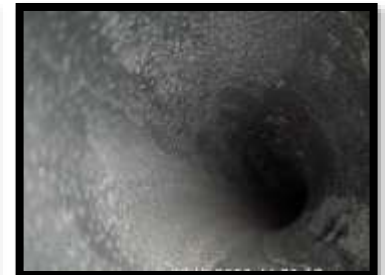
| 2020091444520 | MUD PUMP HOSE | | 17-01-2023 | | Accepted |

Check inside for any damage and wear and distortion by using Borescope camera. Visual carried out for the above description and found free of inside defects at the time of inspection

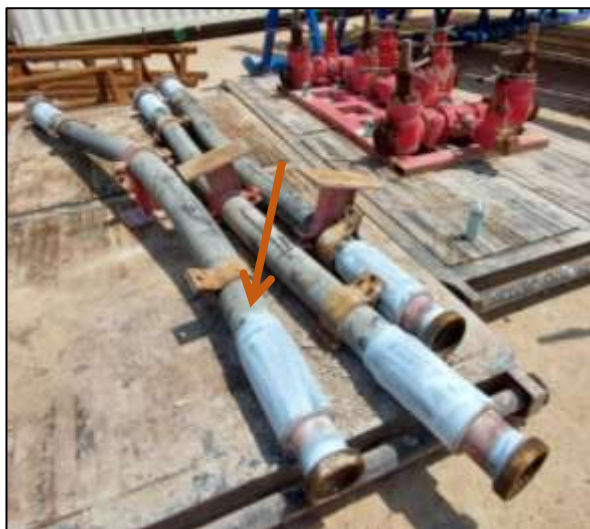
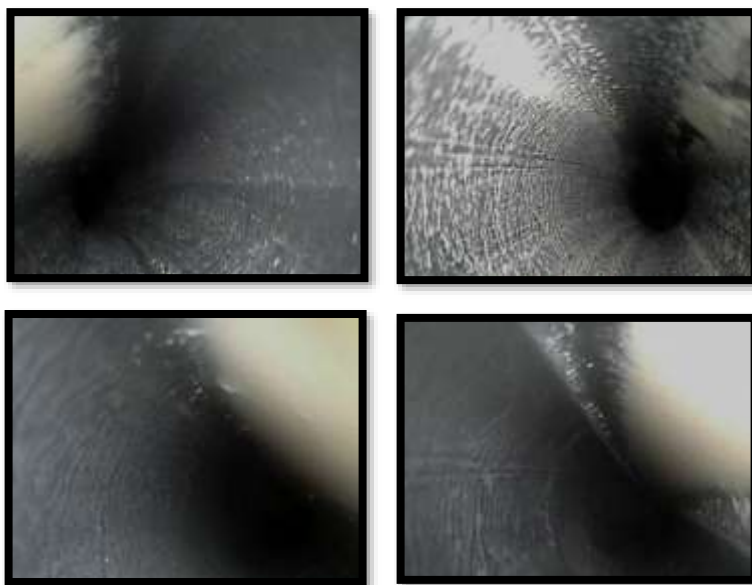
| 2020091444521 | MUD PUMP HOSE | | 17-01-2023 | | <b>Accepted</b> |

Check inside for any damage and wear and distortion by using Borescope camera. Visual carried out for the above description and found free of inside defects at the time of inspection

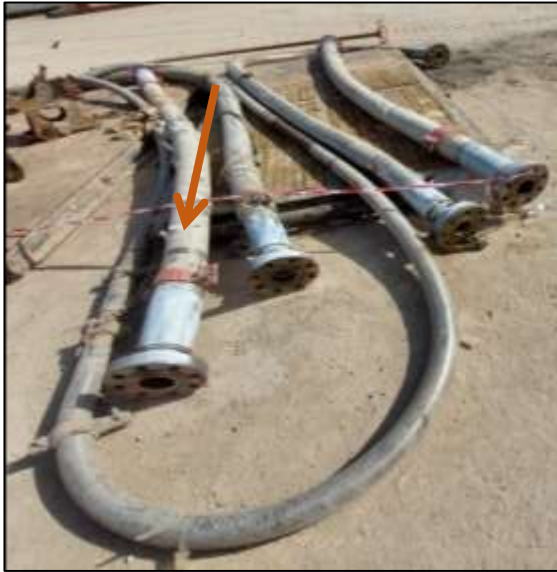
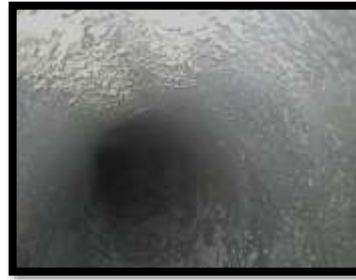
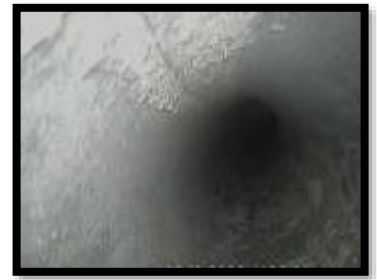
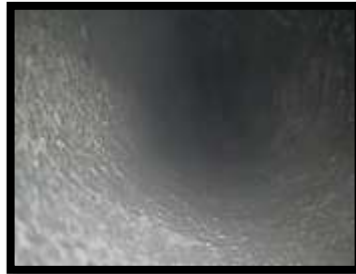
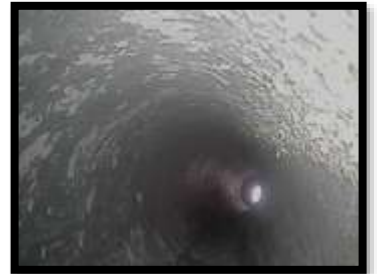
| 2023031140850 | CHOCK MANIFOLD HOSE | | 17-01-2023 | | Accepted |

Check inside for any damage and wear and distortion by using Borescope camera. Visual carried out for the above description and found free of inside defects at the time of inspection

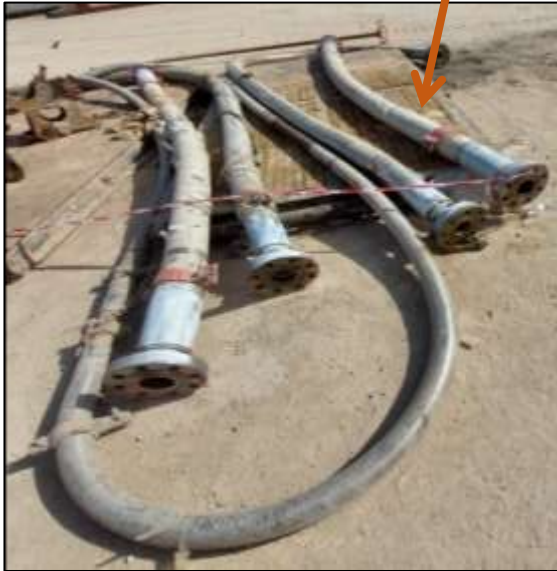
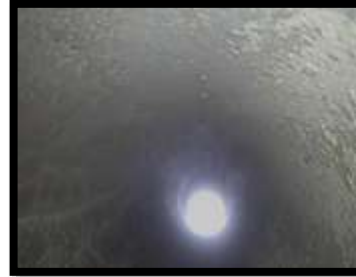
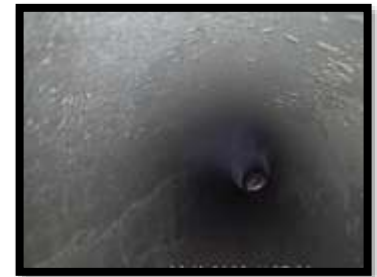
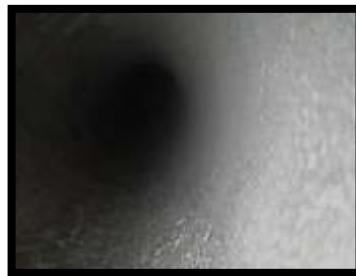
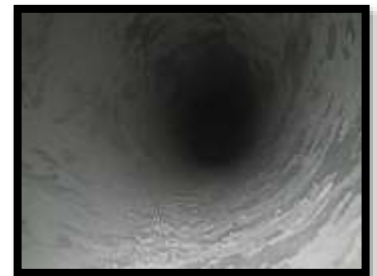
| 2023031140846 | CHOCK MANIFOLD HOSE | | 17-01-2023 | | <b>Accepted</b> |

Check inside for any damage and wear and distortion by using Borescope camera. Visual carried out for the above description and found free of inside defects at the time of inspection

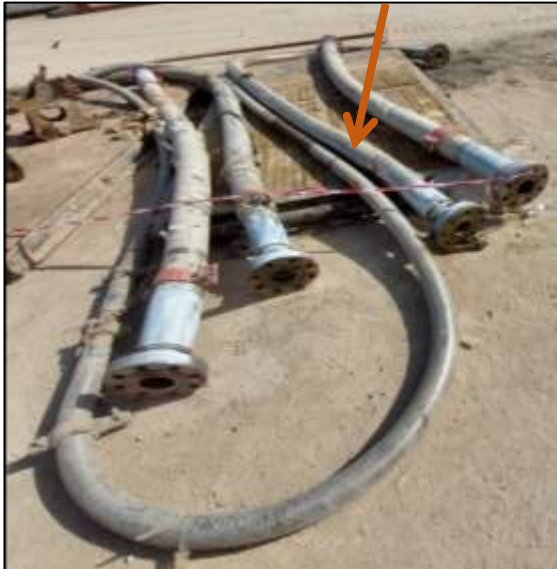
| 210712-102 | CHOCK MANIFOLD HOSE | | 17-01-2023 | | <b>Accepted</b> |

Check inside for any damage and wear and distortion by using Borescope camera. Visual carried out for the above description and found free of inside defects at the time of inspection

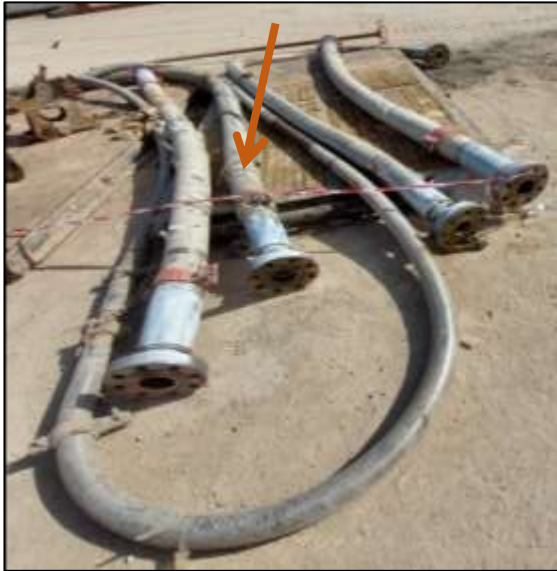
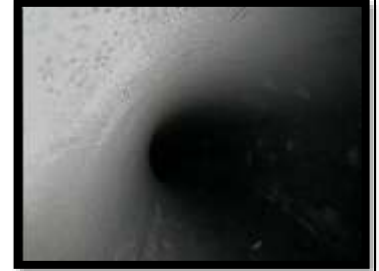
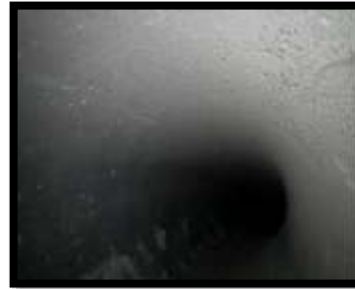
| 210106-101 | CHOCK MANIFOLD HOSE | | 17-01-2023 | | <b>Accepted</b> |

Check inside for any damage and wear and distortion by using Borescope camera. Visual carried out for the above description and found free of inside defects at the time of inspection

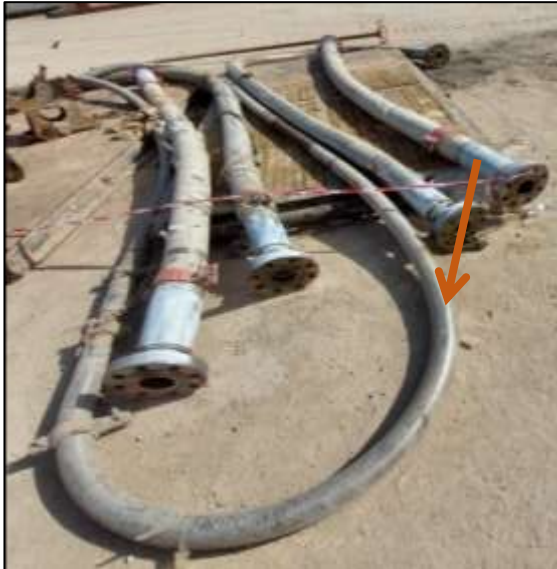
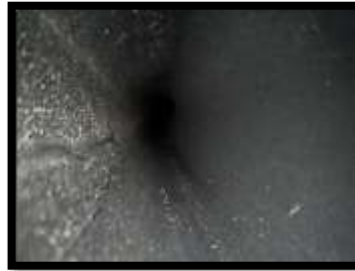
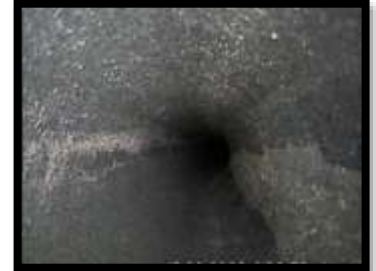
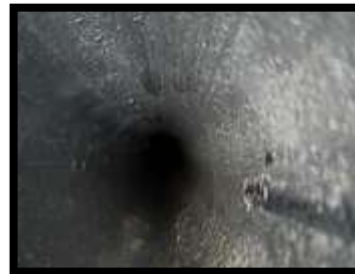
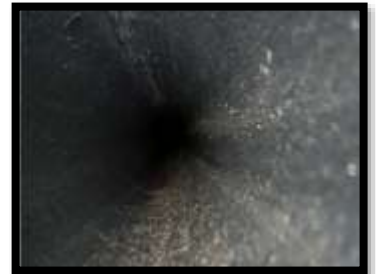
| 514525 | KILL LINE HOSE | | 17-01-2023 | | Accepted |

Check inside for any damage and wear and distortion by using Borescope camera. Visual carried out for the above description and found free of inside defects at the time of inspection

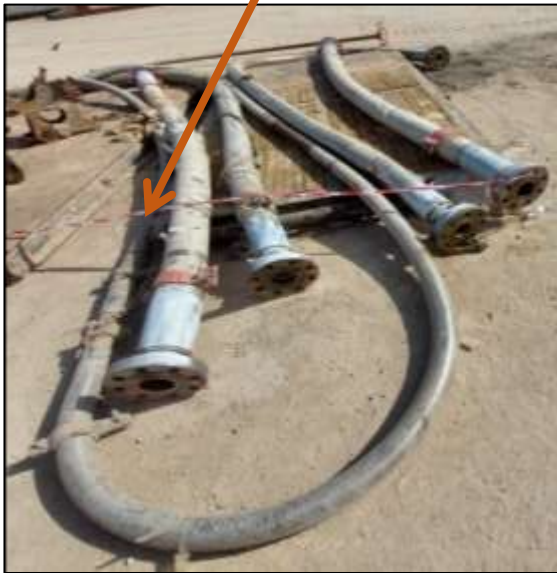
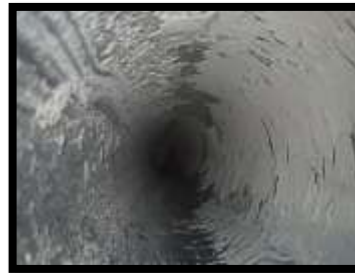
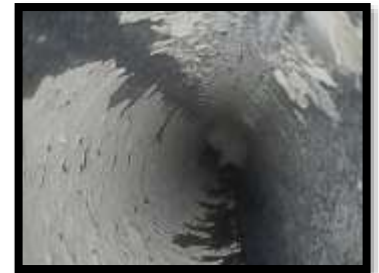
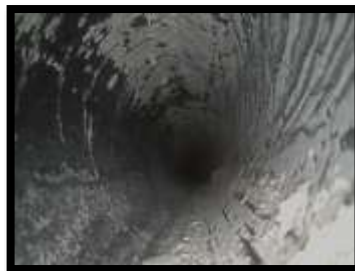
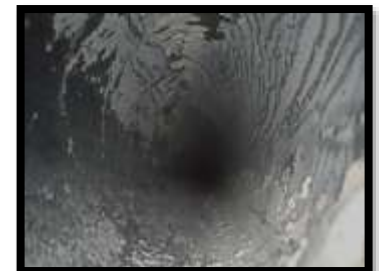
| 514469 | KILL LINE HOSE | | 17-01-2023 | | Accepted |

Check inside for any damage and wear and distortion by using Borescope camera. Visual carried out for the above description and found free of inside defects at the time of inspection
