## Borescope Examination Report

<b>Client Name:</b>	Daqing Drilling Company	<b>Location:</b>	Rig (DQ 1202)	<b>Job Number:</b>	QC-DQ-04-24-0138
<b>Date of Examination:</b>	03-05-2024	<b>Date of Report:</b>	03-05-2024	<b>Certificate No:</b>	QC-DQ-04-24-0138-31-01
<b>Serial Number</b>	<b>Description of the examined equipment</b>				<b>Result</b>
1026942	ROTARY HOSE				<b>Accepted</b>

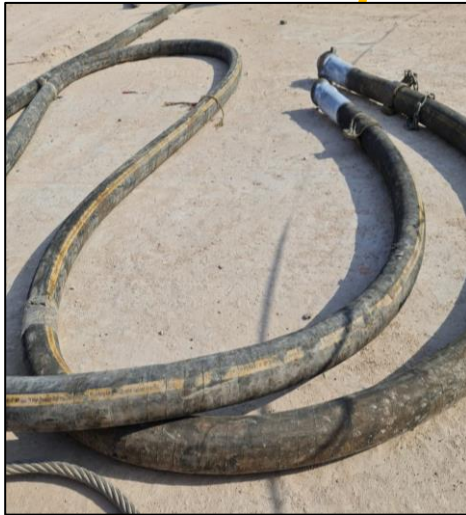
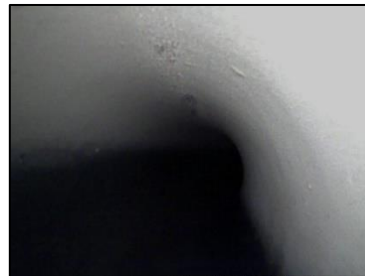
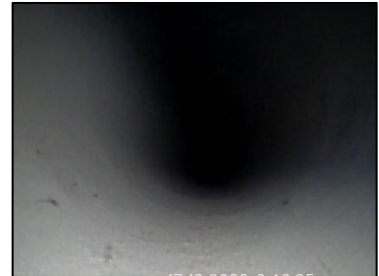
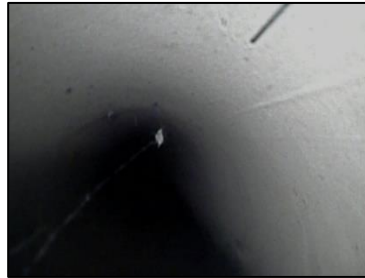
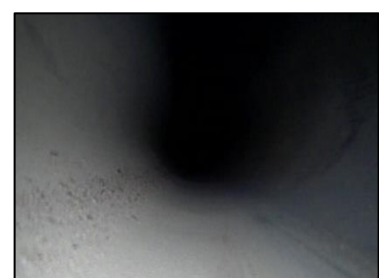
Check inside for any damage and wear and distortion by using Borescope camera. Visual carried out for the above description and found free of inside defects at the time of inspection

**None**

**None**

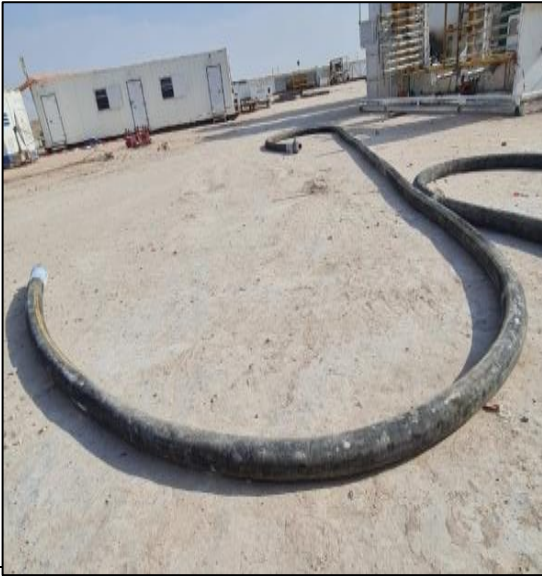
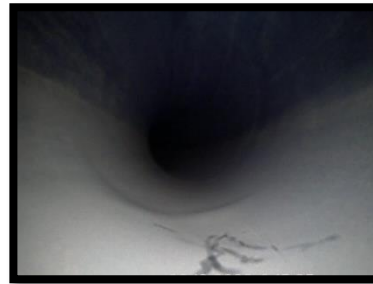
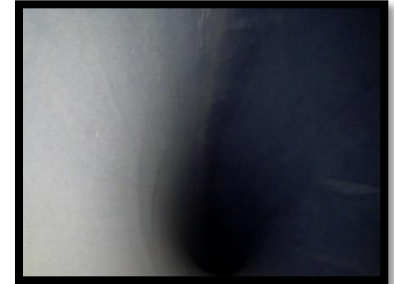
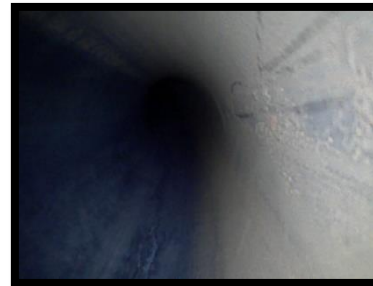
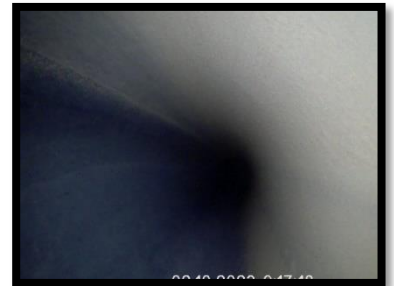
Check inside for any damage and wear and distortion by using Borescope camera. Visual carried out for the above description and found free of inside defects at the time of inspection

**None**

**None**

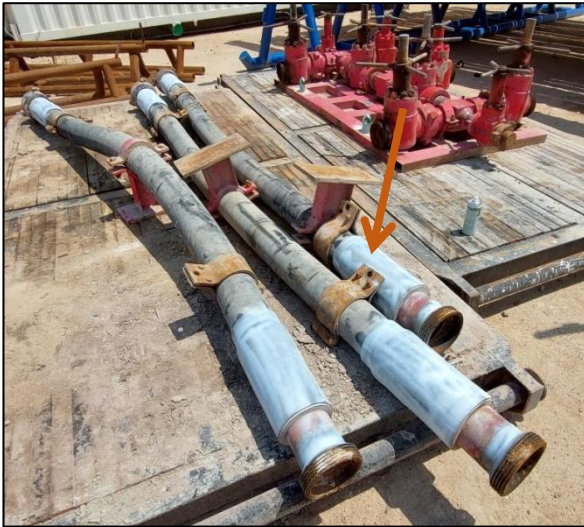
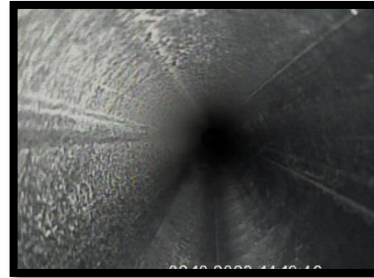
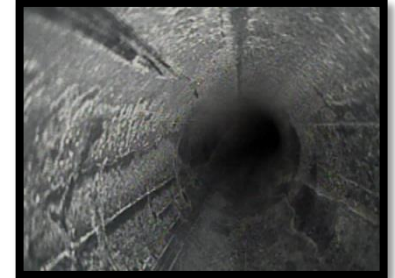
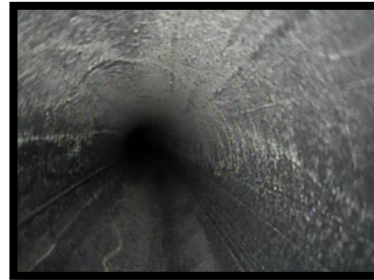
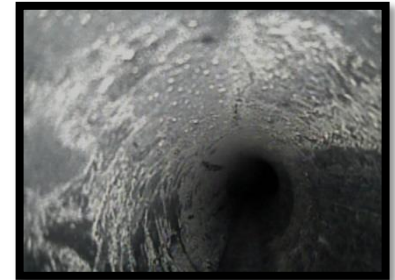
Check inside for any damage and wear and distortion by using Borescope camera. Visual carried out for the above description and found free of inside defects at the time of inspection

**None**

**None**

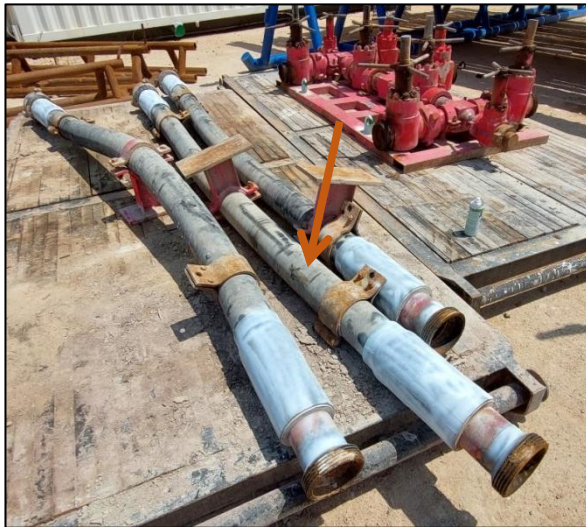
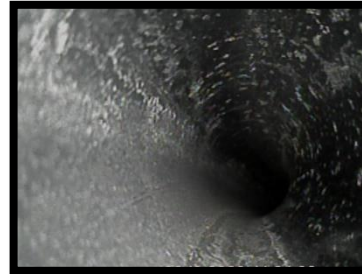
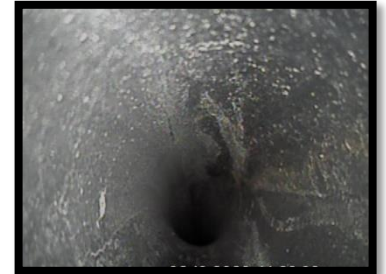
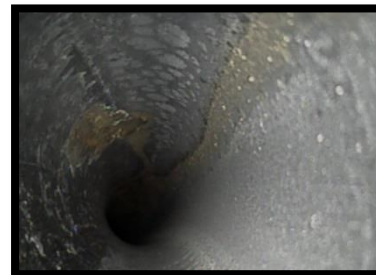
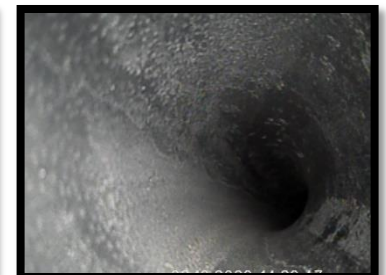
Check inside for any damage and wear and distortion by using Borescope camera. Visual carried out for the above description and found free of inside defects at the time of inspection

**None**

**None**

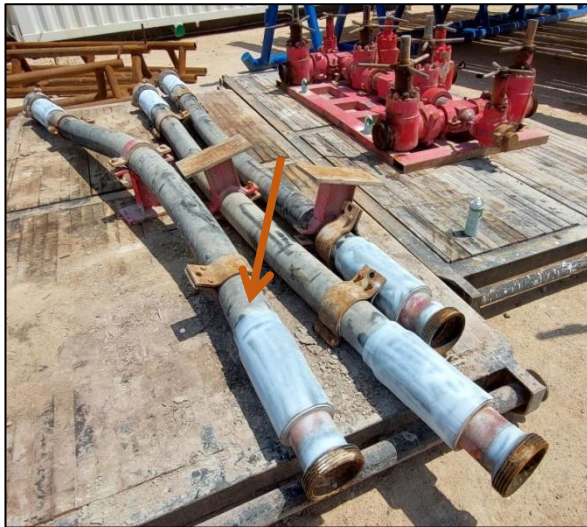
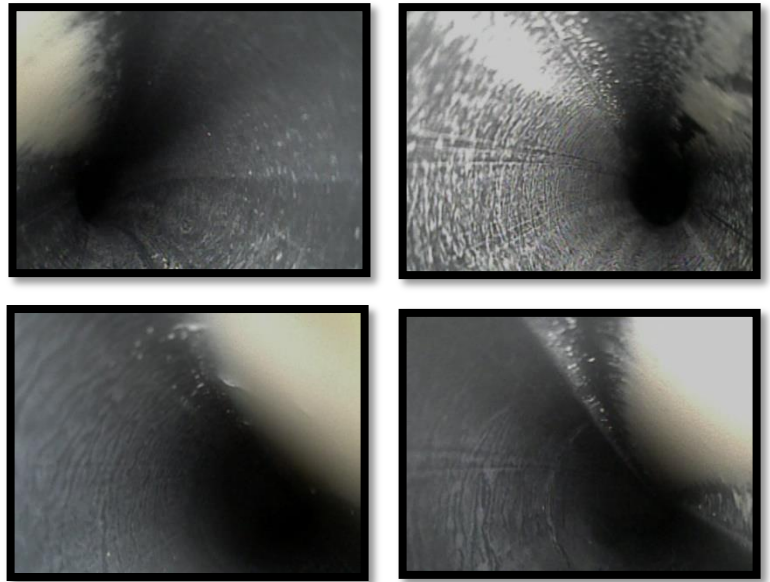
Check inside for any damage and wear and distortion by using Borescope camera. Visual carried out for the above description and found free of inside defects at the time of inspection

**None**

**None**

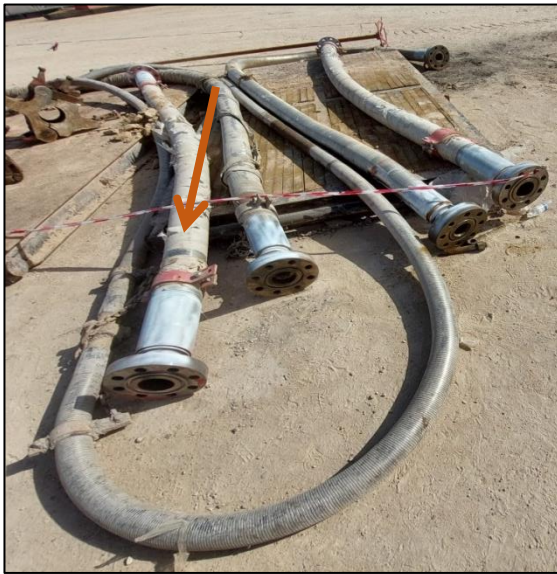
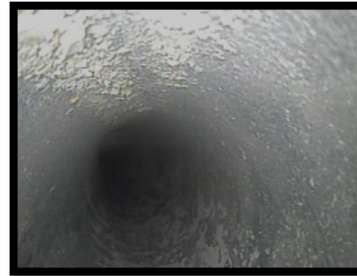
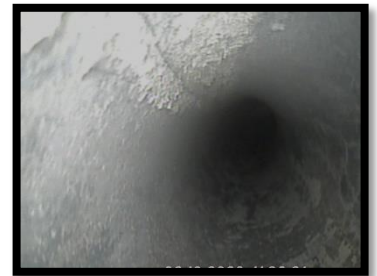
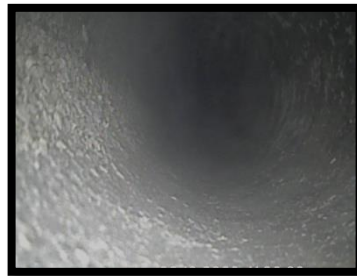
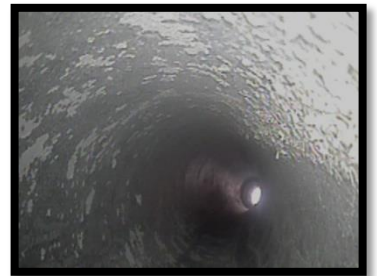
Check inside for any damage and wear and distortion by using Borescope camera. Visual carried out for the above description and found free of inside defects at the time of inspection

**None**

**None**

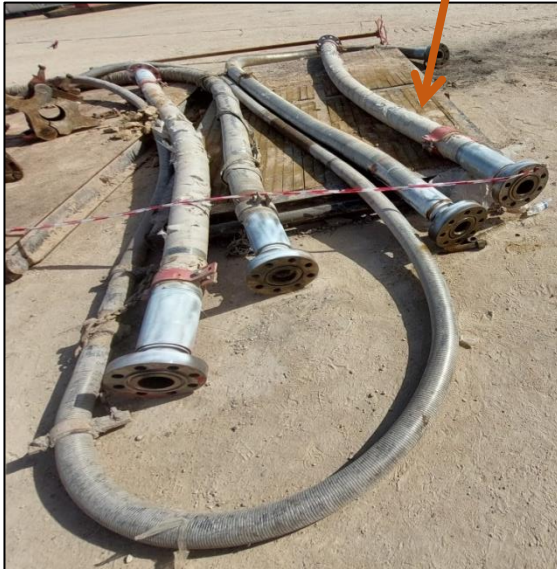
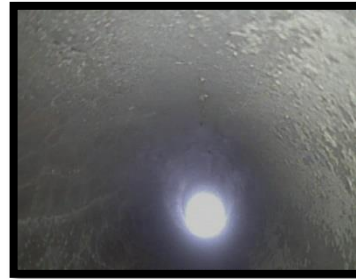
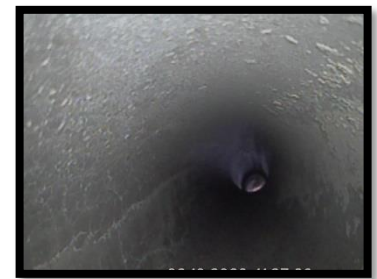
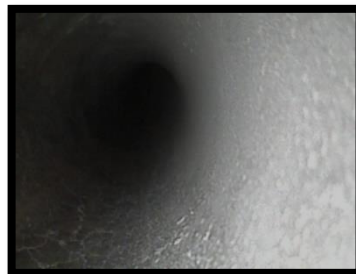
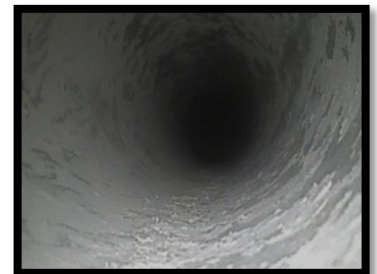
Check inside for any damage and wear and distortion by using Borescope camera. Visual carried out for the above description and found free of inside defects at the time of inspection

**None**

**None**

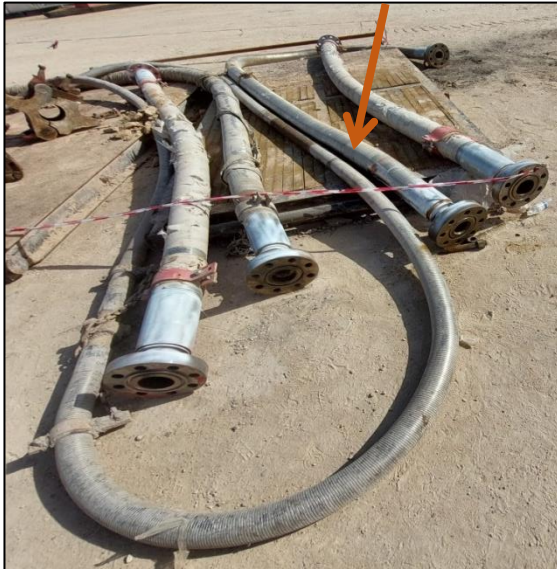
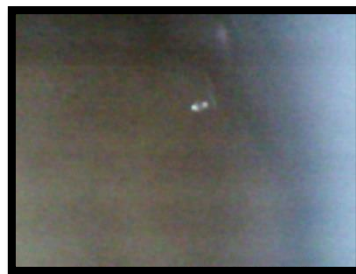
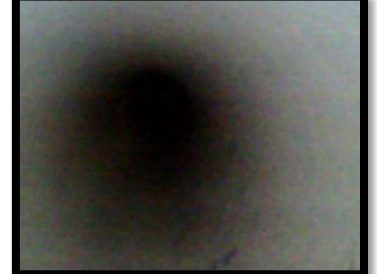
Check inside for any damage and wear and distortion by using Borescope camera. Visual carried out for the above description and found free of inside defects at the time of inspection

**None**

**None**

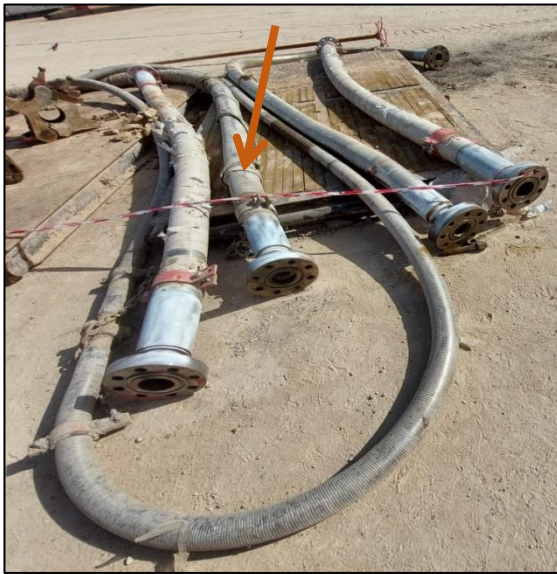
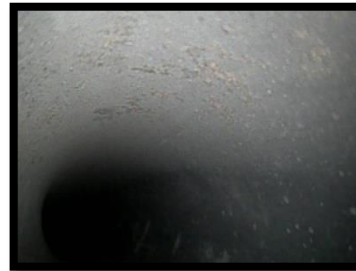
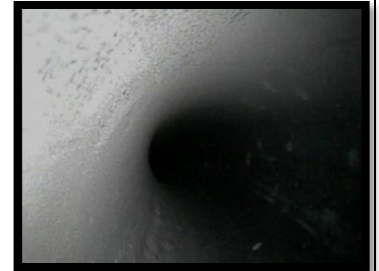
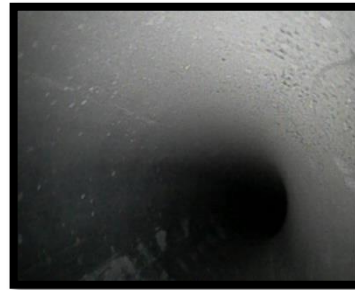
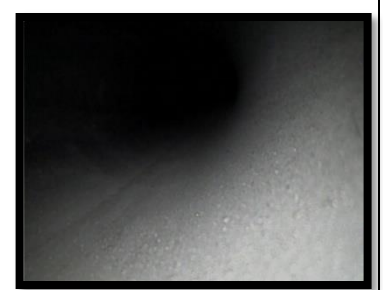
Check inside for any damage and wear and distortion by using Borescope camera. Visual carried out for the above description and found free of inside defects at the time of inspection

**None**

**None**

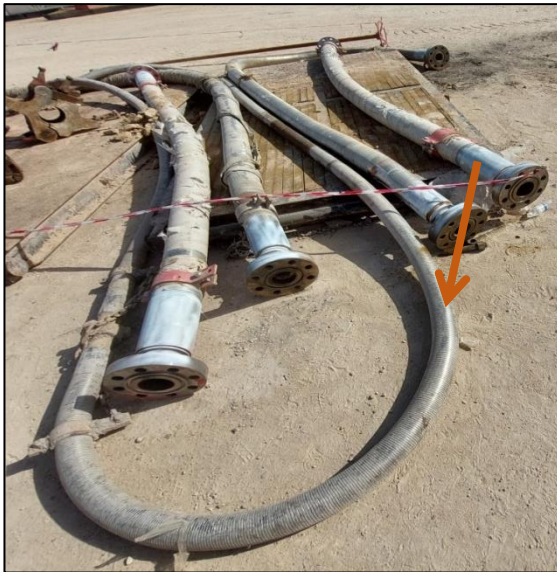
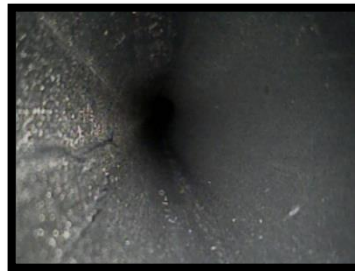
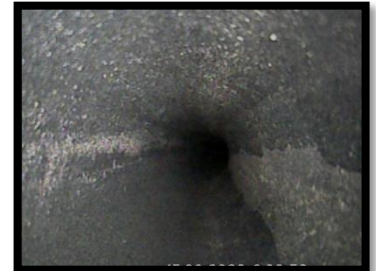
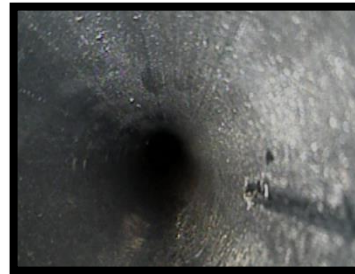
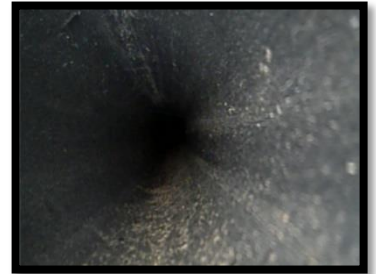
Check inside for any damage and wear and distortion by using Borescope camera. Visual carried out for the above description and found free of inside defects at the time of inspection

**None**

**None**

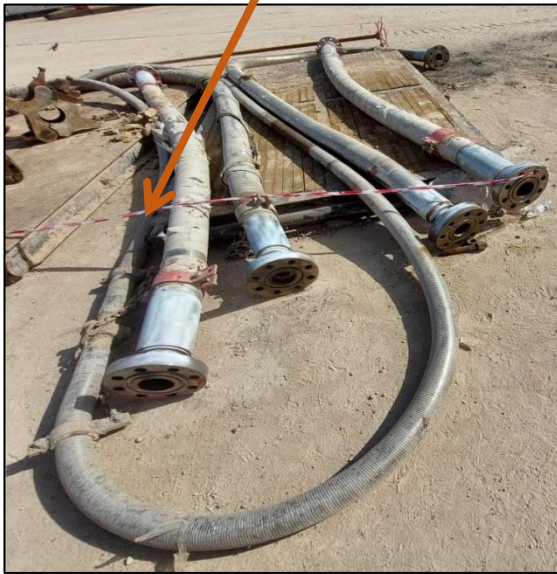
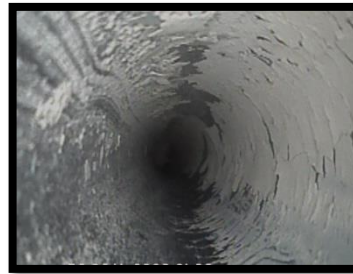
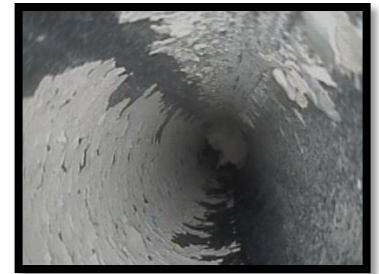
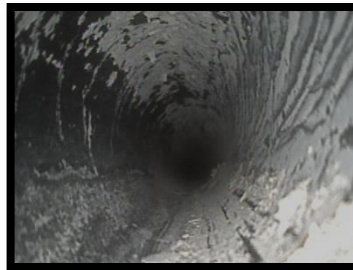
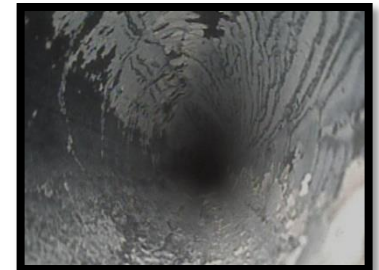
Check inside for any damage and wear and distortion by using Borescope camera. Visual carried out for the above description and found free of inside defects at the time of inspection

**None**

**None**
