## Borescope Examination Report

<b>Client Name:</b>	Daqing Drilling Company	<b>Location:</b>	Rig (DQ 1202)	<b>Job Number:</b>	QC-DQ-04-24-0138
<b>Date of Examination:</b>	03-05-2024	<b>Date of Report:</b>	03-05-2024	<b>Certificate No:</b>	QC-DQ-04-24-0138-31-01
<b>Serial Number</b>	<b>Description of the examined equipment</b>				<b>Result</b>
1026942	ROTARY HOSE				<b>Accepted</b>

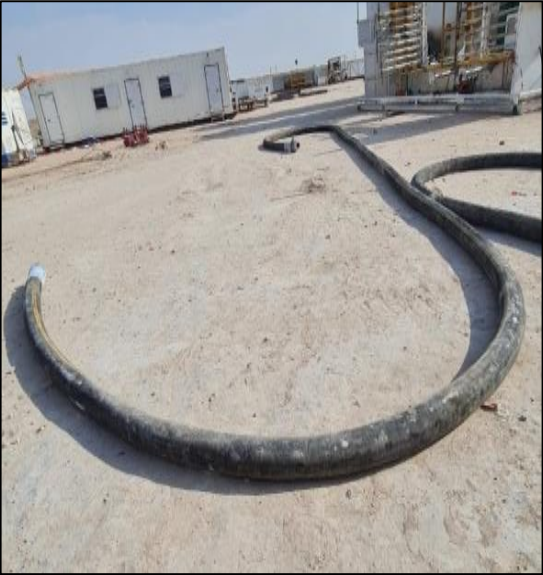
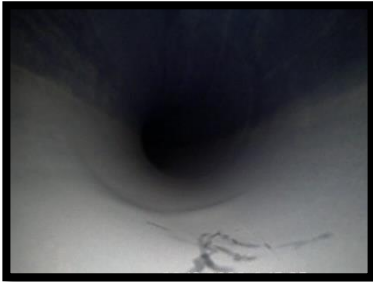
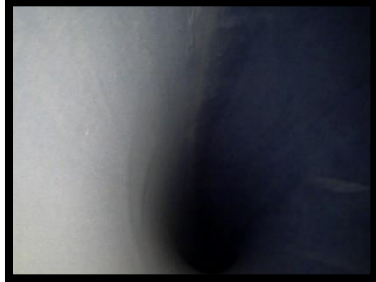
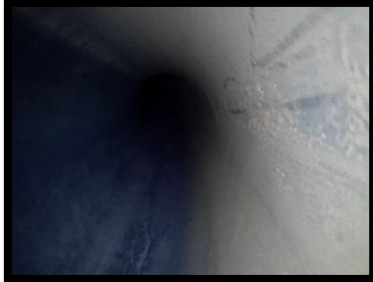
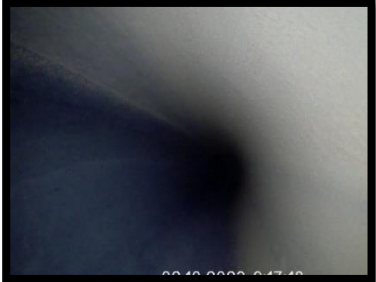
<b>Client Name:</b>	Daqing Drilling Company	<b>Location:</b>	Rig (DQ 1202)	<b>Job Number:</b>	QC-DQ-04-24-0138
<b>Date of Examination:</b>	03-05-2024	<b>Date of Report:</b>	03-05-2024	<b>Certificate No:</b>	QC-DQ-04-24-0138-31-02
<b>Serial Number</b>	<b>Description of the examined equipment</b>				<b>Result</b>
1026947	ROTARY HOSE				Accepted

Check inside for any damage and wear and distortion by using Borescope camera. Visual carried out for the above description and found free of inside defects at the time of inspection

**None**

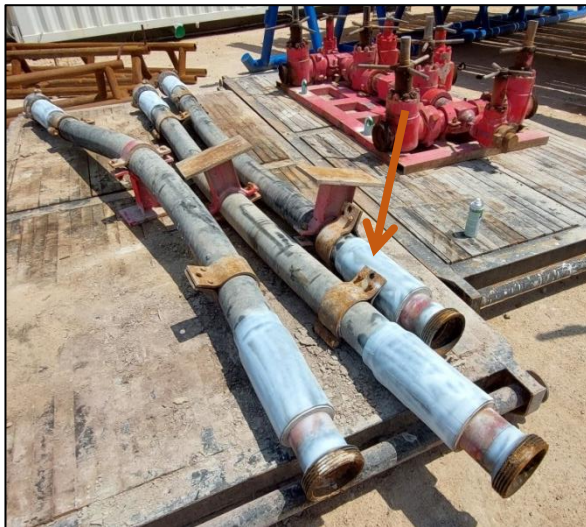
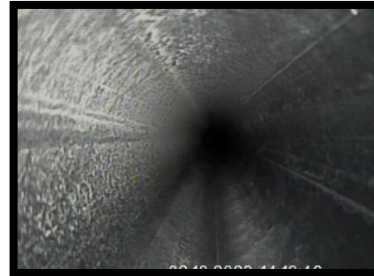
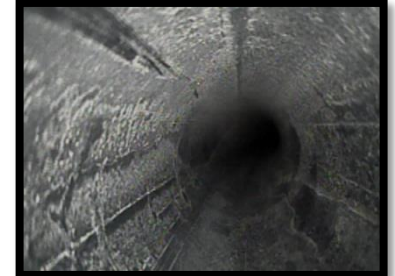
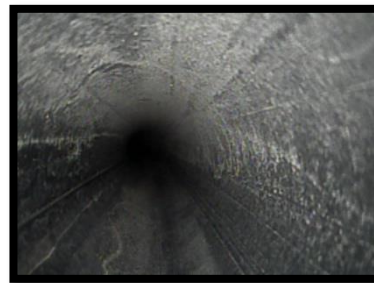
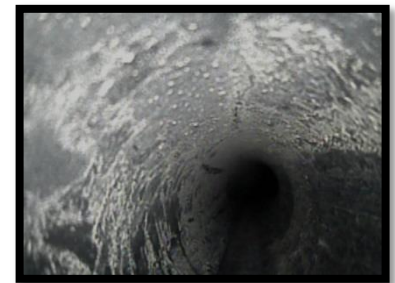
<b>Client Name:</b>	Daqing Drilling Company	<b>Location:</b>	Rig (DQ 1202)	<b>Job Number:</b>	QC-DQ-04-24-0138
<b>Date of Examination:</b>	03-05-2024	<b>Date of Report:</b>	03-05-2024	<b>Certificate No:</b>	QC-DQ-04-24-0138-31-03
<b>Serial Number</b>	<b>Description of the examined equipment</b>				<b>Result</b>
2020091444522	MUD PUMP HOSE				<b>Accepted</b>

Check inside for any damage and wear and distortion by using Borescope camera. Visual carried out for the above description and found free of inside defects at the time of inspection

**None**

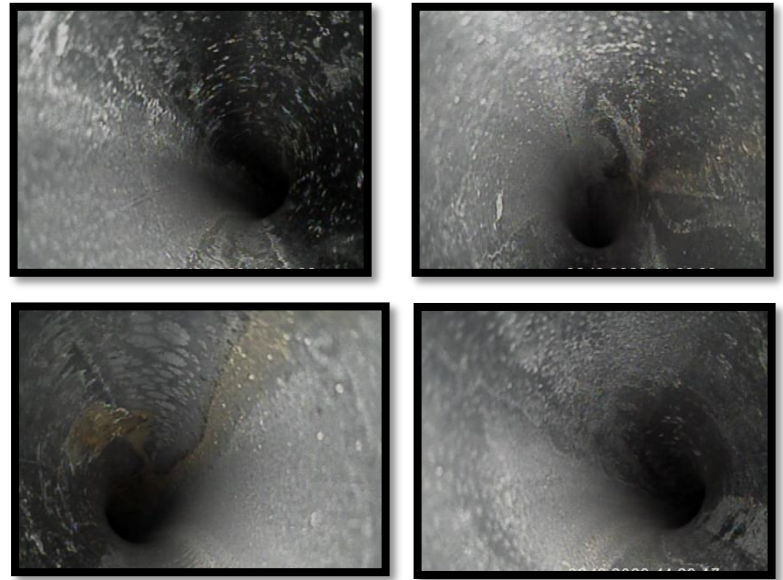
<b>Client Name:</b>	Daqing Drilling Company	<b>Location:</b>	Rig (DQ 1202)	<b>Job Number:</b>	QC-DQ-04-24-0138
<b>Date of Examination:</b>	03-05-2024	<b>Date of Report:</b>	03-05-2024	<b>Certificate No:</b>	QC-DQ-04-24-0138-31-04
<b>Serial Number</b>	<b>Description of the examined equipment</b>				<b>Result</b>
2020091444520	MUD PUMP HOSE				<b>Accepted</b>

Equipment Details					
Standard	API Spec 7k API Spec 16C	Equipment type	Borescope MIQAS	S/N:	M22030007
Test Method	Visual Test (Inside Hose)				
Procedure					
Check inside for any damage and wear and distortion by using Borescope camera. Visual carried out for the					
above description and found free of inside defects at the time of inspection					
Identification of any part found to have a defect and a description of the defect:					
None					
Particulars of any repair, renewal or alteration required to remedy the defect identified above:					
None

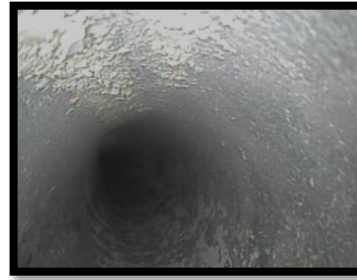
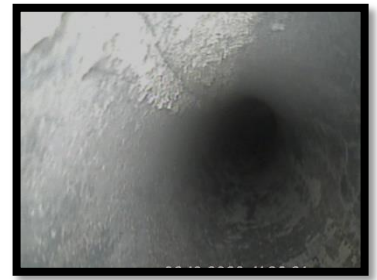
<b>Client Name:</b>	Daqing Drilling Company	<b>Location:</b>	Rig (DQ 1202)	<b>Job Number:</b>	QC-DQ-04-24-0138
<b>Date of Examination:</b>	03-05-2024	<b>Date of Report:</b>	03-05-2024	<b>Certificate No:</b>	QC-DQ-04-24-0138-31-06
<b>Serial Number</b>	<b>Description of the examined equipment</b>				<b>Result</b>
2023031140850	CHOCK MANIFOLD HOSE				<b>Accepted</b>

Check inside for any damage and wear and distortion by using Borescope camera. Visual carried out for the above description and found free of inside defects at the time of inspection

**None**

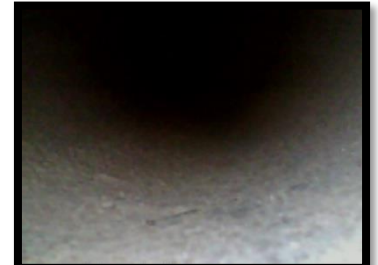
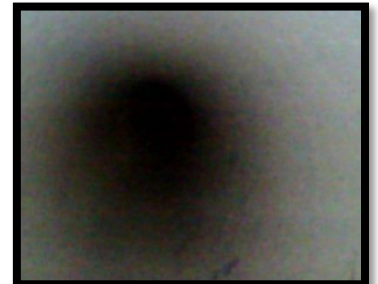
<b>Client Name:</b>	Daqing Drilling Company	<b>Location:</b>	Rig (DQ 1202)	<b>Job Number:</b>	QC-DQ-04-24-0138
<b>Date of Examination:</b>	03-05-2024	<b>Date of Report:</b>	03-05-2024	<b>Certificate No:</b>	QC-DQ-04-24-0138-31-08
<b>Serial Number</b>	<b>Description of the examined equipment</b>				<b>Result</b>
210712-102	CHOCK MANIFOLD HOSE				<b>Accepted</b>

Check inside for any damage and wear and distortion by using Borescope camera. Visual carried out for the above description and found free of inside defects at the time of inspection

**None**

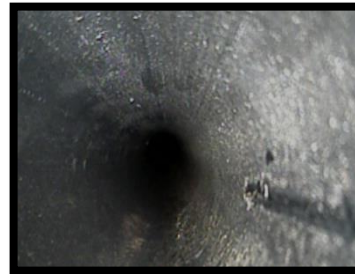
<b>Client Name:</b>	Daqing Drilling Company	<b>Location:</b>	Rig (DQ 1202)	<b>Job Number:</b>	QC-DQ-04-24-0138
<b>Date of Examination:</b>	03-05-2024	<b>Date of Report:</b>	03-05-2024	<b>Certificate No:</b>	QC-DQ-04-24-0138-31-10
<b>Serial Number</b>	<b>Description of the examined equipment</b>				<b>Result</b>
514525	KILL LINE HOSE				<b>Accepted</b>

Check inside for any damage and wear and distortion by using Borescope camera. Visual carried out for the above description and found free of inside defects at the time of inspection

**None**

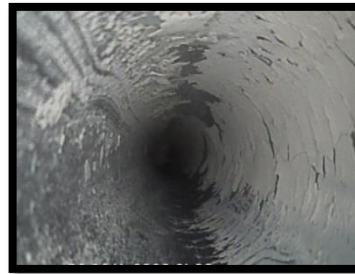
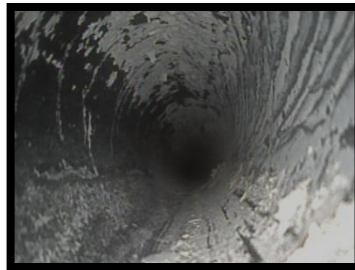
<b>Client Name:</b>	Daqing Drilling Company	<b>Location:</b>	Rig (DQ 1202)	<b>Job Number:</b>	QC-DQ-04-24-0138
<b>Date of Examination:</b>	03-05-2024	<b>Date of Report:</b>	03-05-2024	<b>Certificate No:</b>	QC-DQ-04-24-0138-31-11
<b>Serial Number</b>	<b>Description of the examined equipment</b>				<b>Result</b>
514469	KILL LINE HOSE				<b>Accepted</b>

Check inside for any damage and wear and distortion by using Borescope camera. Visual carried out for the above description and found free of inside defects at the time of inspection

**None**
