Visual & Magnetic Particles Examination Report

| Client Name: | Ecolog International FZE | Date of Examination: | 16-03-2024 | Job Number: | QC-Ecolog-03-24-0087 |
| Location: | Ecolog International FZE Yard Basra Iraq | | | Certificate No: | QC-Ecolog-03-24-0087-01 |
| ECO-1 | Connection Of Jack Truck | | | | Pass |

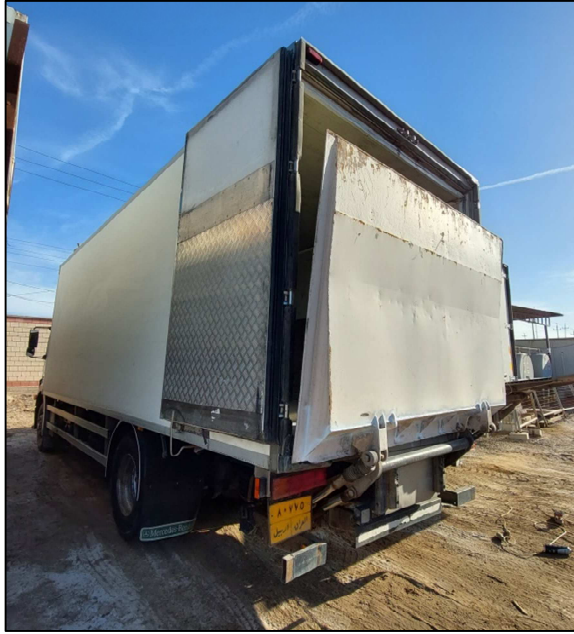
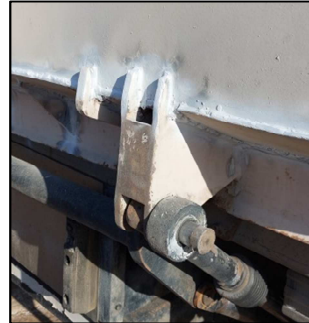
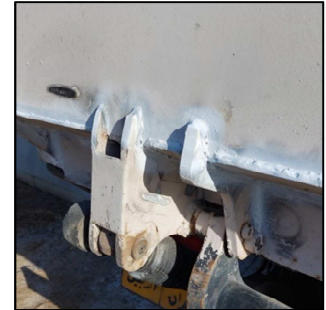
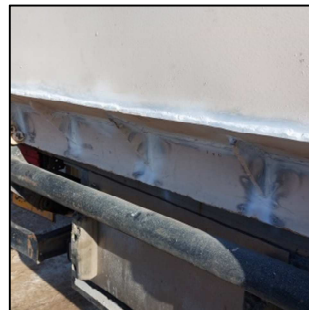
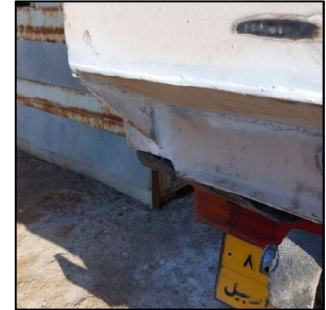
Visual and MPI carried out for the above description and found free of surface defects at the time of inspection

None

None
