Certificate of visual and thorough examination & Load Test

Date of Examination:	07-03-2024	Date of Report:	07-03-2024	Certificate No:	QC-ATS-03-24-0042-01
Client Name:	Aberdeen Company	Location:	Aberdeen Yard	Job Number:	QC-ATS-03-24-0042

Serial Number:	QTY	Description	SWL	PROOF LOAD TEST
ATS-WLFA-23-001	01	<p><u>Wheeled Loader Forklift Attachment- Telescopic</u></p> <p>Fully Welded Steel Construction with Lifting Pad Eye Lifting Pad Eye SN: B1 Dimension: 3416 MM (L) X 1432 MM (W) X 1044 MM (H)</p> <p>Manufacture: Aberdeen Technical Services Date of Manufacture: Nov-2023</p> <p>The distance between the first lifting point:1975 MM, SWL:1095 Kg The distance between the second lifting point:3285 MM, SWL:610 Kg</p> <p>Tare Weight: 625 KG</p>	1095 Kg	1642.5 Kg 1.5 X SWL Static 1205 Kg 1.1 X SWL Dynamic
			610 Kg	915 Kg 1.5 X SWL Static 671 Kg 1.1 X SWL Dynamic

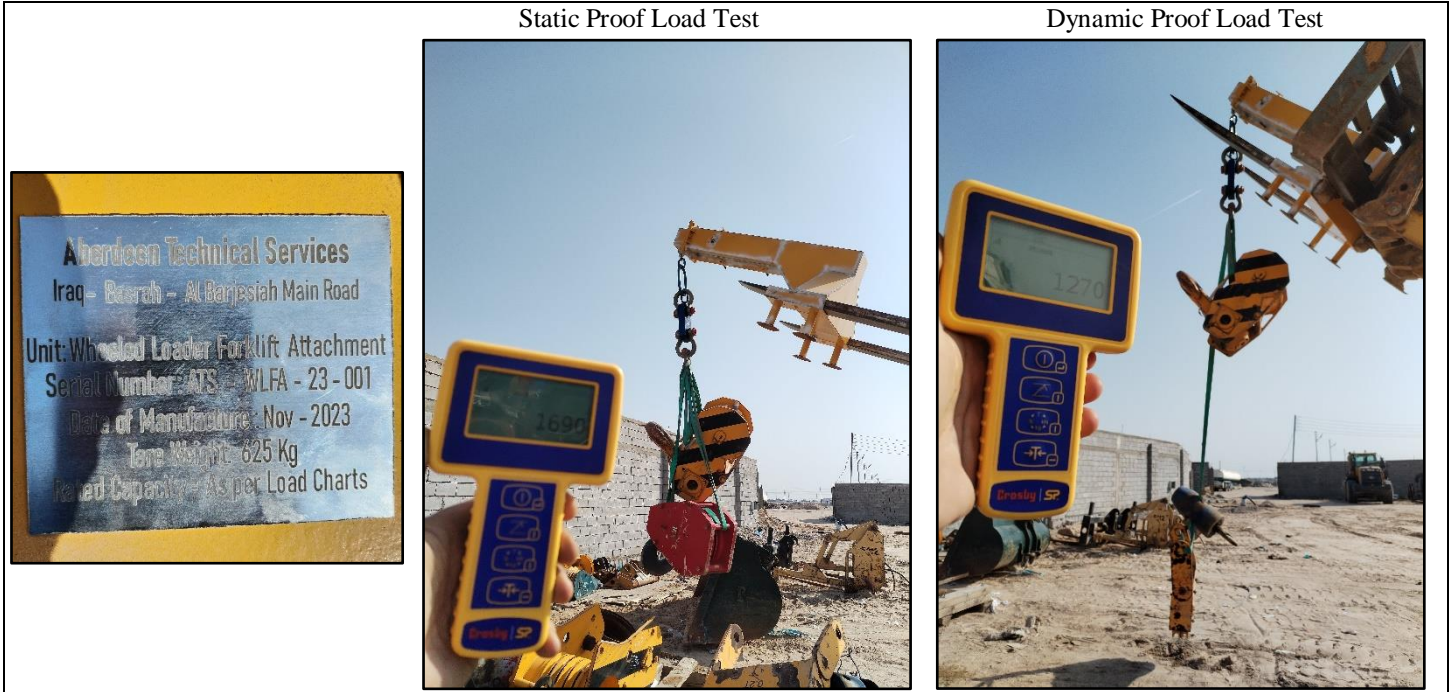
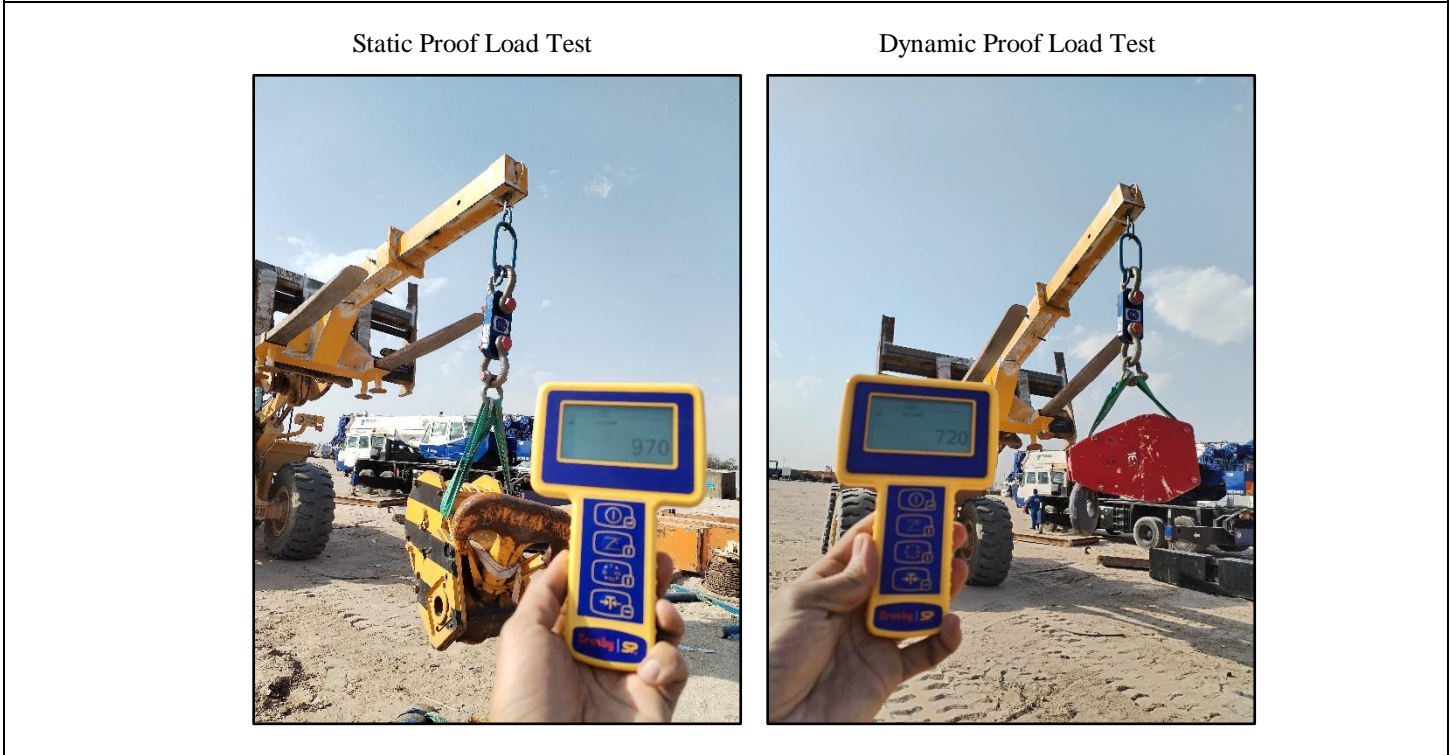
** The subject Items were inspected Visually and dimensionally where no signs of defects were observed at the time of inspection and found satisfactory ** MPI was carried out on the pad eyes Welding Areas and found satisfactory ** Allowable deflection during test.
