VISUAL & DYE PENETRANT EXAMINATION REPORT

Client Name:	Ecolog International FZE	Date of Examination:	16-03-2024	Job Number:	QC-Ecolog-03-24-0087
Location:	Ecolog International FZE Yard Basra Iraq			Certificate No:	QC-Ecolog-03-24-0087-03

Serial Number	Description of the examined equipment	Result
ECO-3	Connection Of Jack Truck	Pass

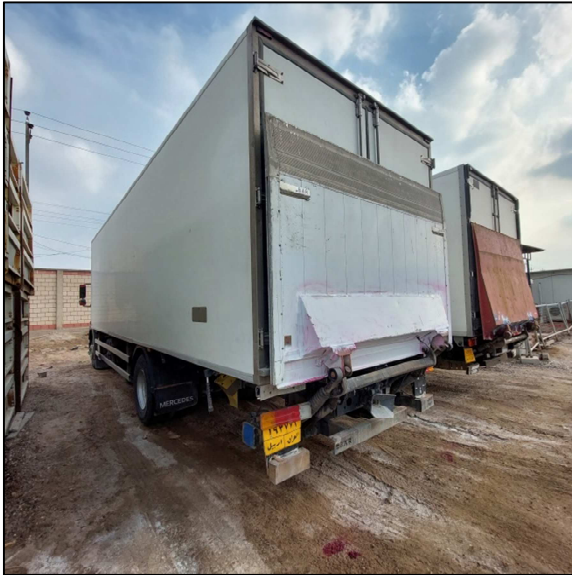
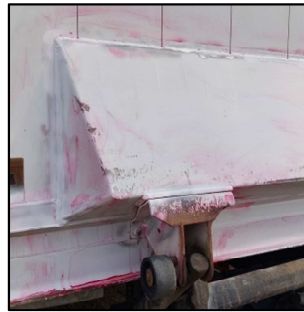
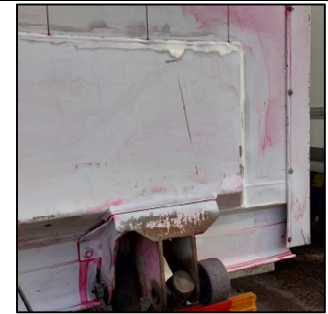
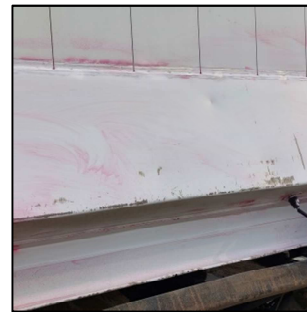
VISUAL, THOROUGH EXAMINATION	Above Item fully inspected and found freedom from deforms, cracks, corrosion & mechanical damage
DYE PENETRANT INSPECTION (DPI)	forge areas inspected and found freedom from cracks and other defects
None	
All DPI Performed as Per Instructions of OEM:
