Visual & Magnetic Particles Examination Report

Client Name:	DAQING DRILLING COMPANY, Iraq			Certificate No:	QC-DQ-05-24-0163-007
Date of Examination:	22-May-2024	Rig & Location:	DQ-037 RU-610	Job Number:	DQ037-RUM-GPS-OPS-2024052101
Serial Number:	Description of the Examined Equipment:				Result:
9069 / 6970	ELEVATOR TDS LINKS				PASS:
Load Rating:	500 Ton

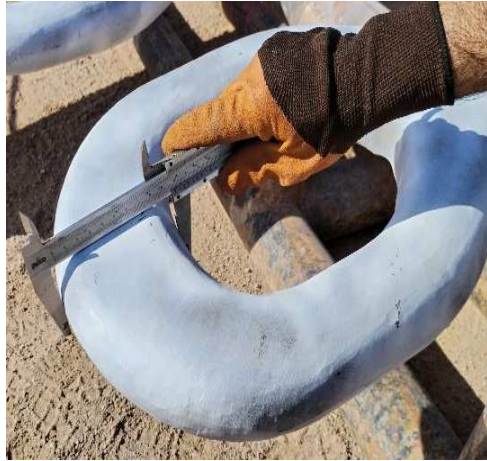
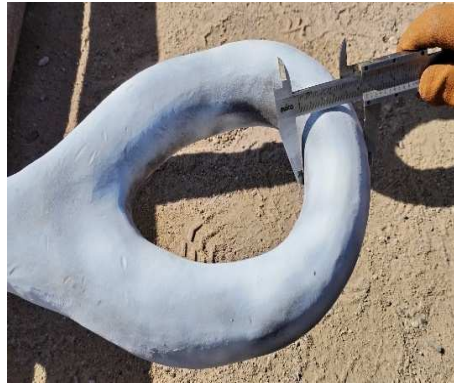
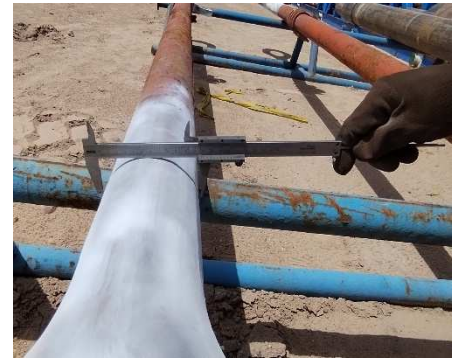
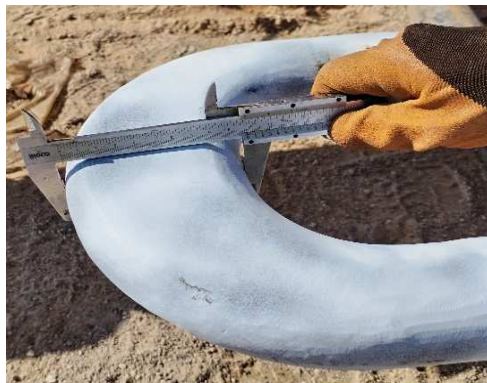
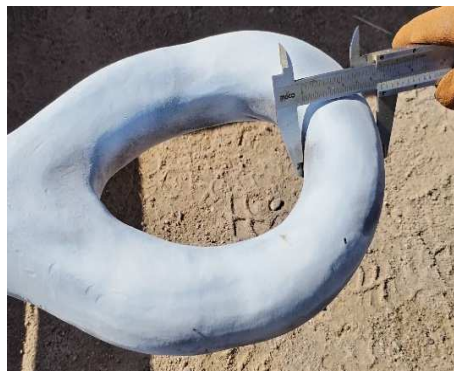
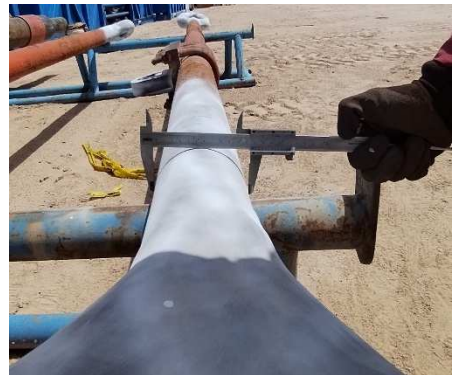
PICTORIAL:

Visual and MPI Carried out for The Above Description and Found Free of Surface Defects at the Time of Inspection:

- The Elevator TDS Link Has Been Inspected and Found Conformable to the Relevant Standard(s)
- The Rig Was Equipped with ZHEJIANG ZHONGHENG INSTRUMENT AND GAUGE CO. LTD Elevator Links.
- Elevator Links Found Stripped Down /Dismantling Condition for CAT III Inspection:
