## Visual & Magnetic Particles Examination Report

Client:	Hong Hua Oil& Gas Engineering Services Ltd	Certificate no:	QC-HH-02-25-051/06
Location:	HH Rig 008	Job Order No:	QC-HH-02-25-051
Date of Examination:	07-Feb-2025	Next Inspection Due:	06-Aug-2025
Serial Number	Description of the examined equipment	Result	
HH-05	SNATCH BLOCK	Accept	
SWL	2 TON

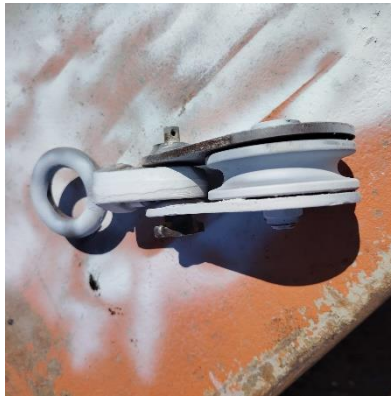
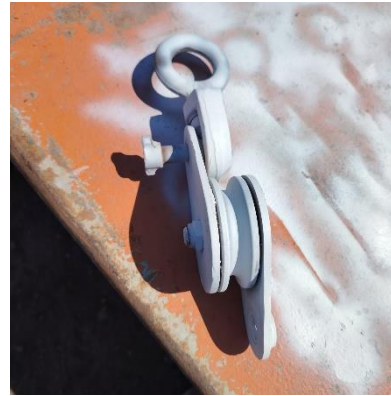
NDT procedure	
Visual and MPI were carried out for the above description and found free of surface defects at the time of inspection	
Identification of any part found to have a defect and a description of the defect: None	
Particulars of any repair, renewal, or alteration required to remedy the defect identified above: None	
All MPI was performed as per the instructions of OEM, and the measurements were done by OEM.

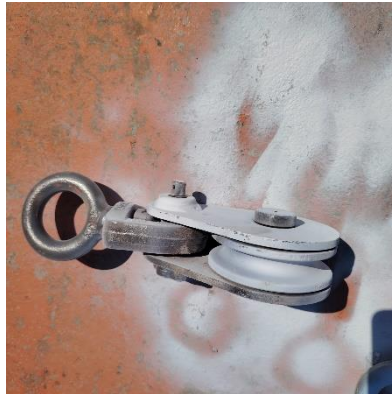
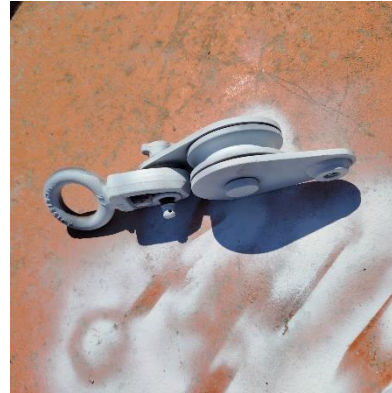
Client:	Hong Hua Oil& Gas Engineering Services Ltd	Certificate no:	QC-HH-02-25-051/07
Location:	HH Rig 008	Job Order No:	QC-HH-02-25-051
Date of Examination:	07-Feb-2025	Next Inspection Due:	06-Aug-2025
Serial Number	Description of the examined equipment	Result	
HH-04	SNATCH BLOCK	Accept	
SWL	2 TON

Visual and MPI were carried out for the above description and found free of surface defects at the time of inspection

Identification of any part found to have a defect and a description of the defect: None

Particulars of any repair, renewal, or alteration required to remedy the defect identified above: None

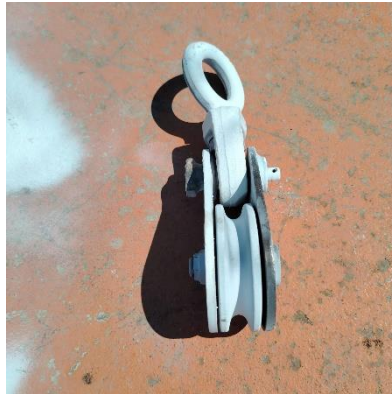
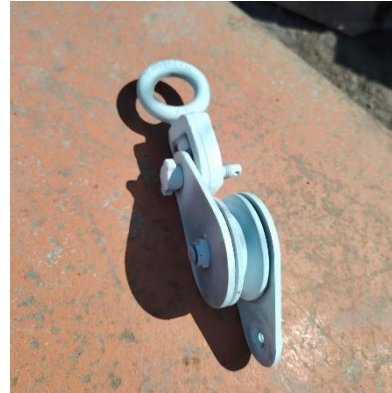
Client:	Hong Hua Oil& Gas Engineering Services Ltd	Certificate no:	QC-HH-02-25-051/06
Location:	HH Rig 008	Job Order No:	QC-HH-02-25-051
Date of Examination:	07-Feb-2025	Next Inspection Due:	06-Aug-2025
Serial Number	Description of the examined equipment	Result	
HH-03	SNATCH BLOCK	Accept	
SWL	2 TON

Visual and MPI were carried out for the above description and found free of surface defects at the time of inspection

Identification of any part found to have a defect and a description of the defect: None

Particulars of any repair, renewal, or alteration required to remedy the defect identified above: None
