Visual & Magnetic Particles Examination Report

Client Name:	Daqing Drilling Company			**Job Number:**	QC-DQ-01-2024-0030
Date of Examination:	17.01.2024	**Location:**	DQ BASE	**Certificate No:**	QC-DQ-01-2024-0030/62

Serial Number	Description of the examined equipment		
11121	Power Casing Tong (Hang Point)	Result	Pass
Sensor Connection SN	4	Size:	4 1/2” – 13 3/8”

CERTIFICATE OF THOROUGH EXAMINATION

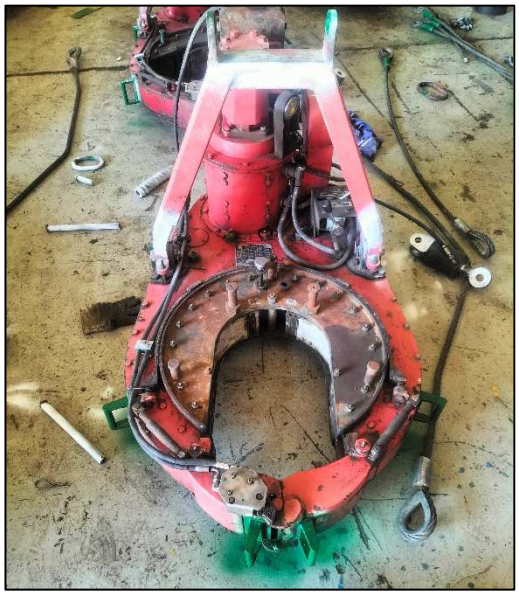
NDT procedure
Visual and MPI carried out for the above description and found free of surface defects at the time of inspection
Identification of any part found to have a defect and a description of the defect:
None
Particulars of any repair, renewal or alteration required to remedy the defect identified above:
None
