CERTIFICATION OF VISUAL, THOROUGH EXAMINATION & MAGNETIC PARTICLE INSPECTION

Client:	HALLIBURTON (HPS)	Report No:	QC-25-02-HPS-NDT-002A	
Location:	HPS YARD	JOB NO:	3022025	
Inspection Date:	Monday, February 3, 2025	Next Inspection Date:	Saturday, August 2, 2025	
Type Of Inspection:	VISUAL , THOROUGH EXAMINATION & MAGNETIC PARTICLE INSPECTION	Specification:	ASTM E709 & ASTM E 1444 (2016) ASME V Article 7 (2019)

CERTIFICATE OF QUALIFICATION VISUAL INSPECTION AND LEAK TESTING

CLIENT:	HALLIBURTON (HPS)		
LOCATION:	HPS YARD	REPORT No.:	QC-25-HALL-HPS-FEB- VT & LEAK -002B
STANDARD:	CUSOMER SPECIFICATION	JOB NO:	3022025
INSPECTION DATE:	Monday, February 3, 2025	Due Date	Saturday, August 2, 2025
TYPE OF INSPECTION:	*VISUAL TESTING AND *LEAK TESTING		
DESCRIPTION:	FRAC TANK	SAP NO:	11918665
MEDIUM USED:	WATER	HOLDING TIME:	15 MINUTES

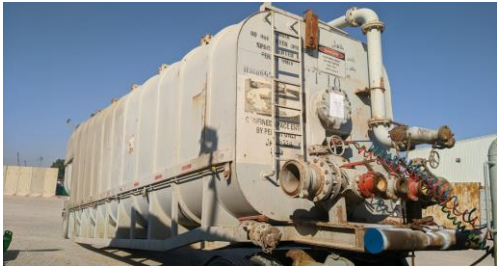
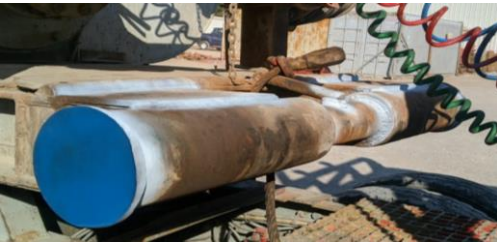
UNIT DESCRIPTION:	FRAC TANK LIFTING LUGS		
	UNIT S/N:	11918665		
	UNIT DIM:	11.50 M (L) X 2.50 M (W) X 3.50 M (H)		
	INSPECTION RESULT :			
	VISUAL , THOROUGH EXAMINATION	unit fully inspected and found free from deforms, cracks, corrosion & mechanical damage		
	MAGNETIC PARTICLE INSPECTION	Welds & forgn areas inspected and found free from cracks and other defects		
FINAL RESULTS	unit found satisfactory and free of defects at the time of inspection			
COMMENT:

Magnetic Particle Inspection With A/C Hand Yoke , Black & White Contrast

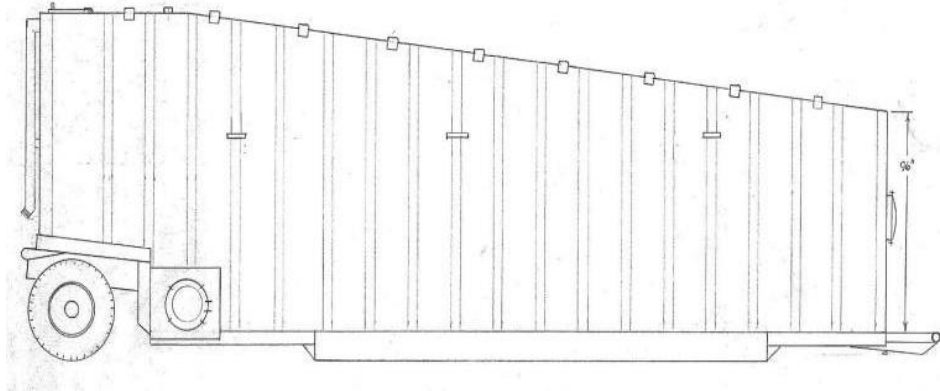
PICTURES

VISUAL TESTING:	Visual Testing of Frac Tank did not found Deforms Mechanical Damage, Cracks and Corrosion. At time of Inspection.
LEAK TESTING:	Leak Testing of Frac Tank did not found any leakage during the holding time. At time of Inspection.

VISUAL TESTING-The above mentioned Frac Tank was found "Satisfactory" Fit for intended used.

LEAK TESTING- The above mentioned Frac Tank was found "Satisfactory" Fit for intended used.
