INSPECTION RIG: HH008

Visual & Magnetic Particles Examination Report

Client:	Hong Hua Oil& Gas Engineering Services Ltd	Certificate no:	QC-HH-01-25-028-001
Location:	HH Rig 008	Job Order No:	QC-HH-01-25-028
Date of Examination:	31-January-2025	Next Inspection Due:	30-January-2030

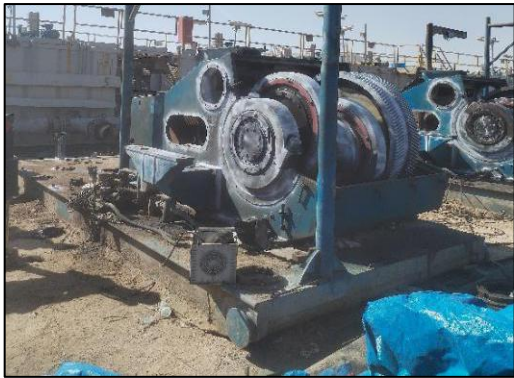
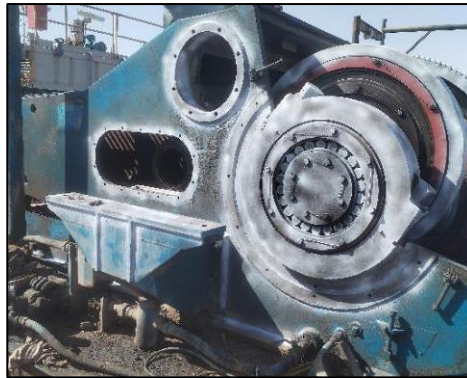
Serial Number	Description of the examined equipment	Result
12-159	Mud Pump # 3 Frame Assembly	Pass

Visual and MPI were carried out for the above description and found free of surface defects at the time of inspection

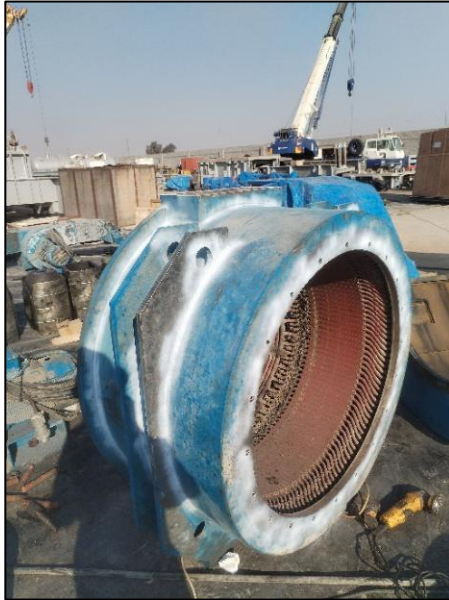
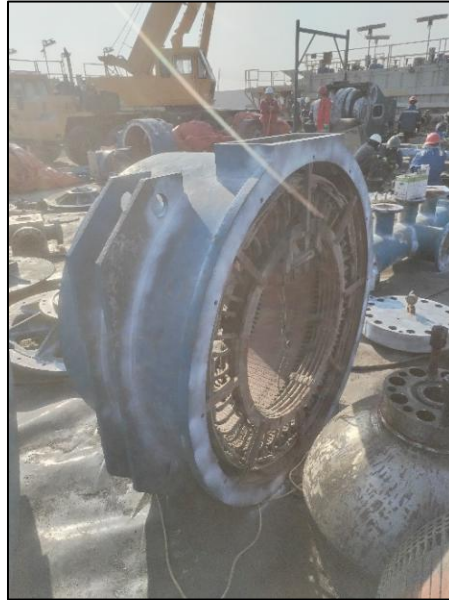
Serial Number	Description of the examined equipment	Result
12-159	Mud Pump # 3 Ac Drilling Motor	Pass

Visual and MPI were carried out for the above description and found free of surface defects at the time of inspection
Identification of any part found to have a defect and a description of the defect: None
Particulars of any repair, renewal, or alteration required to remedy the defect identified above: None
All MPI was performed as per the instructions of OEM, and the measurements were done by OEM.

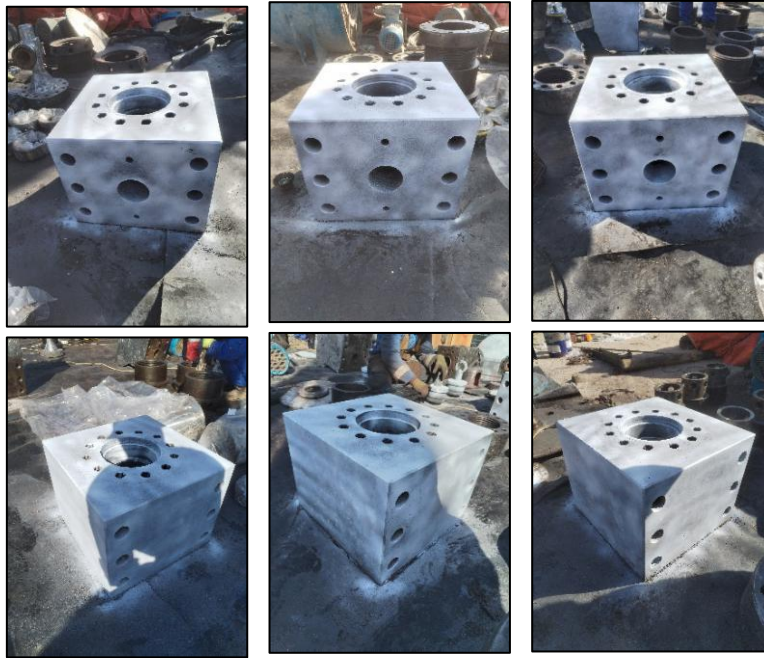
Serial Number	Description of the examined equipment	Result
12-159	3 EA Suction Cylinder Assembly Mud Pump # 3	Pass

Visual and MPI were carried out for the above description and found free of surface defects at the time of inspection
Identification of any part found to have a defect and a description of the defect: None
Particulars of any repair, renewal, or alteration required to remedy the defect identified above: None
All MPI was performed as per the instructions of OEM, and the measurements were done by OEM.

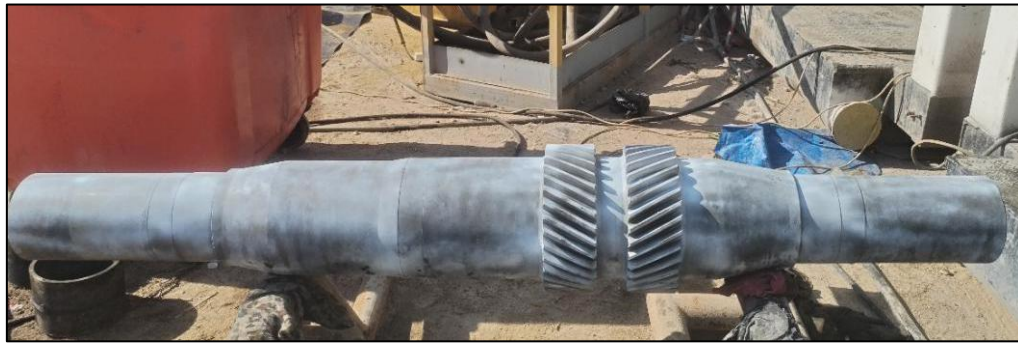
Serial Number	Description of the examined equipment	Result
12-159	Pinion Shaft Mud Pump # 3	Pass

Visual and MPI were carried out for the above description and found free of surface defects at the time of inspection
Identification of any part found to have a defect and a description of the defect: None
Particulars of any repair, renewal, or alteration required to remedy the defect identified above: None
All MPI was performed as per the instructions of OEM, and the measurements were done by OEM.

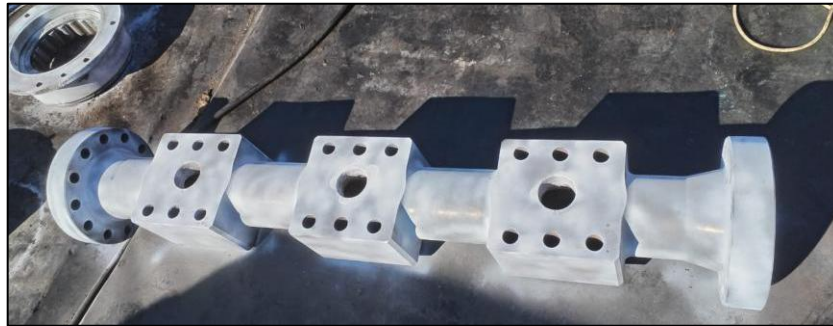
Serial Number	Description of the examined equipment	Result
12-159	Discharge Pipeline Mud Pump # 3	Pass

Visual and MPI were carried out for the above description and found free of surface defects at the time of inspection
Identification of any part found to have a defect and a description of the defect: None
Particulars of any repair, renewal, or alteration required to remedy the defect identified above: None
All MPI was performed as per the instructions of OEM, and the measurements were done by OEM.

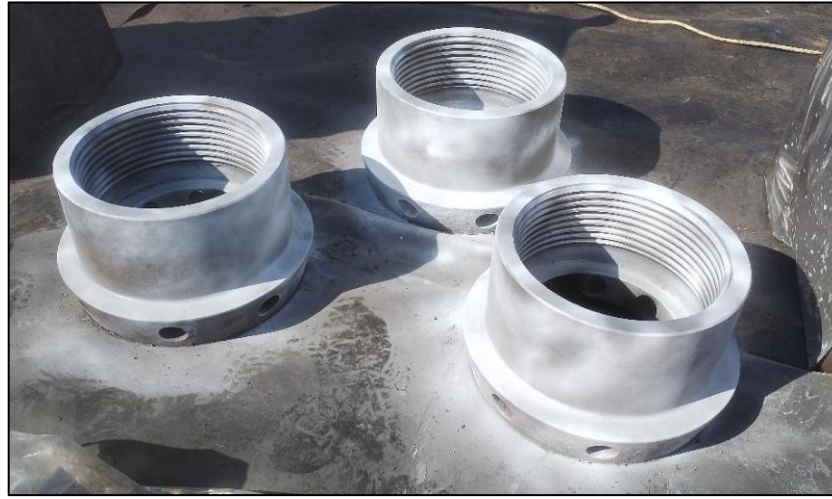
Serial Number	Description of the examined equipment	Result
12-159	3 EA Liner Gland Mud Pump # 3	Pass

Visual and MPI were carried out for the above description and found free of surface defects at the time of inspection
Identification of any part found to have a defect and a description of the defect: None
Particulars of any repair, renewal, or alteration required to remedy the defect identified above: None
All MPI was performed as per the instructions of OEM, and the measurements were done by OEM.

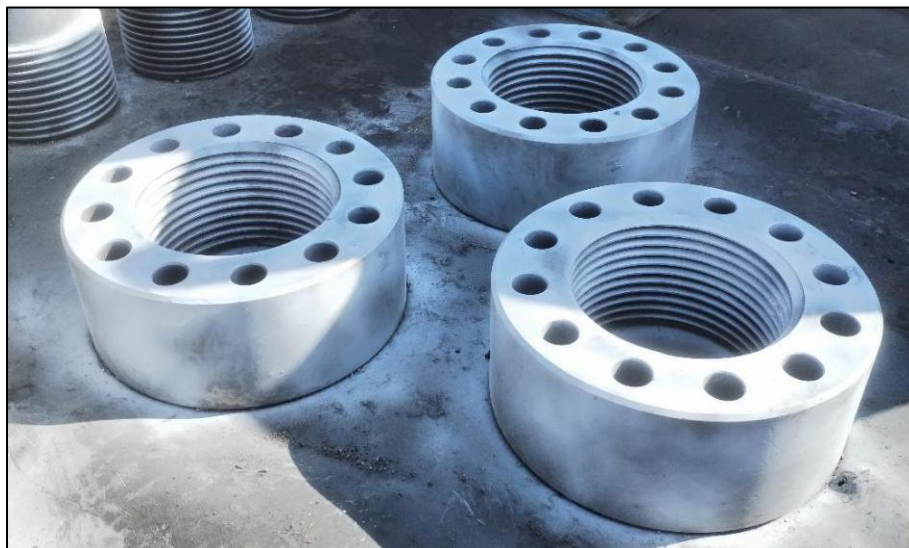
Serial Number	Description of the examined equipment	Result
12-159	3 EA Valve Cap Flange Suction End Mud Pump # 3	Pass

Visual and MPI were carried out for the above description and found free of surface defects at the time of inspection

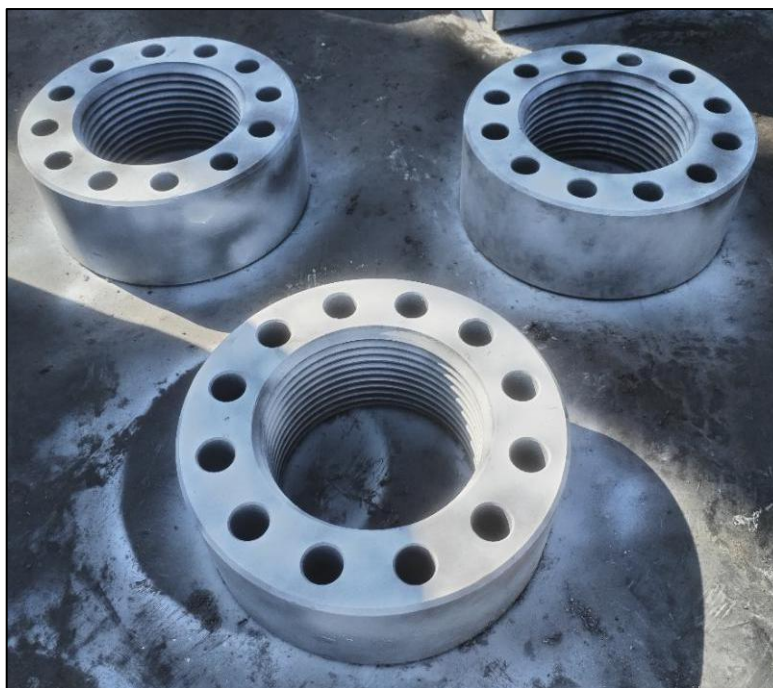
Serial Number	Description of the examined equipment	Result
12-159	3 EA Valve Cap Flange Discharge End Mud Pump # 3	Pass

Visual and MPI were carried out for the above description and found free of surface defects at the time of inspection

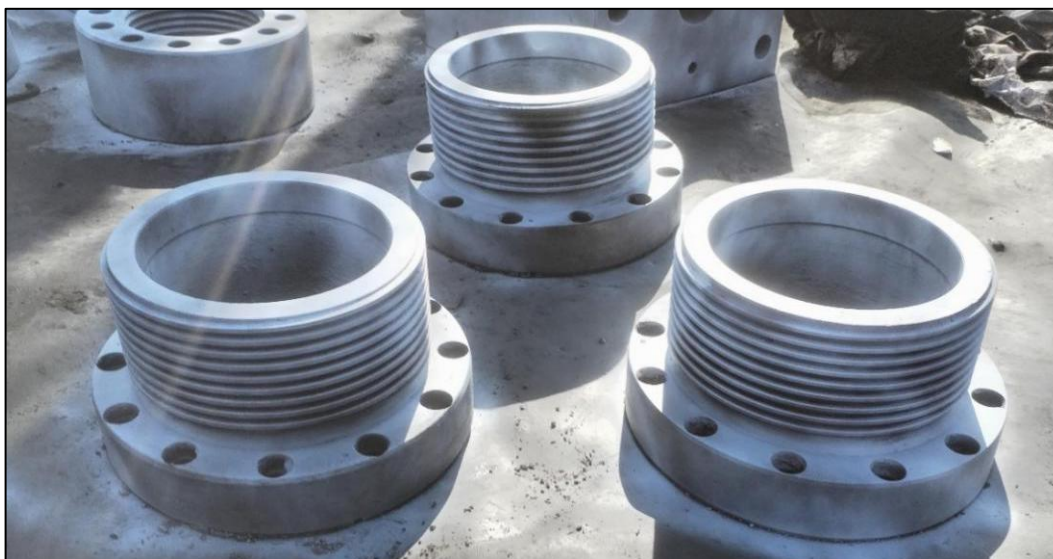
Serial Number	Description of the examined equipment	Result
12-159	3 EA Liner Seat Mud Pump # 3	Pass

Visual and MPI were carried out for the above description and found free of surface defects at the time of inspection
Identification of any part found to have a defect and a description of the defect: None
Particulars of any repair, renewal, or alteration required to remedy the defect identified above: None
All MPI was performed as per the instructions of OEM, and the measurements were done by OEM.

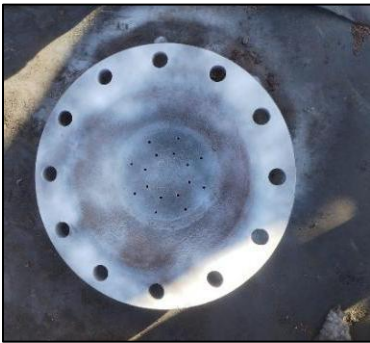
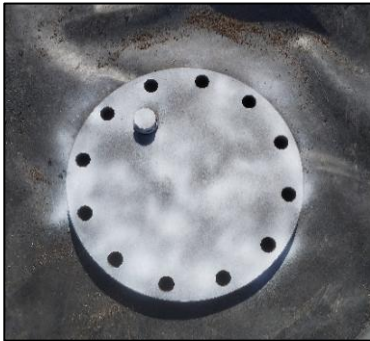
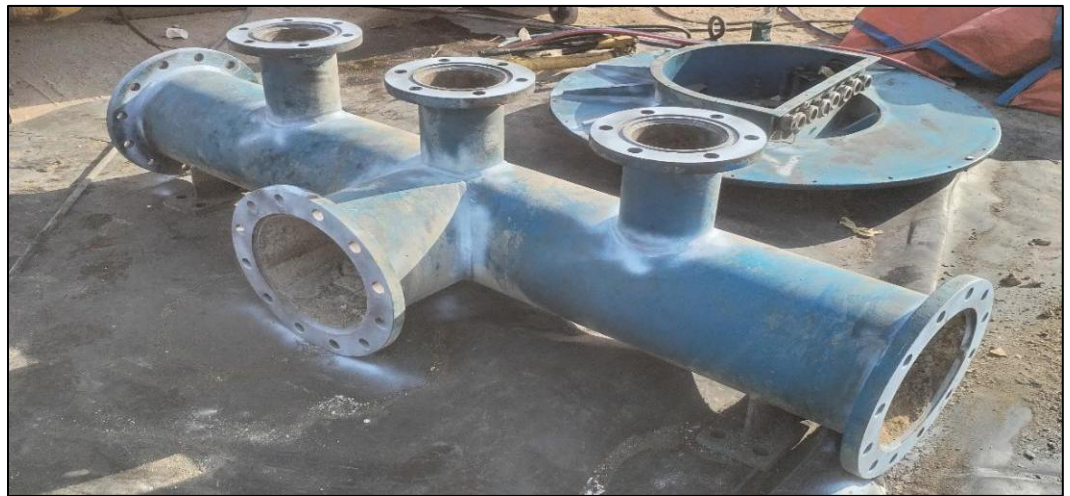
Client:	Hong Hua Oil& Gas Engineering Services Ltd	Certificate no:	QC-HH-01-25-028-015
Location:	HH Rig 008	Job Order No:	QC-HH-01-25-028
Date of Examination:	31-January-2025	Next Inspection Due:	30-January-2030
Serial Number	Description of the examined equipment		Result
12-159	Suction Pipe Mud Pump # 3		Pass

Visual and MPI were carried out for the above description and found free of surface defects at the time of inspection
Identification of any part found to have a defect and a description of the defect: None
Particulars of any repair, renewal, or alteration required to remedy the defect identified above: None
All MPI was performed as per the instructions of OEM, and the measurements were done by OEM.

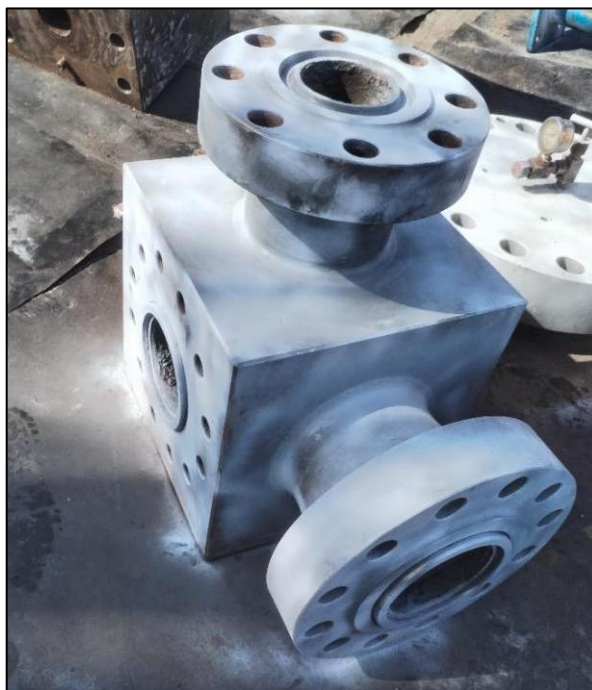
Serial Number	Description of the examined equipment	Result
12-159	Discharge Five – Pass Assembly Mud Pump # 3	Pass

Visual and MPI were carried out for the above description and found free of surface defects at the time of inspection
Identification of any part found to have a defect and a description of the defect: None
Particulars of any repair, renewal, or alteration required to remedy the defect identified above: None
All MPI was performed as per the instructions of OEM, and the measurements were done by OEM.

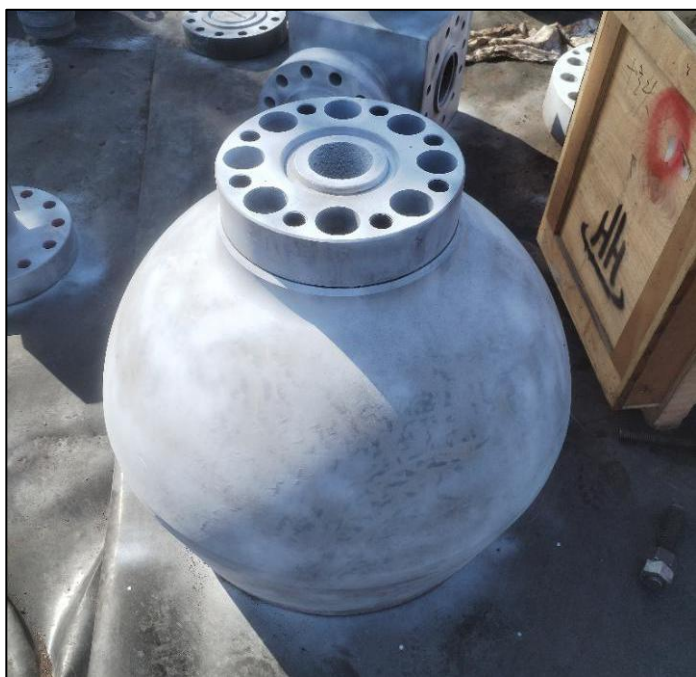
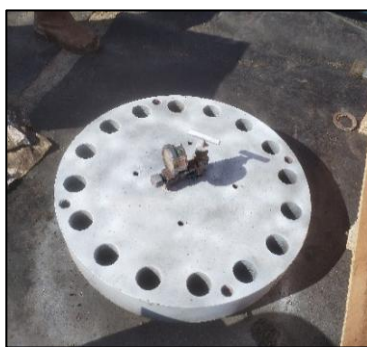
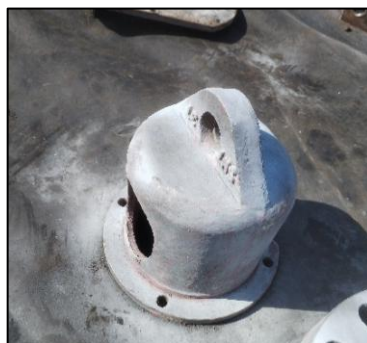
Serial Number	Description of the examined equipment	Result
12-159	Airbag and bolt for Flang Mud Pump # 3	Pass

Visual and MPI were carried out for the above description and found free of surface defects at the time of inspection

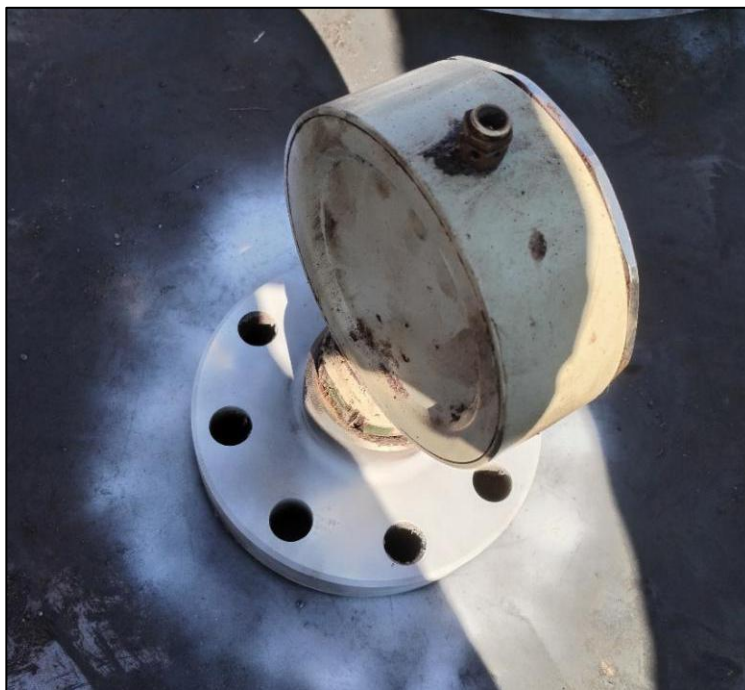
Serial Number	Description of the examined equipment	Result
12-159	Flang of Pressure Gauge Mud Pump # 3	Pass

Visual and MPI were carried out for the above description and found free of surface defects at the time of inspection
Identification of any part found to have a defect and a description of the defect: None
Particulars of any repair, renewal, or alteration required to remedy the defect identified above: None
All MPI was performed as per the instructions of OEM, and the measurements were done by OEM.

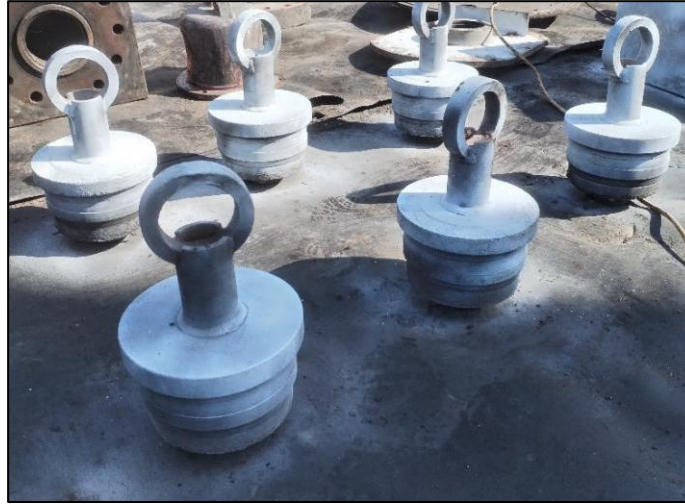
Serial Number	Description of the examined equipment	Result
12-159	3 EA Valve Gland Suction End Mud Pump # 3	Pass

Visual and MPI were carried out for the above description and found free of surface defects at the time of inspection
Identification of any part found to have a defect and a description of the defect: None
Particulars of any repair, renewal, or alteration required to remedy the defect identified above: None
All MPI was performed as per the instructions of OEM, and the measurements were done by OEM.

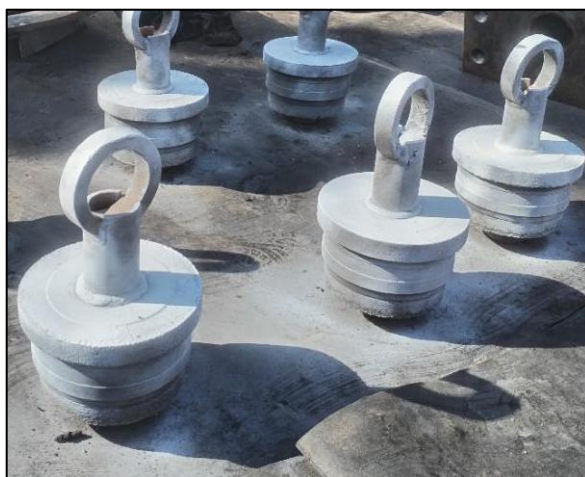
Serial Number	Description of the examined equipment	Result
12-159	3 EA Valve Gland Discharge End Mud Pump # 3	Pass

Visual and MPI were carried out for the above description and found free of surface defects at the time of inspection
Identification of any part found to have a defect and a description of the defect: None
Particulars of any repair, renewal, or alteration required to remedy the defect identified above: None
All MPI was performed as per the instructions of OEM, and the measurements were done by OEM.

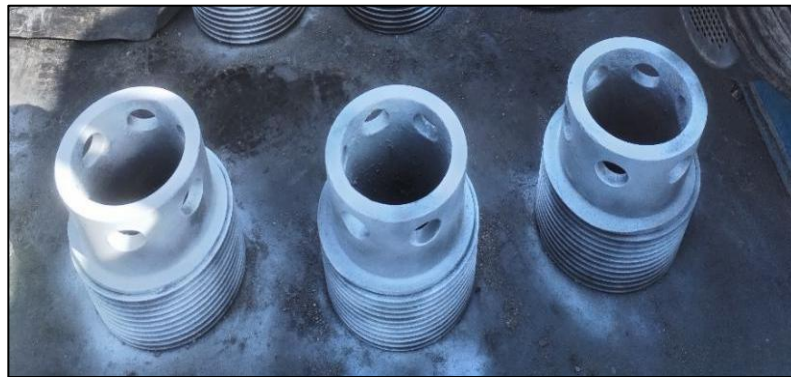
Serial Number	Description of the examined equipment	Result
12-159	3 EA Valve Cap Discharge End Mud Pump # 3	Pass

Visual and MPI were carried out for the above description and found free of surface defects at the time of inspection
Identification of any part found to have a defect and a description of the defect: None
Particulars of any repair, renewal, or alteration required to remedy the defect identified above: None
All MPI was performed as per the instructions of OEM, and the measurements were done by OEM.

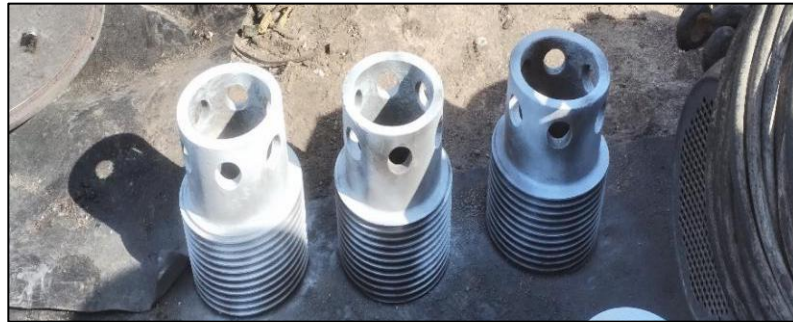
Serial Number	Description of the examined equipment	Result
12-159	3 EA Valve Cap Suction End Mud Pump # 3	Pass

Visual and MPI were carried out for the above description and found free of surface defects at the time of inspection
Identification of any part found to have a defect and a description of the defect: None
Particulars of any repair, renewal, or alteration required to remedy the defect identified above: None
All MPI was performed as per the instructions of OEM, and the measurements were done by OEM.

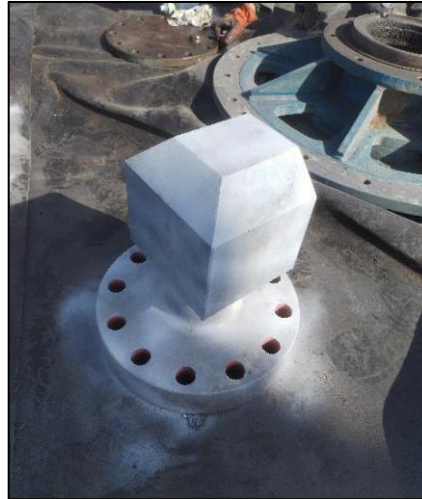
Serial Number	Description of the examined equipment	Result
12-159	Seat of Pressure Gauge Mud Pump # 3	Pass

Visual and MPI were carried out for the above description and found free of surface defects at the time of inspection
Identification of any part found to have a defect and a description of the defect: None
Particulars of any repair, renewal, or alteration required to remedy the defect identified above: None
All MPI was performed as per the instructions of OEM, and the measurements were done by OEM.

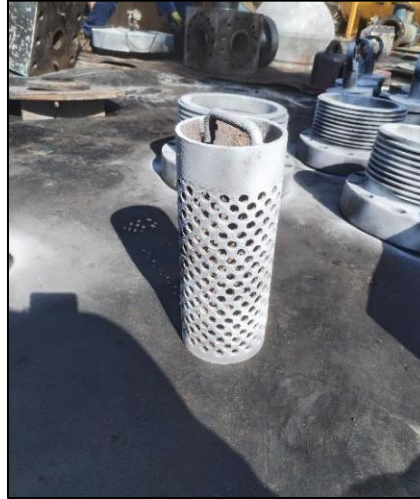
Serial Number	Description of the examined equipment	Result
12-159	Filter Mud Pump # 3	Pass

Visual and MPI were carried out for the above description and found free of surface defects at the time of inspection
Identification of any part found to have a defect and a description of the defect: None
Particulars of any repair, renewal, or alteration required to remedy the defect identified above: None
All MPI was performed as per the instructions of OEM, and the measurements were done by OEM.

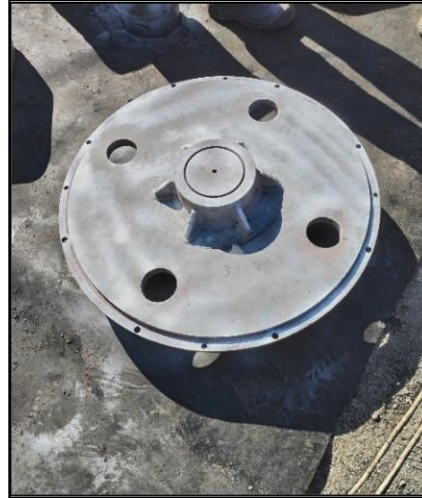
Serial Number	Description of the examined equipment	Result
12-159	Connection Plate Mud Pump # 3	Pass

Visual and MPI were carried out for the above description and found free of surface defects at the time of inspection
Identification of any part found to have a defect and a description of the defect: None
Particulars of any repair, renewal, or alteration required to remedy the defect identified above: None
All MPI was performed as per the instructions of OEM, and the measurements were done by OEM.

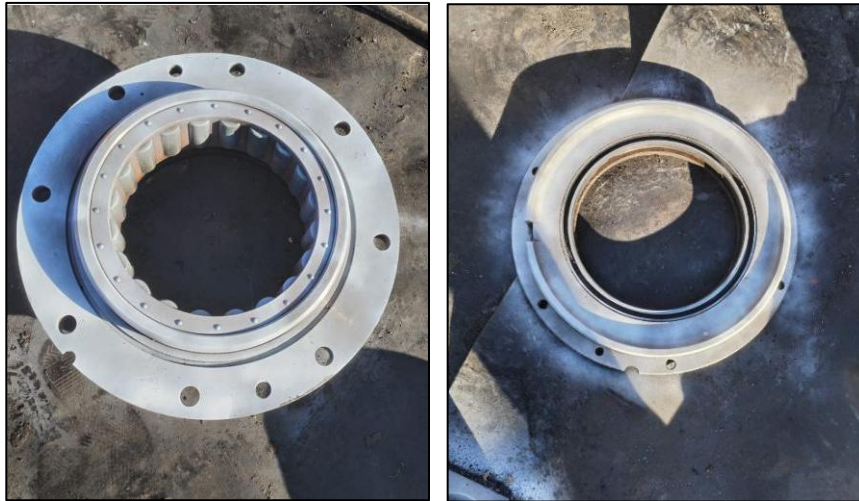
Serial Number	Description of the examined equipment	Result
12-159	Pinion Shaft End Cover Mud Pump # 3	Pass

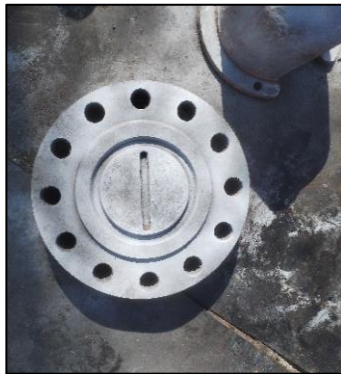
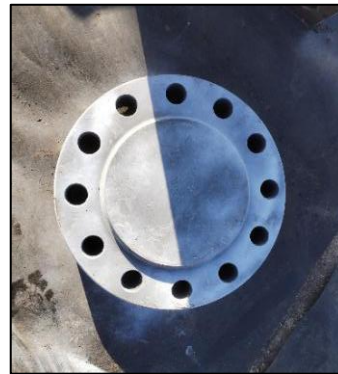
Serial Number	Description of the examined equipment	Result
12-159	Blind Plate Mud Pump # 3	Pass

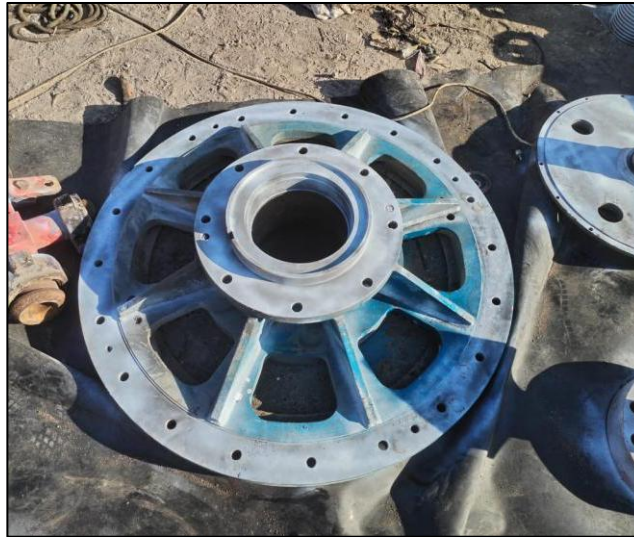
Serial Number	Description of the examined equipment	Result
12-159	Rotator Tray Mud Pump # 3	Pass

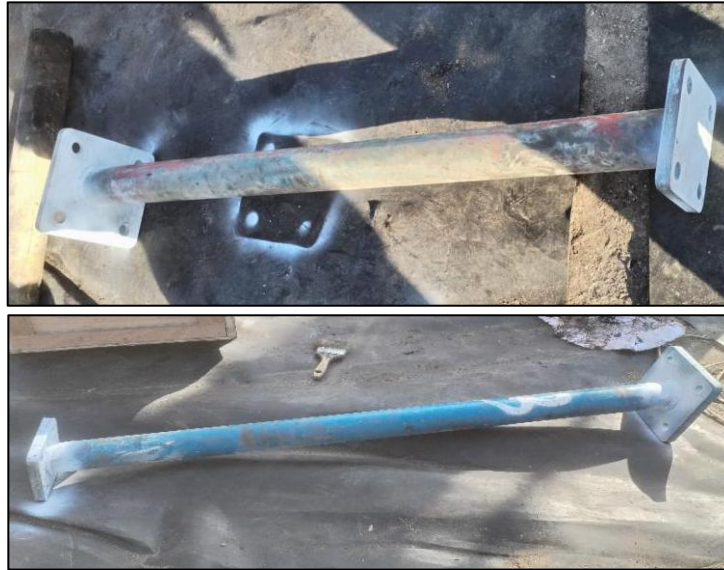
Serial Number	Description of the examined equipment	Result
12-159	2 EA Support Rod Mud Pump # 3	Pass

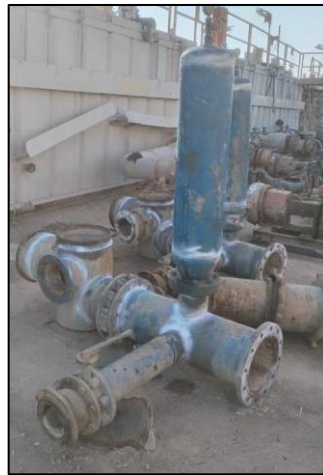
Serial Number	Description of the examined equipment	Result
12-159	Suction Dampener Mud Pump # 3	Pass

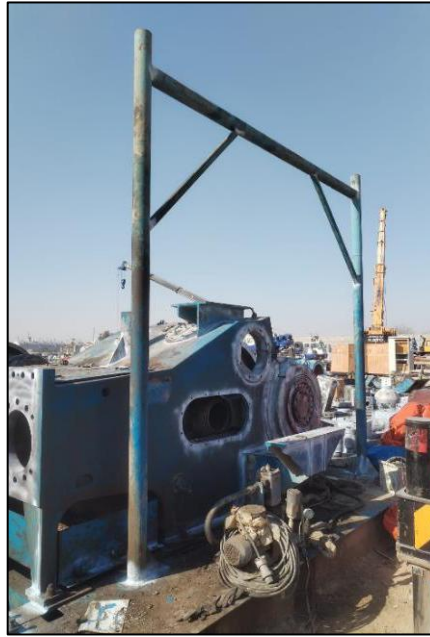
Serial Number	Description of the examined equipment	Result
12-159	Sunshield Stand Mud Pump # 3	Pass

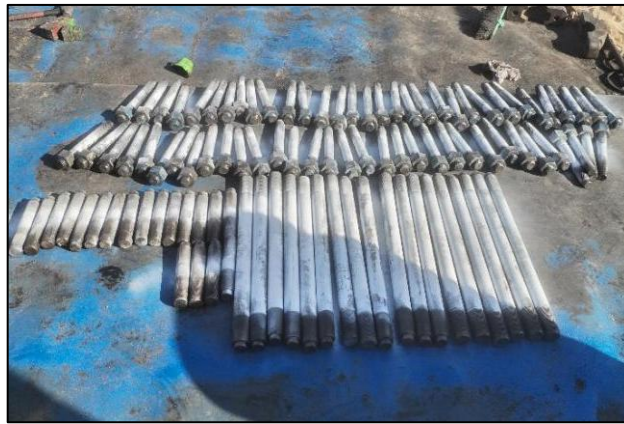
Serial Number	Description of the examined equipment	Result
12-159	Bolts & Nuts Mud Pump # 3	Pass

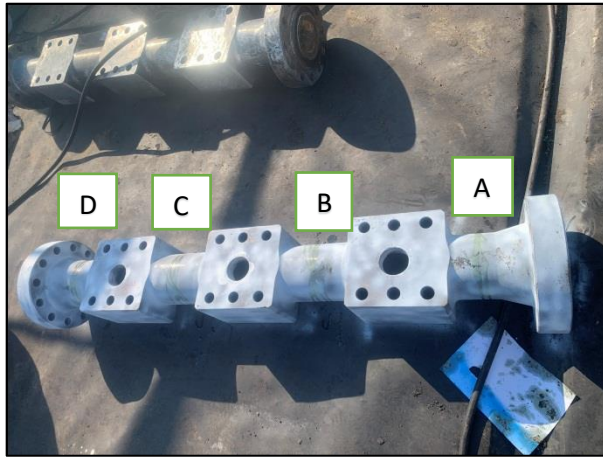
A:12'O CLOCK / FORWARD
B:3'O CLOCK / CENTER
C:6'O CLOCK / AFT

Serial Number	Description of the examined equipment	Result
HH008-037	Discharge Pipe Line (Mud Pump-3)	Accepted
