CERTIFICATE OF VISUAL& NDT AND THOROUGH EXAMINATION

Client Name:	PEG CO.			Job Number:	QC-ATS-01-2024-0002
Date of Examination:	03.01.2024	Location:	ATS Yard	Certificate No:	QC-ATS-01-2024-0002-07
Serial Number:	QTY	Description		SWL	Date of last Thorough examination
ATS-SB-15T/01	01	<p style="text-align: center;">SPREADER BEAM</p> <p>Manufactured: Aberdeen Year of Manufacture: 2023 Two Pad Eyes in The Top of Spreader Beam and Two Pad Eyes in The Bottom TARE WEIGHT:220 KGS Dimension of Spreader beam: 2820 L x 225 W x 605 H (mm) Upper Pad eye:25-ton, P.H:52, L: 30, H: 21 MM Lower Pad eye:17-ton, P.H:43, L: 26, H: 19 MM Span Length: 2300 mm Date of last Proof Load test: 09.07.2023 By SCOPE</p>		15000 KG	09.07.2023
Reference Standard:		BS EN 13155:2020			
Is this the first examination after Installation or assembly at a new site or location?		<input type="checkbox"/> YES <input type="checkbox"/> NO <input checked="" type="checkbox"/>		Was the examination carried out: Within an interval of 6 months?

Visual & Magnetic Particles Examination Report

Client Name:	PEG CO.		Job Number:	QC-ATS-01-2024-0002
Date of Examination:	03.01.2024	Location:	ATS Yard	Certificate No: QC-ATS-01-2024-0002

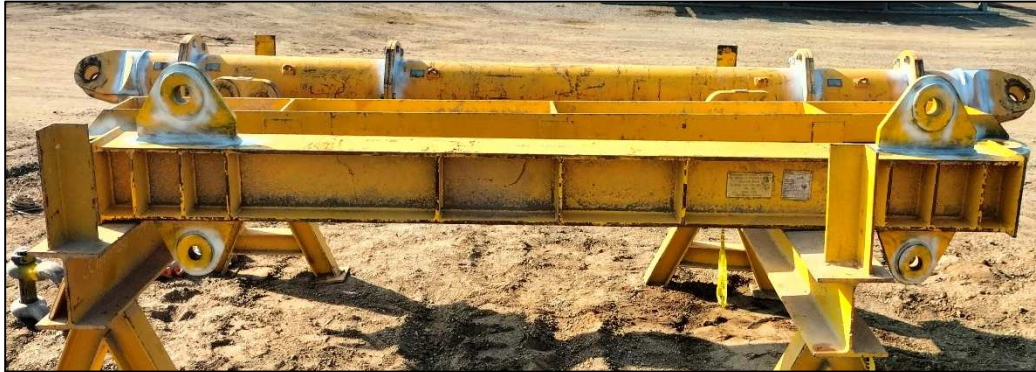
Visual and MPI carried out for the above description and found free of surface defects at the time of inspection

None

None
