## Visual & Magnetic Particles Examination Certificate

<b>Client Name:</b>	Zhongman Petroleum Engineering Technology Service (Hong Kong) Co. Limited Iraq Branch	<b>Job Number:</b>	QC-2023-1594
<b>Date of Examination:</b>	24.11.2023	<b>Location:</b>	ZPEC Rig 20
<b>Certificate No:</b>	QC-2023-1594-03		
<b>Serial Number</b>	<b>Description of the examined equipment</b>		<b>Result</b>
1010102	Substructure D.S Upper Lifting Lugs		Pass
<b>Lifting Lugs SN:</b>	SB17 TO SB20	<b>Each lug SWL:</b>	20 KN

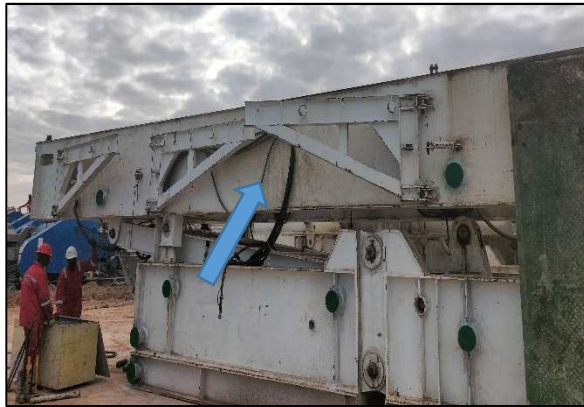
Visual and MPI carried out for the above description and found free of surface defects at the time of inspection

None

None
