DRILL PIPE SLIP CAT IV 06 MONTHS INSPECTION REPORT

Customer:	Daqing Drilling Company	Date of Service:	27-01-2024
Department:	DQ RIG -12	Location:	DQ RIG -12
Report No:	QC-DQ-01-24-0044-MPI-05	Specification:	API RP 8B

Equipment :	DRILL PIPE SLIP 350 TON
Serial NO :	01037
MFG :	JIANG SU RU TANG OF CHINA
Specification :	API RP 7L
Quantity :	01 Set
Frequency :	06 Months

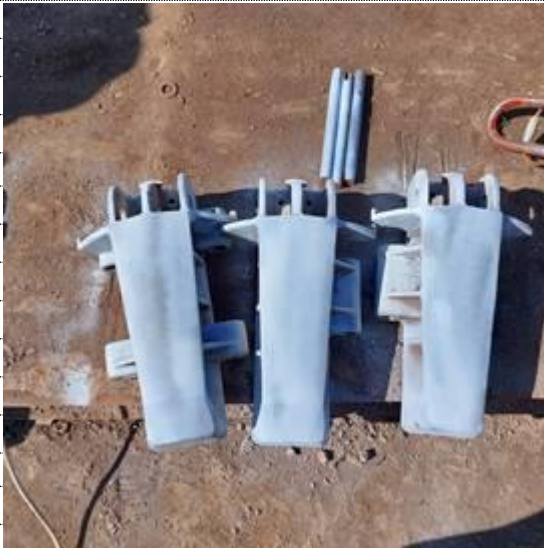
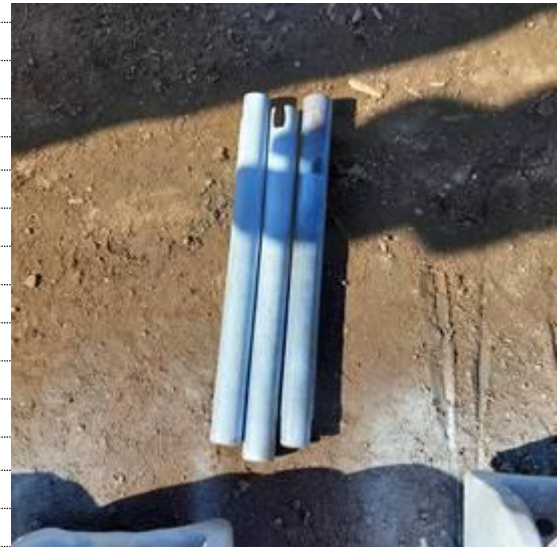
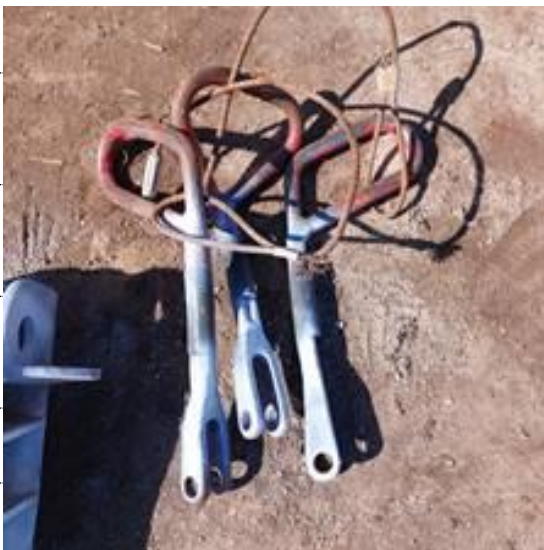
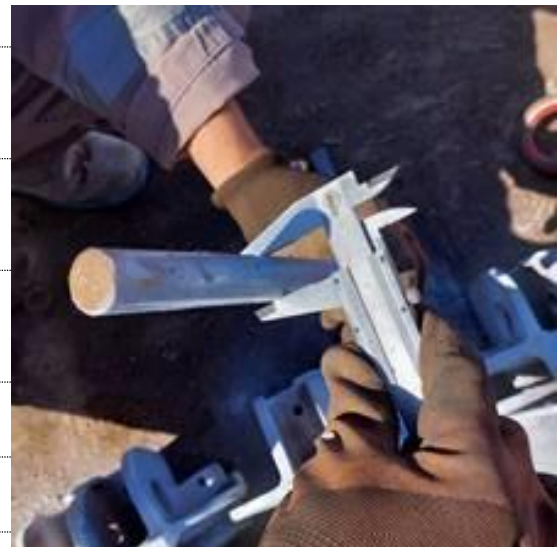
Procedure Manual Slips 3.5" Drill Pipe

**** Visual & MPI was carried out on the available critical areas of the 5" Drill Pipe Slip and Found Satisfactory for Further Use.**

**** CAT IV Inspection was carried out on 5" Drill Pipe Slip & found Satisfactory at the Time of Inspection.**
