DRILL PIPE SLIP CAT IV 06 MONTHS INSPECTION REPORT

Customer:	Daqing Drilling Company	Date of Service:	27-01-2024
Department:	DQ RIG -12	Location:	DQ RIG -12
Report No:	QC-DQ-01-24-0044-MPI-06	Specification:	API RP 8B

Equipment :	DRILL PIPE SLIP
Serial NO :	141271
MFG :	JIANG SU RU TANG OF CHINA
Specification :	API RP 7L
Quantity :	01 Set
Frequency :	06 Months

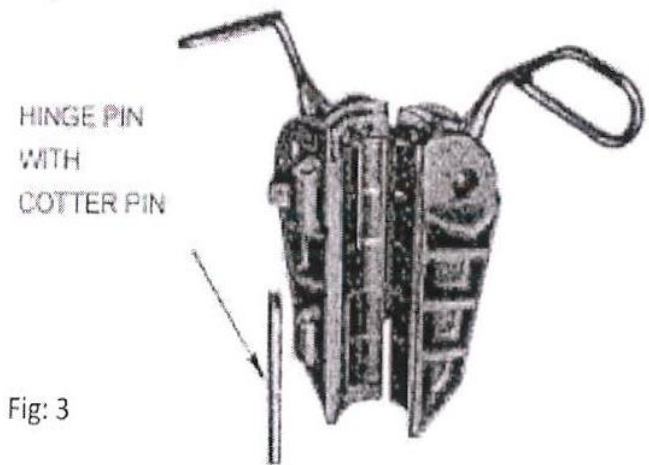
Description	Valued	OEM Valued	Result
The max allowable clearance between dies and slot	1.31 mm	3.2 mm	Accept
The min value of Pin OD	22.75 mm	21 mm	Accept
The maximum wear value of hole	23.53 mm	24.5 mm	Accept
The maximum clearance between pin and hole	0.68 mm	2 mm	Accept
The maximum allowable wear of the outside surface of slip	0.795 mm	1.6 mm	Accept

No wear on the outside surface of the slips

Pin hole diameter design value and the maximum allowable wear:
