INSPECTION CERTIFICATE OF 8 ¼” MAIN BODY#WES825BP501

| Client Name: | AL-ESNAAD OIL TOOL FOR OIL SERVICES.LLC | Report No.: | QC-24-04-AL-ESNAAD-003 |
| Acceptance criteria. | DS-1, Volume 4 Fifth Edition | Date of Inspection: | 20.APR.2024 |

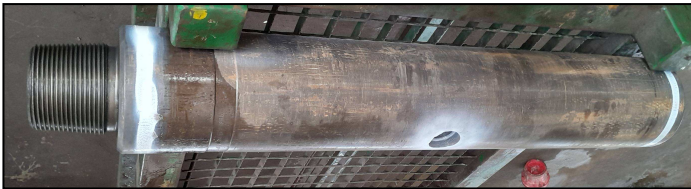
| Serial No. | Description | Connection | | Result Inspection | | | Dimensional 3 Inspection | | | | | | | | | | | | | | |
|---|---|---|---|---|---|---|---|---|---|---|---|---|---|---|---|---|---|---|---|---|---|
| WES825BP501 | 8 ¼” MAIN BODY | 6<br>5/8”Reg | 6<br>5/8”Reg | Acc. | Acc. | Acc. | 8<br>3/16” | 3 ½” | 5 3/8” | 1” | 4<br>15/16” | 7 ½” | 8<br>3/16” | 6<br>1/16” | 5/8” | - | - | 7 ½” | - | - | 40 ¼” |
| Conclusion: | | ■ 8 ¼” MAIN BODY was found “Acceptable At time of Inspection Ready For Use. | | | | | | | | | | | | | | | | | | | |
