ELEVATOR 5 1/2" D/P CAT IV INSPECTION REPORT				
Customer:	Daqing Drilling Company	Date of inspection:	05-05-2024	
Rig Name:	Rig (DQ 1202)	Report No:	QC-DQ-04-24-0138 <b>-29-02</b>	
Type of Inspection:	CAT IV Inspection.	Specification:	API RP 8B

<u>PROCEDURE</u>			
The Rig Was Equipped with Jiangs	u RYTONG PETRO Machinery Co., LTD (ELEVATOR 5" D/P)			
ΟΤΥ·	1 (set)			
	ELEVATOR 5 1/2" D/P			
	DDZ 5 ½" EU.5IEU-350 (ton)			
SN:				
Manufacture:	Jiangsu RYTONG PETRO Machinery Co., Ltd			
Date Of Manufacture:				
SIZE:				
Ref Standard:				
NEXT EXAMINATION:	After 6 Month

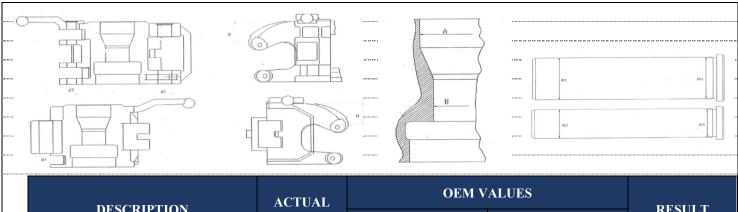
DESCRIPTION	ACTUAL	OEM VALUES		DECILLT
DESCRIPTION	VALUE	STANDARD VALUE	MIN. VALUE	RESULT
Lifting Ear (H)	127 mm	Ø 128 mm	110 mm	ACCEPT
Hinge Pin Hole (d1)	67. mm	Ø 68 mm	Ø 62 mm	ACCEPT
Latch Pin Hole (d2)	47.18 mm	Ø 48 mm	Ø 42 mm	ACCEPT
Hinge Pin (Ø1)	67 mm	Ø 68 mm	Ø 62 mm	ACCEPT
Latch Pin (Ø2)	47 mm	Ø 48 mm	Ø 42 mm	ACCEPT

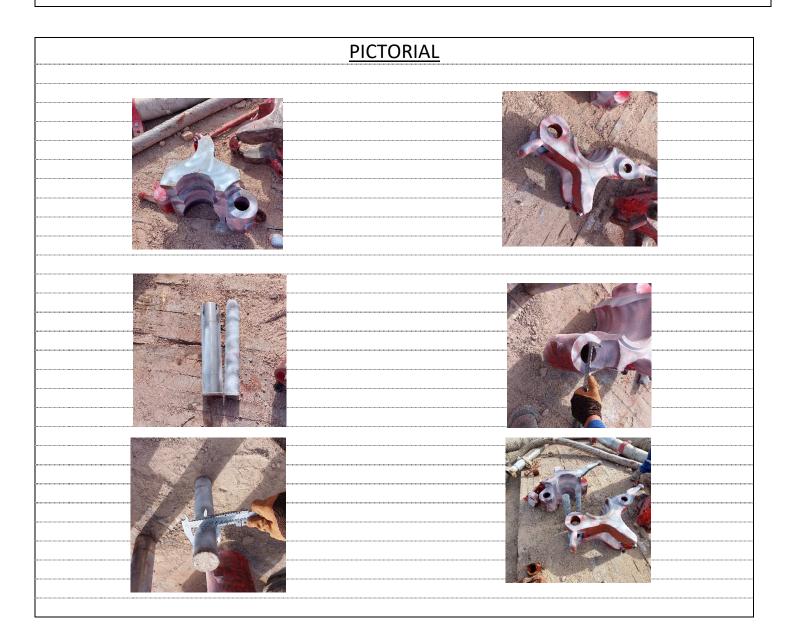
** CAT IV Inspection Was Carried Out on ELEVATOR and Found Accepted at The Inspection.	Time of
