## Certificate of Thorough Examination & NDT of Lifting Equipment

<b>Client Name:</b>	Daqing Drilling Company	<b>Location:</b>	Rig (DQ 1202)	<b>Job Number:</b>	QC-DQ-04-24-0138
<b>Date of Examination:</b>	01-05-2024	<b>Date of Report:</b>	01-05-2024	<b>Certificate No:</b>	QC-DQ-04-24-0138-16-74

Serial Number:	QTY	Description	SWL	Date of last Thorough examination
225C	01	Lifting Bracket Pad Eye	10 TON	17-11-2023
		MAST UPPER SECTION POWER TONG BRACKET		
		Pad Eye Dimension Thickness: 30 MM Pin Hole: 38 MM Length: 150 MM Height: 150 MM Bracket Body Height: 350 MM Bracket Body Jaw Inside Width: 175 MM Bracket Body Pin Holes: 82 MM Bracket Pins : 79 MM

## Visual & Magnetic Particles Examination Report

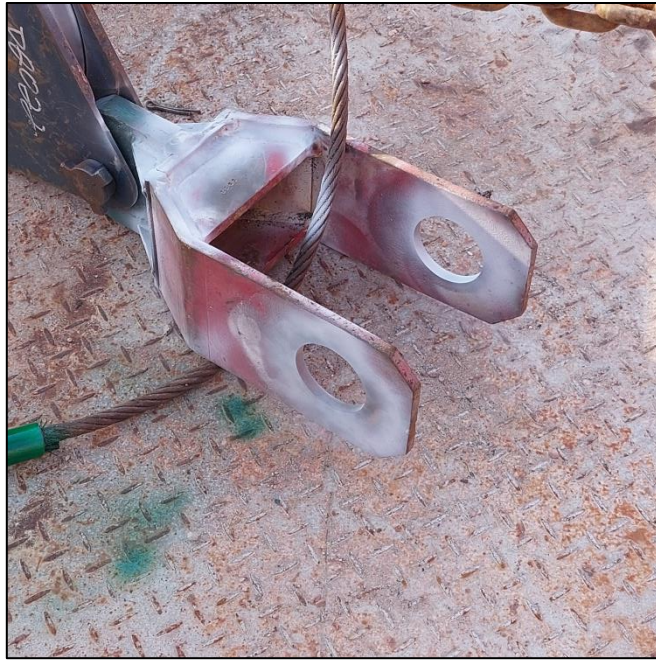
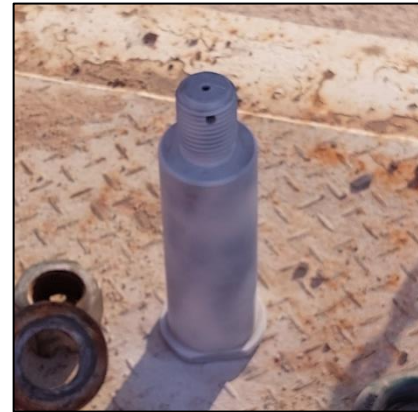
<b>Client Name:</b>	Daqing Drilling Company	<b>Location:</b>	Rig (DQ 1202)	<b>Job Number:</b>	QC-DQ-04-24-0138
<b>Date of Examination:</b>	01-05-2024	<b>Date of Report:</b>	01-05-2024	<b>Certificate No:</b>	QC-DQ-04-24-0138-16-74A
<b>Unit Serial Number</b>	<b>Description of the examined equipment</b>				<b>Result</b>
225C	MAST UPPER SECTION POWER TONG BRACKET PAD EYE				Pass

NDT Equipment Details					
Standard	ASTM E709	Viewing Condition:	Colored Media	Method	WET
Yoke	Permanent	Serial No:	PY-09	Due Date	14-08-2024
White Contrast	WCP-2	Batch No:	220602	Due Date	06-2025
Black Ink	7HF	Batch No:	220605	Due Date	7-1-2025
NDT procedure					
Visual and MPI carried out for the above description and found free of surface defects at the time of inspection					
Identification of any part found to have a defect and a description of the defect:					
None					
Particulars of any repair, renewal or alteration required to remedy the defect identified above:					
None					
ASNT Level II Inspector Name:	Name of person authenticating:	Signature & Stamp:		Date of Next Through Examination:	
Abdullah Mofeed	Mohamed Abdullah

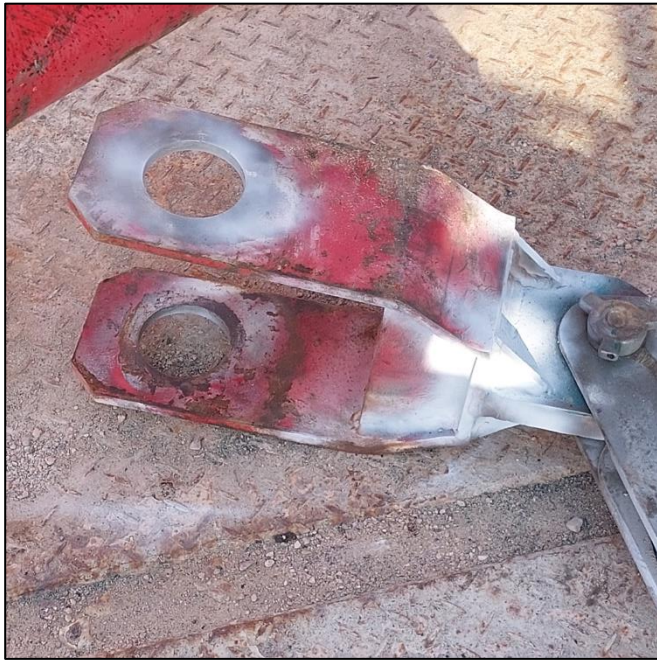
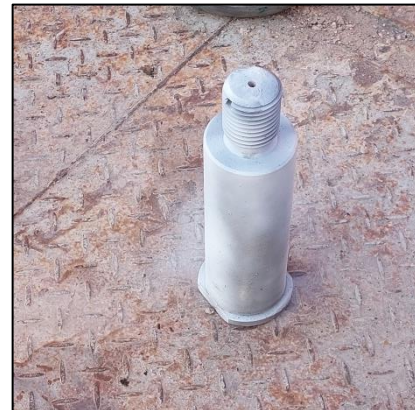
<b>Client Name:</b>	Daqing Drilling Company	<b>Location:</b>	Rig (DQ 1202)	<b>Job Number:</b>	QC-DQ-04-24-0138
<b>Date of Examination:</b>	01-05-2024	<b>Date of Report:</b>	01-05-2024	<b>Certificate No:</b>	QC-DQ-04-24-0138-16-75A
<b>Unit Serial Number</b>	<b>Description of the examined equipment</b>				<b>Result</b>
225A	MAST UPPER SECTION POWER TONG BRACKET PAD EYE				Pass

NDT Equipment Details					
Standard	ASTM E709	Viewing Condition:	Colored Media	Method	WET
Yoke	Permanent	Serial No:	PY-09	Due Date	14-08-2024
White Contrast	WCP-2	Batch No:	220602	Due Date	06-2025
Black Ink	7HF	Batch No:	220605	Due Date	7-1-2025
NDT procedure					
Visual and MPI carried out for the above description and found free of surface defects at the time of inspection					
Identification of any part found to have a defect and a description of the defect:					
None					
Particulars of any repair, renewal or alteration required to remedy the defect identified above:					
None					
ASNT Level II Inspector Name:	Name of person authenticating:	Signature & Stamp:		Date of Next Through Examination:	
Abdullah Mofeed	Mohamed Abdullah

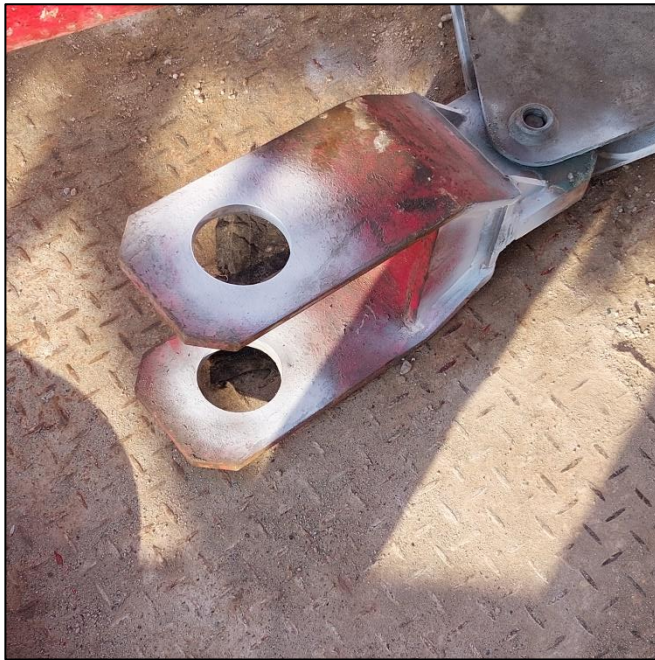
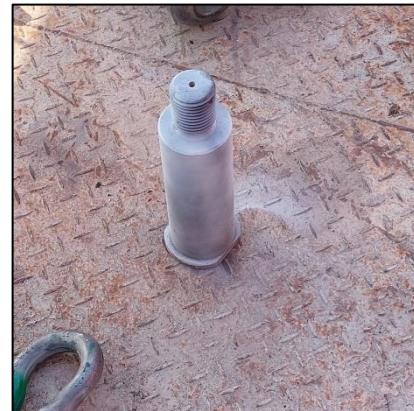
Client Name:	Daqing Drilling Company	Location:	Rig (DQ 1202)	Job Number:	QC-DQ-04-24-0138
Date of Examination:	01-05-2024	Date of Report:	01-05-2024	Certificate No:	QC-DQ-04-24-0138-16-76A
Unit Serial Number	Description of the examined equipment				Result
225B	MAST UPPER SECTION POWER TONG BRACKET PAD EYE				Pass

NDT Equipment Details					
Standard	ASTM E709	Viewing Condition:	Colored Media	Method	WET
Yoke	Permanent	Serial No:	PY-09	Due Date	14-08-2024
White Contrast	WCP-2	Batch No:	220602	Due Date	06-2025
Black Ink	7HF	Batch No:	220605	Due Date	7-1-2025
NDT procedure					
Visual and MPI carried out for the above description and found free of surface defects at the time of inspection					
Identification of any part found to have a defect and a description of the defect:					
None					
Particulars of any repair, renewal or alteration required to remedy the defect identified above:					
None					
ASNT Level II Inspector Name:	Name of person authenticating:	Signature & Stamp:		Date of Next Through Examination:	
Abdullah Mofeed	Mohamed Abdullah
