ELEVATOR 5 1/2" D/P CAT IV INSPECTION REPORT

<i>Customer:</i>	Daqing Drilling Company	<i>Date of inspection:</i>	29-05-2024
<i>Rig Name:</i>	Rig (DQ -037)	<i>Report No:</i>	QC-DQ-05-24-0171-12
<i>Type of Inspection:</i>	CAT IV Inspection.	<i>Specification:</i>	API RP 8B

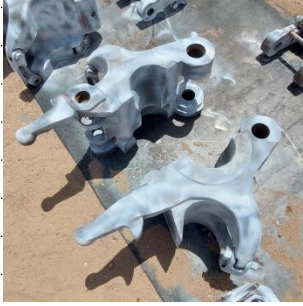
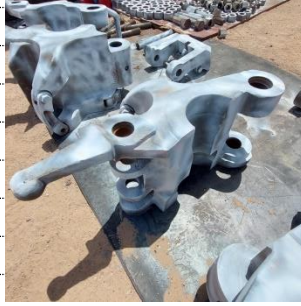
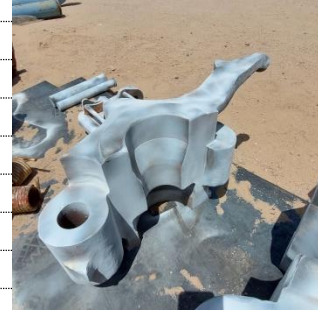
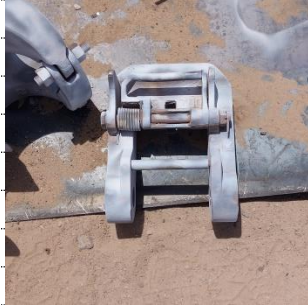
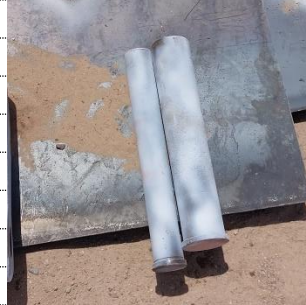
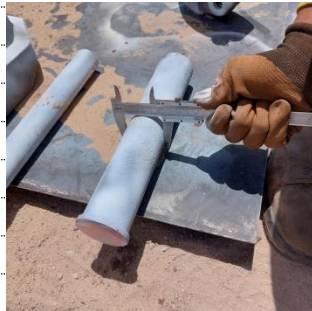
PICTORIAL

** Visual And MPI Was Carried Out on The Available Welding and Critical Areas of The ELEVATOR and Found Satisfactory for Further Use.

** CAT IV Inspection Was Carried Out on ELEVATOR and Found Accepted at The Time of Inspection.
