ELEVATOR 5 1/2" D/P CAT IV INSPECTION REPORT

Customer:	Daqing Drilling Company	Date of inspection:	29-05-2024
Rig Name:	Rig (DQ -037)	Report No:	QC-DQ-05-24-0171-13
Type of Inspection:	CAT IV Inspection.	Specification:	API RP 8B

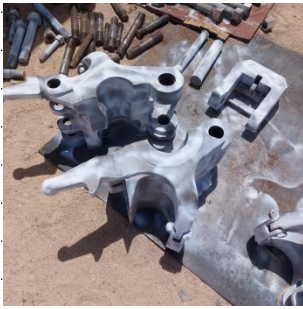
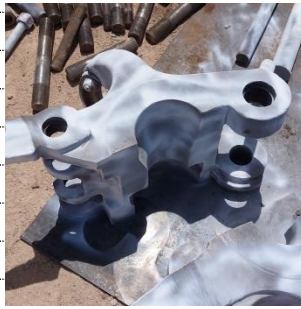
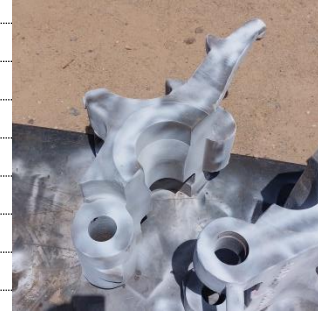
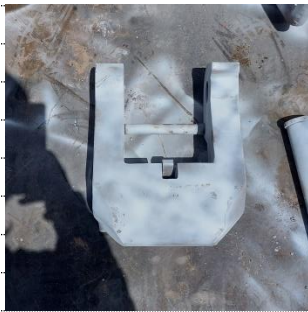
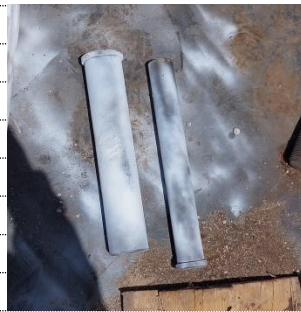
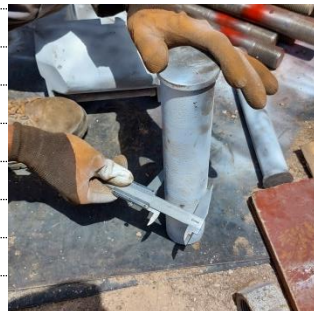
PICTORIAL

CAT IV Inspection Was Carried Out on ELEVATOR D/P and Found Accepted at The Time of Inspection.
