## SIDE DOOR ELEVATOR 3 1/2" 250 TON CAT IV INSPECTION REPORT

<b>Customer:</b>	<b>HONG HUA OIL &amp; GAS ENGINEERING SERVICES.</b>	<b>Date of inspection:</b>	<b>14-July-2024</b>
<b>Rig Name:</b>	<b>HH-29 / AS-67</b>	<b>Report No:</b>	<b>QC-HH-May-24-0203-007</b>
<b>Type of Inspection:</b>	<b>CAT IV Inspection.</b>	<b>Specification:</b>	<b>API RP 8B</b>

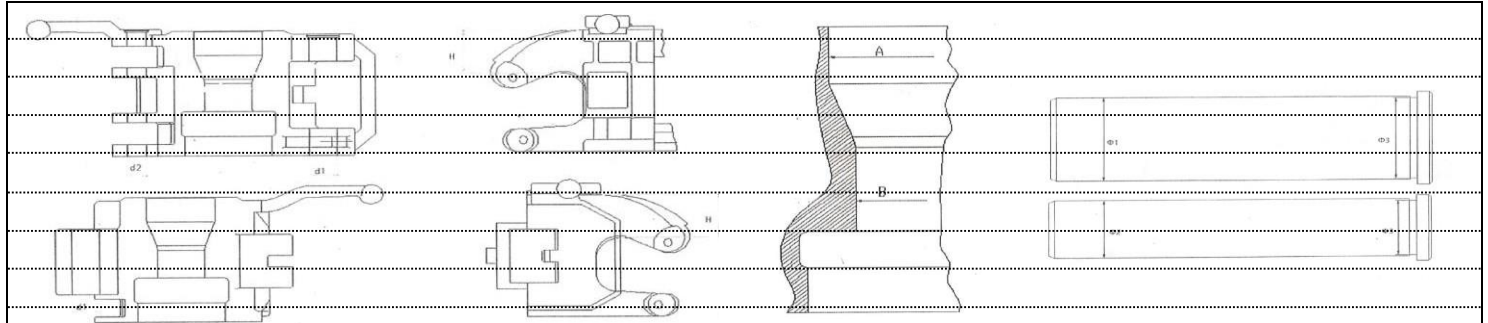
DESCRIPTION	ACTUAL VALUE	OEM VALUES MIN & MAX VALUE	RESULT
Lifting Ear (D)	110	Min:10 8m m	Qualified
Hinge Pin Hole (A)	57.19	Max:57.37 m m	Qualified
Hinge Pin (A)	57	Min:56.8 8m m	Qualified
The clearance A	0.79	Max:0.889 m m	Qualified
Latch Pin Hole (B)	39.95	Max:40.18 m m	Qualified
Latch Pin (B)	39.9	Min:39.7 7m m	Qualified
The clearance B	0.19	Max:0.762 m m	Qualified
Hight (G)	77.3mm	Min:40 m m	Qualified
The distance (E)from the center	194mm	194mm	Qualified
Pin Hole Maximum Clearance (A)	57.25mm	57.67mm	Qualified
Pin Hole Maximum Clearance (B)	40.31mm	40.46mm	Qualified

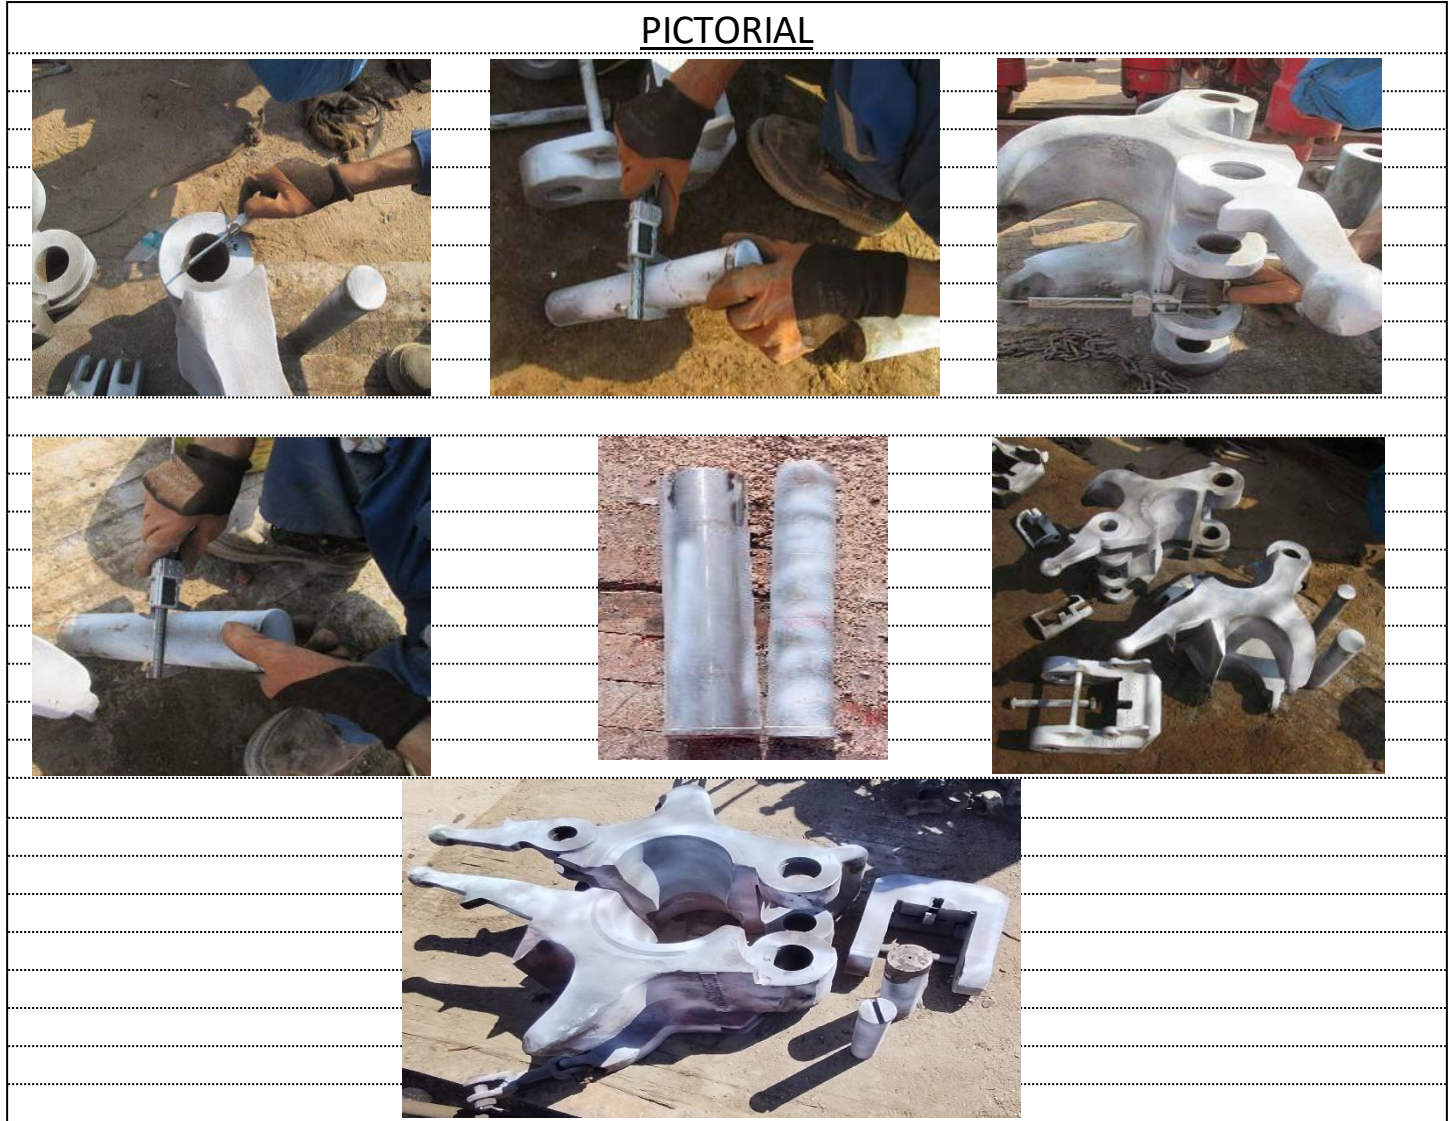
### PICTORIAL

CAT IV Inspection Was Carried Out on Side Door Elevator 3 1/2" and Found Accepted At The Time of Inspection:
