DEADLINE ANCHOR CAT III INSPECTION CERTIFICATE

| Type Of Inspection: | CAT III INSPECTION | Report No: | QC-HH-07-24-0202/03 |
| Rig & Location: | H.H RIG 029 | Specification: | API RP 8B - ASTM E709 |

| Equipment: | DEADLINE ANCHOR |

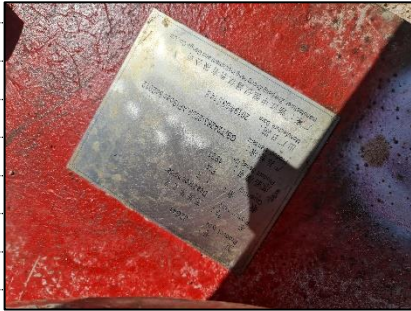
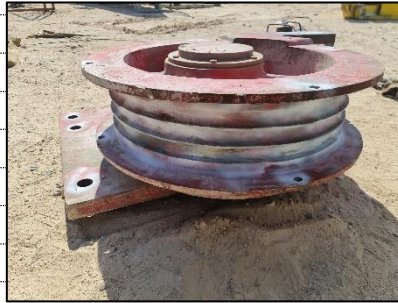
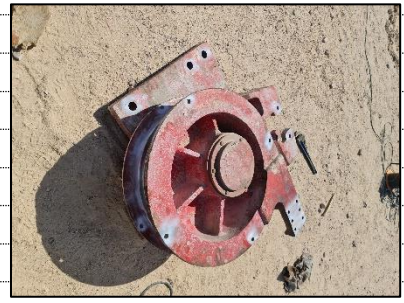
PICTORIAL

- ** Visual and MPI Was Carried Out on the Available Critical & Welding Areas of the Deadline Anchor and Found Satisfactory for Further Use.**
- ** CAT III Inspection Was Carried Out on Deadline Anchor and Found Accepted at The Time of Inspection.**

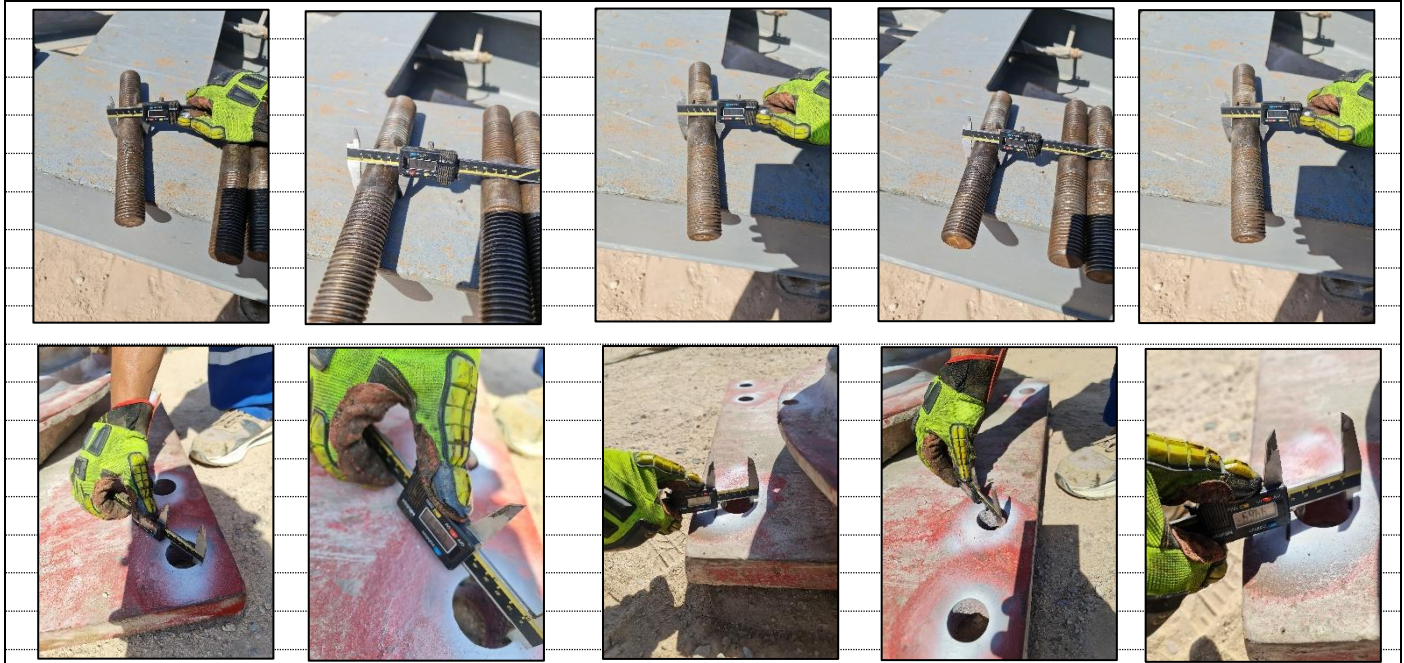
| Qty | Actual Pin diameter | Actual Pin hole diameter |
| 01 | 41.77 mm | 44.36 mm |
| 02 | 42.01 mm | 45.63 mm |
| 03 | 41.42 mm | 44.69 mm |
| 04 | 41.56 mm | 44.37 mm |
| 05 | 41.84 mm | 44.65 mm |
