## Certificate of Thorough Examination & NDT of Lifting Equipment

<b>Client Name:</b> Hong Hua Oil& Gas Engineering Services Ltd		<b>Job Number:</b> QC-HH-07-0201-01					
<b>Date of Examination:</b> 14.07.2024		<b>Location:</b> HH Rig 029					
<b>Certificate No:</b> QC-HH-07-0201-02/73							
Serial Number:	QTY	Description	SWL Each Pad Eye:				
A B C D	04	Fabricated Pad Eyes Driller Cabin Lifting Pad Eyes  Pad Eye Dimension Thickness: 26 mm Pin Hole: 26 mm Length: 136 mm Height: 66 mm	4 KN				
		<b>Date of last Thorough examination</b> 06.01.2024

## Visual & Magnetic Particles Examination Report

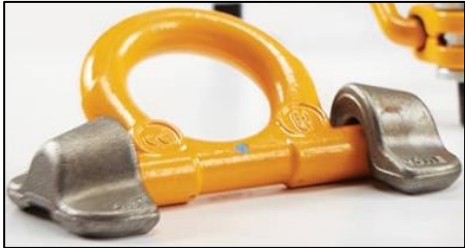
<b>Client Name:</b>	Hong Hua Oil& Gas Engineering Services Ltd	<b>Job Number:</b>	QC-HH-07-0201-01
<b>Date of Examination:</b>	14.07.2024	<b>Location:</b>	HH Rig 029
<b>Certificate No:</b>	QC-HH-07-0201-02/75		
<b>Serial Number:</b>	<b>QTY</b>	<b>Description</b>	<b>SWL Each Pad Eye:</b>
1-1 1-2 1-3 1-4 1-5 1-6 1-7 1-8	08	<b>Lifting Yoke for Draw works SN: JC18-008</b>  Type: YPG  Manufacturer: Traction Lavage	16 TON
		<b>Date of last Thorough examination</b> 19.10.2023

<b>NDT procedure</b>			
Visual and MPI carried out for the above description and found free of surface defects at the time of inspection			
Identification of any part found to have a defect and a description of the defect:			
None			
Particulars of any repair, renewal or alteration required to remedy the defect identified above:			
None

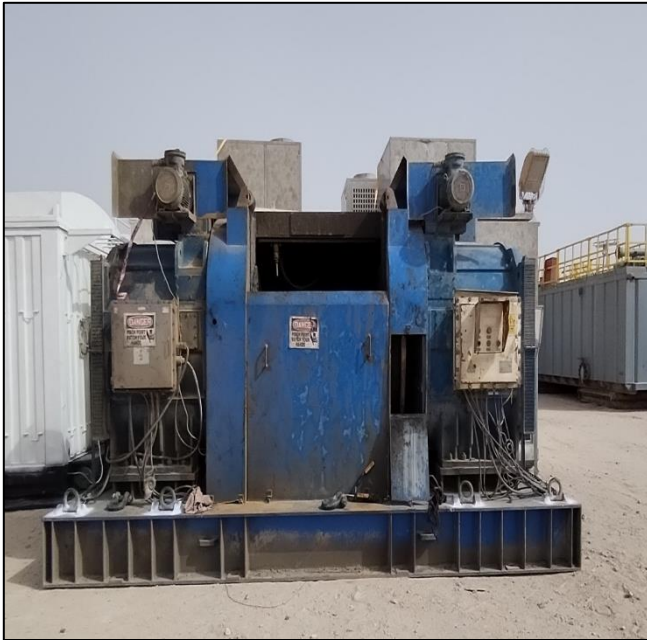
<b>Client Name:</b>	Hong Hua Oil& Gas Engineering Services Ltd	<b>Job Number:</b>	QC-HH-07-0201-01
<b>Date of Examination:</b>	14.07.2024	<b>Location:</b>	HH Rig 029
		<b>Certificate No:</b>	QC-HH-07-0201-03/76
<b>Serial Number</b>	<b>Description of the examined equipment</b>		<b>Result</b>
JC18-008	Lifting Yoke for Draw works		Pass
<b>Lifting Yoke Serial Number</b>	1-1 & 1-2 & 1-3 & 1-4	<b>SWL Each Lifting Yoke:</b>	16 TON

Visual and MPI carried out for the above description and found free of surface defects at the time of inspection

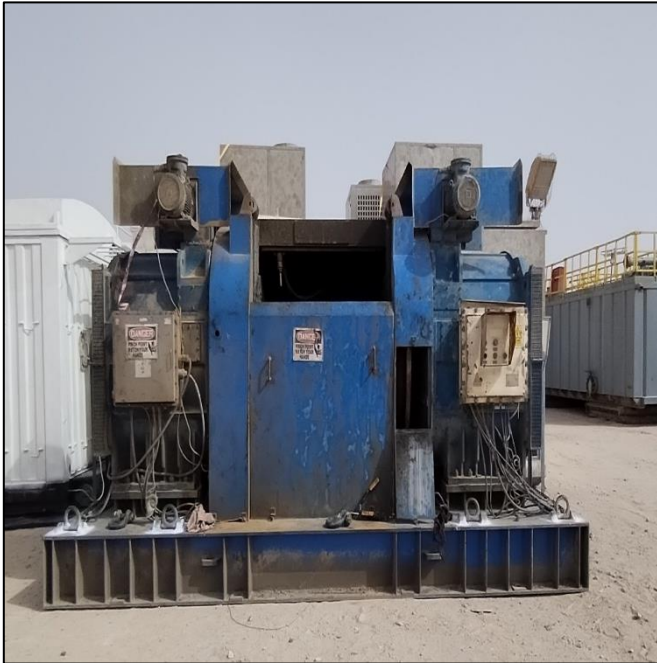
<b>Client Name:</b>	Hong Hua Oil& Gas Engineering Services Ltd	<b>Job Number:</b>	QC-HH-07-0201-01
<b>Date of Examination:</b>	14.07.2024	<b>Location:</b>	HH Rig 029
<b>Certificate No:</b>	QC-HH-07-0201-03/77		
<b>Serial Number</b>	<b>Description of the examined equipment</b>		<b>Result</b>
JC18-008	Lifting Yoke for Draw works		Pass
<b>Lifting Yoke Serial Number</b>	1-5 & 1-6 & 1-7 & 1-8	<b>SWL Each Lifting Yoke:</b>	16 TON

NDT Equipment Details					
Standard	ASTM E709	Viewing Condition:	Colored Media	Method	WET
Yoke	Permanent	Serial No:	PY-10	Due Date	12.08.2024
White Contrast	WCP-2	Batch No:	220602	Due Date	06-2025
Black Ink	7HF	Batch No:	220605	Due Date	7-1-2025
NDT procedure					
Visual and MPI carried out for the above description and found free of surface defects at the time of inspection					
Identification of any part found to have a defect and a description of the defect:					
None					
Particulars of any repair, renewal or alteration required to remedy the defect identified above:					
None

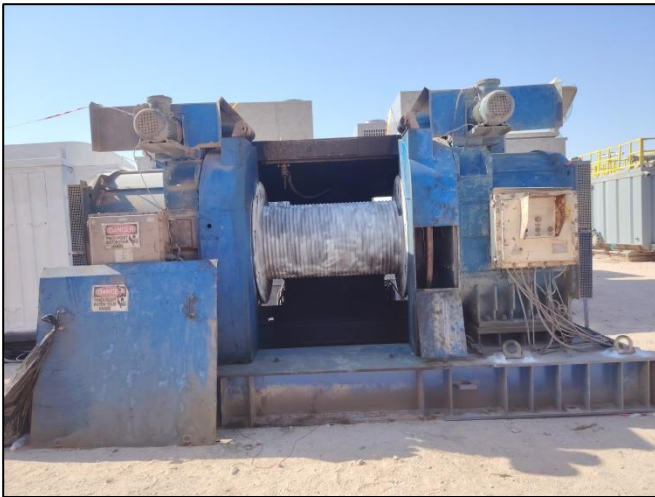
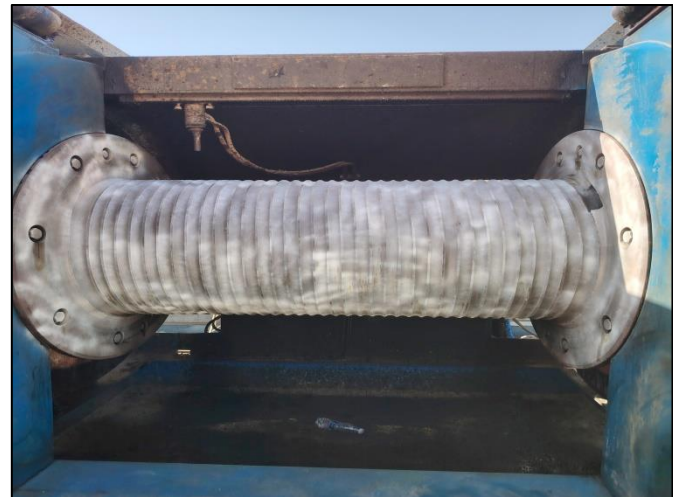
<b>Client Name:</b>	Hong Hua Oil& Gas Engineering Services Ltd	<b>Job Number:</b>	QC-HH-07-0201-01
<b>Date of Examination:</b>	14.07.2024	<b>Location:</b>	HH Rig 029
<b>Certificate No:</b>			QC-HH-07-0201-03/78
<b>Serial Number</b>	<b>Description of the examined equipment</b>		<b>Result</b>
JC18-008	Draw works Drum		Pass

NDT Equipment Details					
Standard	ASTM E709	Viewing Condition:	Colored Media	Method	WET
Yoke	Permanent	Serial No:	PY-10	Due Date	12.08.2024
White Contrast	WCP-2	Batch No:	220602	Due Date	06-2025
Black Ink	7HF	Batch No:	220605	Due Date	7-1-2025
NDT procedure					
Visual and MPI carried out for the above description and found free of surface defects at the time of inspection					
Identification of any part found to have a defect and a description of the defect:					
None					
Particulars of any repair, renewal or alteration required to remedy the defect identified above:					
None
