INSPECTION CERTIFICATE OF 8 1/4" MAIN BODY#SBM825BP152

| Client Name: | AL-ESNAAD OIL TOOL FOR OIL SERVICES.LLC | Report No.: | QC-24-08-AL-ESNAAD-005 |
| Acceptance criteria. | DS-1, Volume 4 Fifth Edition | Date of Inspection: | 31.AUG.2024 |

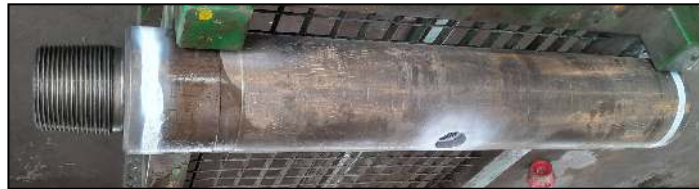
| Serial No. | Description | Connection | | Result Inspection | | | Dimensional 3 Inspection | | | | | | | | | | | | | | |
|---|---|---|---|---|---|---|---|---|---|---|---|---|---|---|---|---|---|---|---|---|---|
| SBM825BP152 | 8 1/4" MAIN BODY | 6 5/8"Reg | 6 5/8"Reg | Acc. | Acc. | Acc. | 8 1/4" | 3 1/2" | 5 3/8" | 3/4" | 5" | 7 9/16" | 8 1/4" | 6 1/16" | 5/8" | -- | - | 7 9/16" | - | - | 44 15/16" |

Conclusion: ■ 8 1/4" MAIN BODY was found "Acceptable At time of Inspection Ready For Use."
