DEFECTED CERTIFICATE OF 8 1/4" MAIN BODY#NOR825BP336

Client Name:	AL-ESNAAD OIL TOOL FOR OIL SERVICES.LLC	Report No.:	QC-24-08-AL-ESNAAD-007
Acceptance criteria:	DS-1, Volume 4 Fifth Edition	Date of Inspection:	31.AUG.2024
Work Location:	AL-ESNAAD OIL TOOL YARD	COMPANY NAME:	AL-ESNAAD
TEST EQUIPMENT & CONSUMABLE DETAILS			
WHITE CONTRAST WCP-2	Batch #: 220602 Manufacture: Magnaflux Exp Date: JUN,2025	TECHNICAL DETAILS	Wet Visible Continuous
BLACK INK 7HF	Batch#: 220605 Manufacture: Magnaflux Exp Date: JULY.2025	COIL(1200 AMP-TURNS/IN	22713 Cal.25.JUL.2024 Cal Due24.FEB.2025
FLUORESCENT 14HF	Batch #: 220306 Manufacture: Magnaflux Exp Date: March.2025	A.C HAND YOKE	PY-10 Cal.25.JUL.2024 Cal Due24.FEB.2025
INTENSITY METER	SR#1608000134 CAL.Date Cal. 25.JUL.2024 Cal Due 24.FEB.2025	UV BLACK LIGHT	SR#1895313 Cal.25.JUL.2024 Cal Due24.FEB.2025
LEAD GAGE	SR#AH07KF0026 GAEMAKER LG- Cal. 25.JUL.2024 Cal Due 24.FEB.2025	THREAD PROFILE GAGE	SR#21336 Cal. Cal.25.JUL.2024 Cal Due24.FEB.2025 SR#21335 Cal. Cal.25.JUL.2024 Cal Due24.FEB.2025

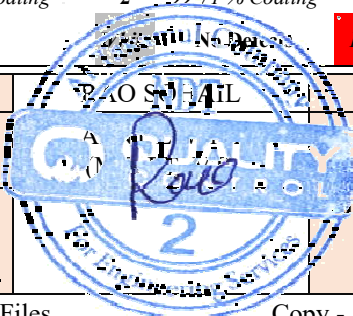
Serial No.	Description	Connection		Result Inspection			Dimensional 3 Inspection														
		Pin	Box	Pin	Box	Body	Pin					Box				Body					
							OD(In)	ID(In)	SRG φ(In)	SRG w(In)	Pin λ(In)	Bevel φ(In)	OD(In)	CB φ(In)	CB δ(In)	BB φ(In)	BB δ(In)	Bevel φ(In)	Pin λ(In)	Box T λ(In)	Overall λ(In)
NOR825BP336	8 1/4" MAIN BODY	6 5/8"Reg	6 5/8"Reg	Acc.	Acc.	BODY CRACK	8 3/16"	3 1/2"	5 3/8"	3/4"	5"	7 5/8"	8 3/16"	6 1/16"	5/8"	--	-	7 5/8"	-	-	42 3/16"
Conclusion:		8 1/4" MAIN BODY was found UnAcceptable From Body Crack Junk.
