DEFECTED CERTIFICATE OF 8 1/4" MAIN BODY#SBM825298

Client Name:	AL-ESNAAD OIL TOOL FOR OIL SERVICES.LLC	Report No.:	QC-24-08-AL-ESNAAD-008
Acceptance criteria:	DS-1, Volume 4 Fifth Edition	Date of Inspection:	31.AUG.2024
Work Location:	AL-ESNAAD OIL TOOL YARD	COMPANY NAME:	AL-ESNAAD
TEST EQUIPMENT & CONSUMABLE DETAILS			
WHITE CONTRAST WCP-2	Batch #: 220602 Manufacture: Magnaflux Exp Date: JUN.2025	TECHNICAL DETAILS	Wet Visible Continuous
BLACK INK 7HF	Batch#.220605 Manufacture: Magnaflux Exp Date: JULY.2025	COIL(1200 AMP-TURNS/IN	22713 Cal.25.JUL.2024 Cal Due24.FEB.2025
FLUORESCENT 14HF	Batch #: 220306 Manufacture: Magnaflux Exp Date: March.2025	A.C HAND YOKE	PY-10 Cal.25.JUL.2024 Cal Due24.FEB.2025
INTENSITY METER	SR#1608000134 CAL.Date Cal. 25.JUL.2024 Cal Due 24.FEB.2025	UV BLACK LIGHT	SR#1895313 Cal.25.JUL.2024 Cal Due24.FEB.2025
LEAD GAGE	SR#AH07KF0026 GAEMAKER LG- Cal. 25.JUL.2024 Cal Due 24.FEB.2025	THREAD PROFILE GAGE	SR#21336 Cal. Cal.25.JUL.2024 Cal Due24.FEB.2025 SR#21335 Cal. Cal.25.JUL.2024 Cal Due24.FEB.2025

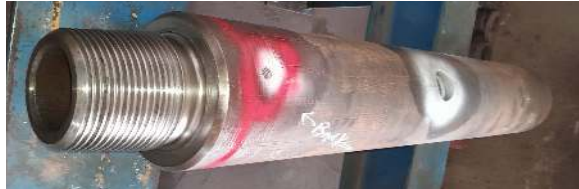
Serial No.	Description	Connection		Result Inspection			Dimensional 3 Inspection														
		Pin	Box	Pin	Box	Body	Pin					Box					Body				
							OD(In)	ID(In)	SRG φ(In)	SRG ∅ (In)	Pin λ(In)	Bevel φ(In)	OD(In)	CB φ(In)	CB δ(In)	BB φ(In)	BB δ(In)	Bevel φ(In)	Pin λ(In)	Box T λ(In)	Overall λ(In)
SBM825BP298	8 1/4" MAIN BODY	6 5/8"Reg	6 5/8"Reg	Acc.	Acc.	BODY CRACK	8 3/32"	3 1/2"	5 3/8"	1"	5"	7 1/2"	8 3/32"	6 1/16"	5/8"	--	-	7 1/2"	-	-	43 1/4"

Conclusion: 8 1/4" MAIN BODY was found UnAcceptable From Body Crack Junk.
