DEFECTED CERTIFICATE OF 8 1/4" BALL CATCHER BOX#WES825BP338&X-OVER PIN#MJS2302508

Client Name:	AL-ESNAAD OIL TOOL FOR OIL SERVICES.LLC	Report No.:	QC-24-08-AL-ESNAAD-010
Acceptance criteria:	DS-1, Volume 4 Fifth Edition	Date of Inspection:	31.AUG.2024
Work Location:	AL-ESNAAD OIL TOOL YARD	COMPANY NAME:	AL-ESNAAD
TEST EQUIPMENT & CONSUMABLE DETAILS			
WHITE CONTRAST WCP-2	Batch #: 220602 Manufacture: Magnaflux Exp Date: JUN,2025	TECHNICAL DETAILS	Wet Visible Continuous
BLACK INK 7HF	Batch#: 220605 Manufacture: Magnaflux Exp Date: JULY,2025	COIL(1200 AMP-TURNS/IN	22713 Cal.25.JUL.2024 Cal Due24.FEB.2025
FLUORESCENT 14HF	Batch #: 220306 Manufacture: Magnaflux Exp Date: March,2025	A.C HAND YOKE	PY-10 Cal.25.JUL.2024 Cal Due24.FEB.2025
INTENSITY METER	SR#1608000134 CAL.Date Cal. 25.JUL.2024 Cal Due 24.FEB.2025	UV BLACK LIGHT	SR#1895313 Cal.25.JUL.2024 Cal Due24.FEB.2025
LEAD GAGE	SR#AH07KF0026 GAEMAKER LG- Cal. 25.JUL.2024 Cal Due 24.FEB.2025	THREAD PROFILE GAGE	SR#21336 Cal. Cal.25.JUL.2024 Cal Due24.FEB.2025 SR#21335 Cal. Cal.25.JUL.2024 Cal Due24.FEB.2025

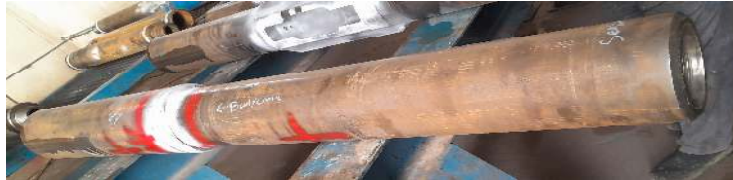
Serial No.	Description	Connection		Result Inspection			Dimensional 3 Inspection														
		Pin	Box	Pin	Box	Body	Pin					Box					Body				
							OD(In)	ID(In)	SRG φ(In)	SRG ∅ (In)	Pin λ(In)	Bevel φ(In)	OD(In)	CB φ(In)	CB δ(In)	BB φ(In)	BB δ(In)	Bevel φ(In)	Pin T λ(In)	Box T λ(In)	Overall λ(In)
WES825BP338/MJS2302508	8 1/4" BALL CATCHER/X-OVER	7 5/8"Reg	6 5/8"Reg	Acc.	S.W.O	BODY CRACK	9 1/2"	2 7/8"	6 3/8"	1"	5 1/4"	8 13/16"	8 5/32"	6 1/16"	5/8"	--	-	7 1/2"	-	-	83 1/2"

Conclusion: X-OVER was found "UnAcceptable From Pin Side Body Crack Rejected&8 1/4" Ball Catcher Box Side Body Crack&Seal WashOut Rejected.
