CERTIFICATION OF VISUAL, THOROUGH EXAMINATION & MAGNETIC PARTICLE INSPECTION

Client:	HALLIBURTON (HPS)	Report No:	QC-24-10-HPS-NDT-035A	
Location:	WQ1-562	JOB NO:	181024	
Inspection Date:	Tuesday, October 22, 2024	Next Inspection Date:	Monday, April 21, 2025	
Type Of Inspection:	VISUAL , THOROUGH EXAMINATION & MAGNETIC PARTICLE INSPECTION		Specification:	ASTM E709 & ASTM E 1444 (2016) ASME V Article 7 (2019)
		UNIT DESCRIPTION:	FRAC TANK LIFTING LUGS	
		UNIT S/N:	13253285	
		UNIT DIM:	14.20 M (L) X 2.90 M (W) X 4.40 M (H)	
		INSPECTION RESULT :		
		VISUAL , THOROUGH EXAMINATION	unit fully inspected and found free from deforms, cracks, corrosion & mechanical damage	
MAGNETIC PARTICLE INSPECTION	Welds & forgn areas inspected and found free from cracks and other defects			
FINAL RESULTS	THE ABOVE INSPECTED AREAS WAS ACCEPTED			
COMMENT:				
Magnetic Particle Inspection With A/C Hand Yoke , Black & White Contrast

CERTIFICATE OF QUALIFICATION VISUAL INSPECTION AND LEAK TESTING

CLIENT:	HALLIBURTON (HPS)	REPORT No.:	QC-24-10-HPS-VT & LEAK -35B
LOCATION:	WQ1-562	STANDARD:	CUSOMER SPECIFICATION
INSPECTION DATE:	Tuesday, October 22, 2024	NEXT INSPECTION DATE	Monday, April 21, 2025
TYPE OF

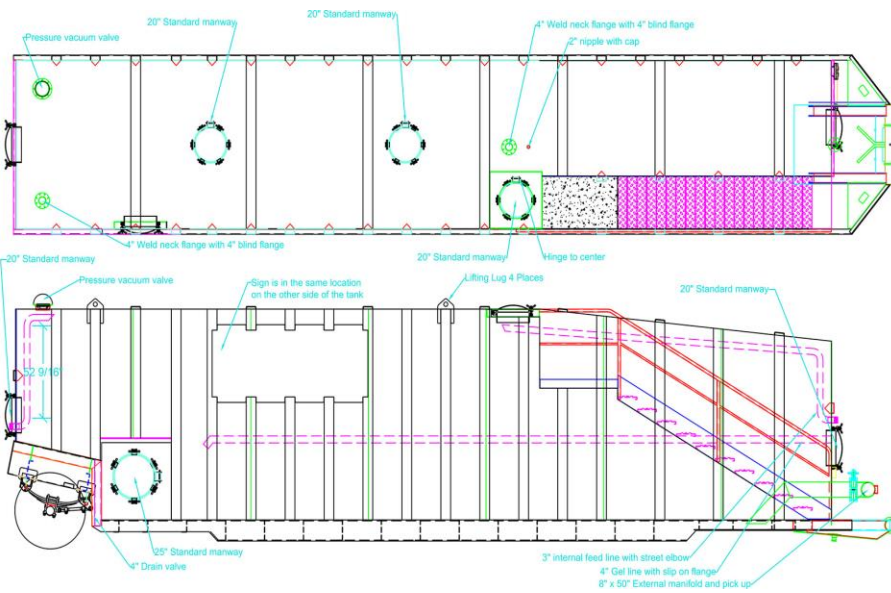
PICTURES

VISUAL TESTING:	Visual Testing of Frac Tank did not found Deforms Mechanical Damage, Cracks and Corrosion. At time of Inspection.
LEAK TESTING:	Leak Testing of Frac Tank did not found any leakage during the holding time. At time of Inspection.

VISUAL TESTING-The above mentioned Frac Tank was found "Satisfactory" Fit for intended used.

LEAK TESTING- The above mentioned Frac Tank was found "Satisfactory" Fit for intended used.
