CERTIFICATION OF VISUAL, THOROUGH EXAMINATION & MAGNETIC PARTICLE INSPECTION

Client:	HALLIBURTON (HPS)	Report No:	QC-24-10-HPS-NDT-036A
Location:	WQ1-562	JOB NO:	181024
Inspection Date:	Tuesday, October 22, 2024	Next Inspection Date:	Monday, April 21, 2025
Type Of Inspection:	VISUAL , THOROUGH EXAMINATION & MAGNETIC PARTICLE INSPECTION	Specification:	ASTM E709 & ASTM E 1444 (2016) ASME V Article 7 (2019)

CERTIFICATE OF QUALIFICATION VISUAL INSPECTION AND LEAK TESTING

CLIENT:	HALLIBURTON (HPS)	REPORT No.:	QC-24-10-HPS-VT & LEAK -36B
LOCATION:	WQ1-562	STANDARD:	CUSOMER SPECIFICATION
INSPECTION DATE:	Tuesday, October 22, 2024	NEXT INSPECTION DATE	Monday, April 21, 2025
TYPE OF INSPECTION:	*VISUAL INSPECTION AND *LEAK TESTING		
DESCRIPTION:	FRAC TANK	SAP NO:	13253286
MEDIUM USED:	WATER	HOLDING TIME:	15 MINUTES

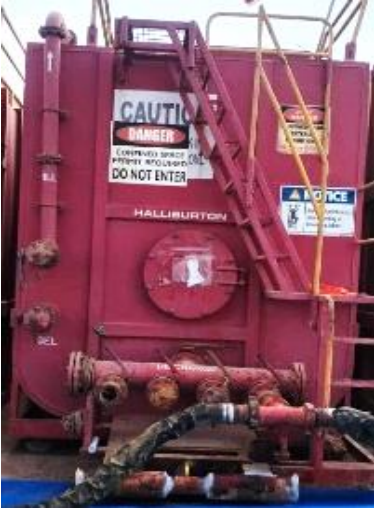
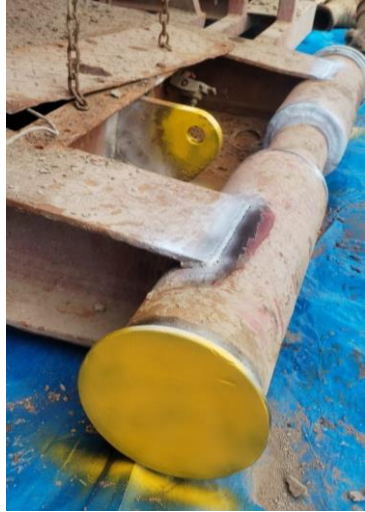
UNIT DESCRIPTION:	FRAC TANK LIFTING LUGS
		UNIT S/N:	13253286
		UNIT DIM:	14.20 M (L) X 2.90 M (W) X 4.40 M (H)
		INSPECTION RESULT :	
VISUAL , THOROUGH EXAMINATION	unit fully inspected and found free from deforms, cracks, corrosion & mechanical damage		
MAGNETIC PARTICLE INSPECTION	Welds & forgn areas inspected and found free from cracks and other defects		
FINAL RESULTS	THE ABOVE INSPECTED AREAS WAS ACCEPTED		
COMMENT:

Magnetic Particle Inspection With A/C Hand Yoke , Black & White Contrast
