Certificate of Thorough Examination & NDT of Lifting Equipment

Client:	Hong Hua Oil& Gas Engineering Services Ltd	Certificate no:	QC-HH-01-25-004-01
Location:	HH Rig 008	Job Order No:	QC-HH-01-25-004
Date of Examination:	19-January-2025	Next Inspection Due:	18-July-2025

Serial Number:	QTY	Description	SWL Each Lug:	Date of last Thorough examination
DZ42-1 DZ42-2 DZ42-3 DZ42-4	04	Substructure Front Lower Section O.D.S Lifting Lugs Fully Welded Steel Construction With Eight Bottom Trunnions Lifting Lugs. Trunnion Lug Dimension: Pipe OD: 190 mm Pipe Length: 205 mm	18 Ton	N/A

Visual & Magnetic Particles Examination Report

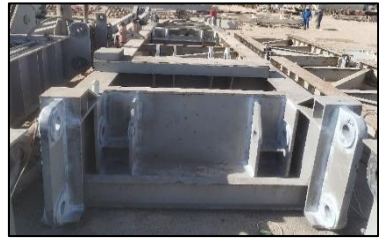
Visual and MPI were carried out for the above description and found free of surface defects at the time of inspection

Identification of any part found to have a defect and a description of the defect: None

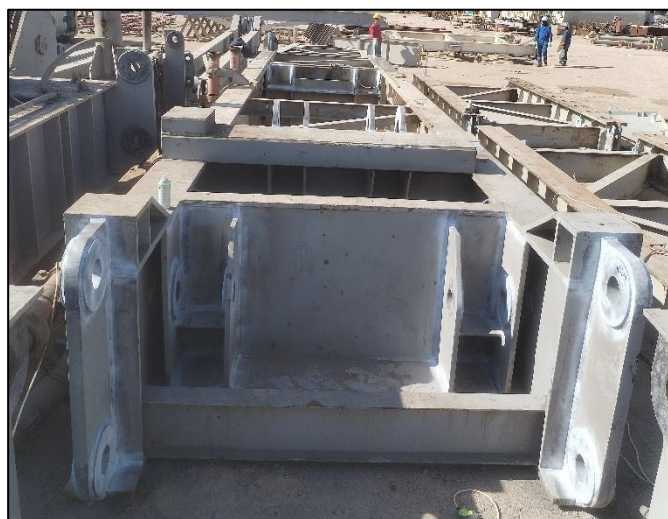
Serial Number	Description of the examined equipment	Result
DZ-12-045	Substructure Front Lower Section O.D.S Lifting Lugs	Accept
Connecting SN:	DZ42-1, DZ42-2, DZ42-3, DZ42-4	SWL Each Lug: 18 Ton

Visual and MPI were carried out for the above description and found free of surface defects at the time of inspection

Identification of any part found to have a defect and a description of the defect: None

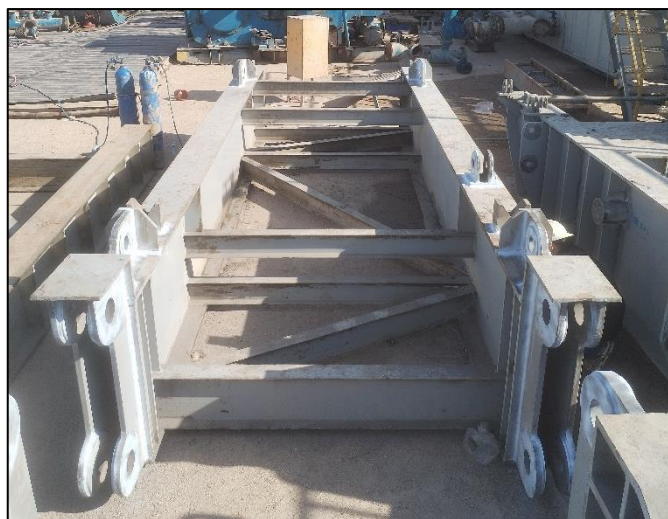
Client:	Hong Hua Oil& Gas Engineering Services Ltd	Certificate no:	QC-HH-01-25-004-04
Location:	HH Rig 008	Job Order No:	QC-HH-01-25-004
Date of Examination:	19-January-2025	Next Inspection Due:	18-July-2025
Serial Number	Description of the examined equipment		Result
DZ-12-045	Substructure Rear Lower Section O.D.S Lifting Lugs		Accept
Connecting SN:	DZ45-1, DZ45-2, DZ45-3, DZ45-4	SWL Each Lug:	18 Ton

Visual and MPI were carried out for the above description and found free of surface defects at the time of inspection

Identification of any part found to have a defect and a description of the defect: None

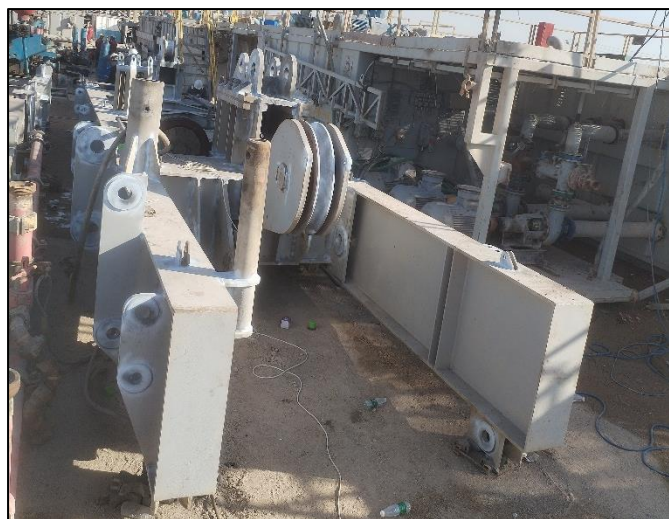
Client:	Hong Hua Oil& Gas Engineering Services Ltd	Certificate no:	QC-HH-01-25-004-06
Location:	HH Rig 008	Job Order No:	QC-HH-01-25-004
Date of Examination:	19-January-2025	Next Inspection Due:	18-July-2025
Serial Number	Description of the examined equipment		Result
DZ-12-045	Substructure Upper Section O.D.S Lifting Lugs		Accept
Connecting SN:	DZ38-1, DZ38-2, DZ38-3, DZ38-4	SWL Each Lug:	8.4 Ton

Visual and MPI were carried out for the above description and found free of surface defects at the time of inspection

Identification of any part found to have a defect and a description of the defect: None

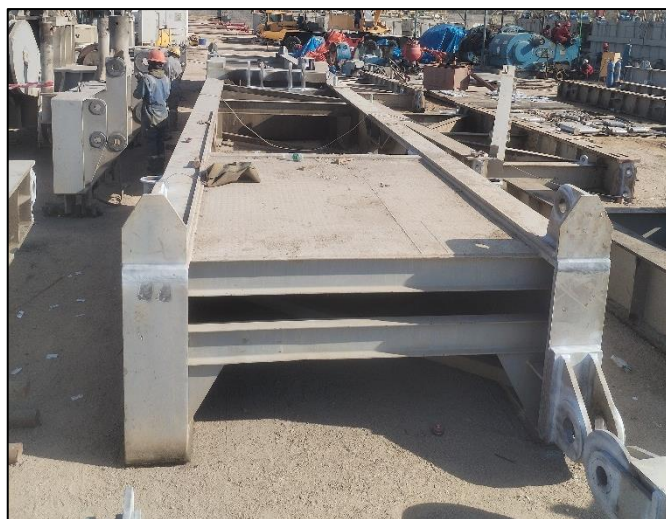
Client:	Hong Hua Oil& Gas Engineering Services Ltd	Certificate no:	QC-HH-01-25-004-08
Location:	HH Rig 008	Job Order No:	QC-HH-01-25-004
Date of Examination:	19-January-2025	Next Inspection Due:	18-July-2025
Serial Number	Description of the examined equipment		Result
DZ-12-045	Substructure Front Lower Section D.S Lifting Lugs		Accept
Connecting SN:	DZ41-1, DZ41-2, DZ41-3, DZ41-4	SWL Each Lug:	18 Ton

Visual and MPI were carried out for the above description and found free of surface defects at the time of inspection

Identification of any part found to have a defect and a description of the defect: None

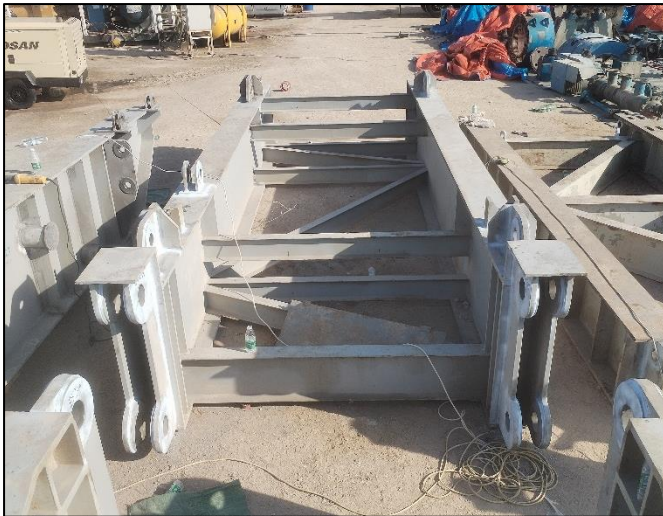
Client:	Hong Hua Oil& Gas Engineering Services Ltd	Certificate no:	QC-HH-01-25-004-10
Location:	HH Rig 008	Job Order No:	QC-HH-01-25-004
Date of Examination:	19-January-2025	Next Inspection Due:	18-July-2025
Serial Number	Description of the examined equipment		Result
DZ-12-045	Substructure Rear Lower Section D.S Lifting Lugs		Accept
Connecting SN:	DZ46-1, DZ46-2, DZ46-3, DZ46-4	SWL Each Lug:	18 Ton

Visual and MPI were carried out for the above description and found free of surface defects at the time of inspection

Identification of any part found to have a defect and a description of the defect: None

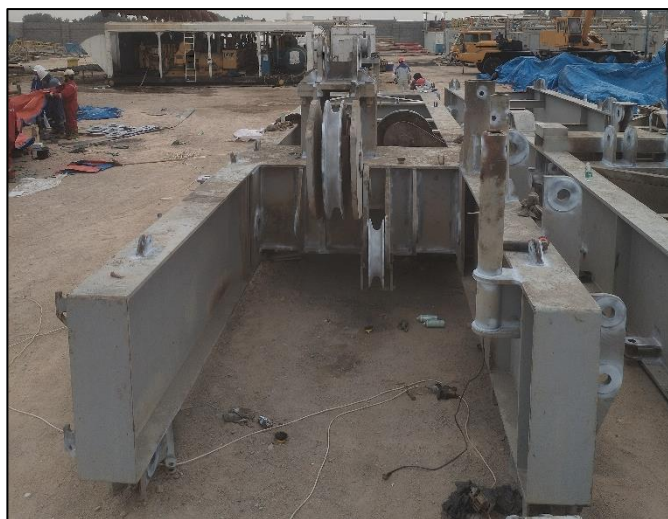
Client:	Hong Hua Oil& Gas Engineering Services Ltd	Certificate no:	QC-HH-01-25-004-12
Location:	HH Rig 008	Job Order No:	QC-HH-01-25-004
Date of Examination:	19-January-2025	Next Inspection Due:	18-July-2025
Serial Number	Description of the examined equipment		Result
DZ-12-045	Substructure Upper Section D.S Lifting Lugs		Accept
Connecting SN:	DZ34-1, DZ34-2, DZ34-3, DZ34-4	SWL Each Lug:	8.2 Ton

Visual and MPI were carried out for the above description and found free of surface defects at the time of inspection

Identification of any part found to have a defect and a description of the defect: None

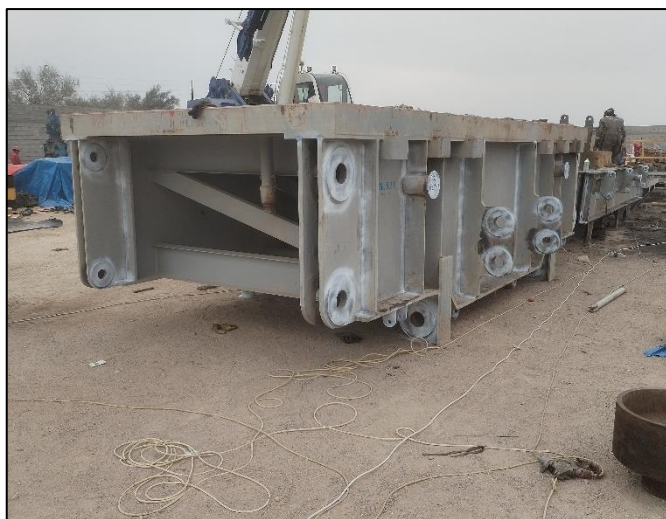
Client:	Hong Hua Oil& Gas Engineering Services Ltd	Certificate no:	QC-HH-01-25-004-13
Location:	HH Rig 008	Job Order No:	QC-HH-01-25-004
Date of Examination:	19-January-2025	Next Inspection Due:	18-July-2025
Serial Number	Description of the examined equipment		Result
DZ-12-045	Substructure Set Back Beam Lifting Lugs		Accept
Connecting SN:	DZ35-1, DZ35-2, DZ35-3, DZ35-4	SWL Each Lug:	5.2 Ton

Visual and MPI were carried out for the above description and found free of surface defects at the time of inspection

Identification of any part found to have a defect and a description of the defect: None

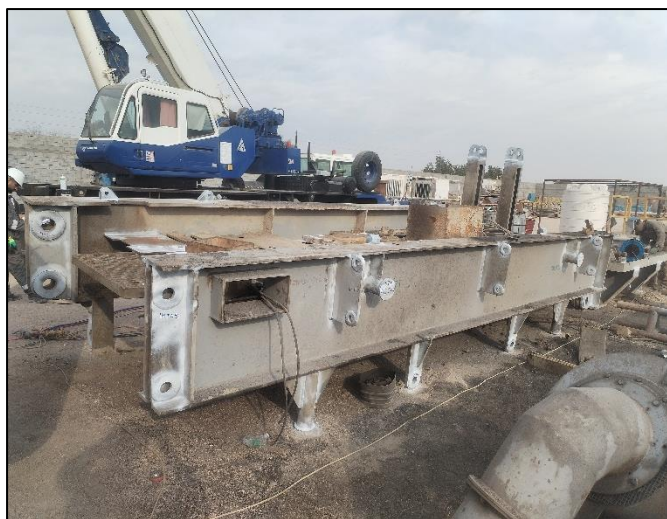
Client:	Hong Hua Oil& Gas Engineering Services Ltd	Certificate no:	QC-HH-01-25-004-14
Location:	HH Rig 008	Job Order No:	QC-HH-01-25-004
Date of Examination:	19-January-2025	Next Inspection Due:	18-July-2025
Serial Number	Description of the examined equipment		Result
DZ-12-045	Substructure Rotary Table Motor Beam Lifting Lugs		Accept
Connecting SN:	DZ37-1, DZ37-2, DZ37-3, DZ37-4	SWL Each Lug:	0.7 Ton

Visual and MPI were carried out for the above description and found free of surface defects at the time of inspection

Identification of any part found to have a defect and a description of the defect: None

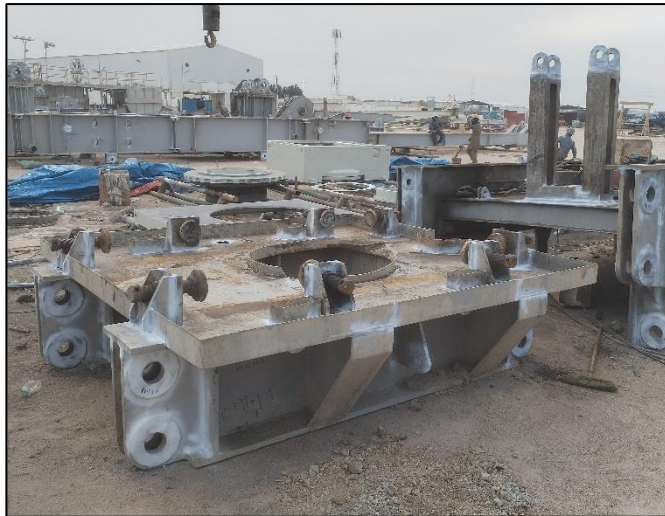
Client:	Hong Hua Oil& Gas Engineering Services Ltd	Certificate no:	QC-HH-01-25-004-15
Location:	HH Rig 008	Job Order No:	QC-HH-01-25-004
Date of Examination:	19-January-2025	Next Inspection Due:	18-July-2025
Serial Number	Description of the examined equipment		Result
DZ-12-045	Substructure Rotary Table Base Lifting Lugs		Accept
Connecting SN:	DZ36-1, DZ36-2, DZ36-3, DZ36-4	SWL Each Lug:	2.8 Ton

Visual and MPI were carried out for the above description and found free of surface defects at the time of inspection

Identification of any part found to have a defect and a description of the defect: None

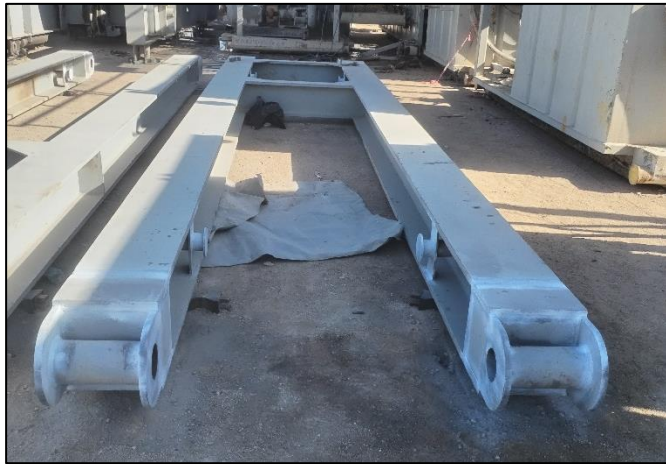
Client:	Hong Hua Oil& Gas Engineering Services Ltd	Certificate no:	QC-HH-01-25-004-16
Location:	HH Rig 008	Job Order No:	QC-HH-01-25-004
Date of Examination:	19-January-2025	Next Inspection Due:	18-July-2025
Serial Number	Description of the examined equipment		Result
DZ-12-045	Substructure Front Column O.D.S Lifting Lugs		Accept
Connecting SN:	DZ23-1, DZ23-2, DZ23-3, DZ23-4	SWL Each Lug:	2.1 Ton

Visual and MPI were carried out for the above description and found free of surface defects at the time of inspection

Identification of any part found to have a defect and a description of the defect: None

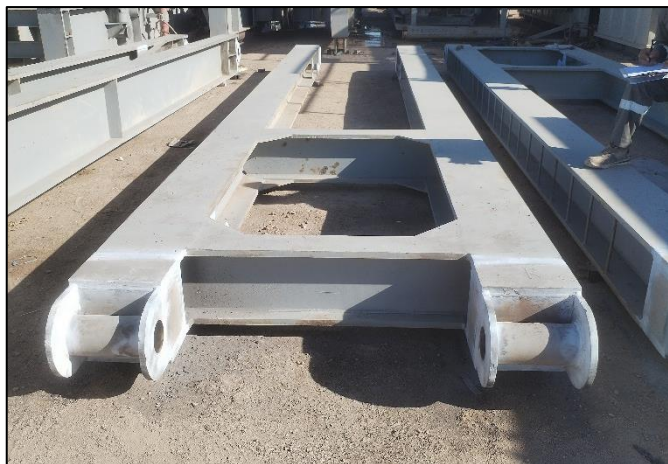
Client:	Hong Hua Oil & Gas Engineering Services Ltd	Certificate no:	QC-HH-01-25-004-17
Location:	HH Rig 008	Job Order No:	QC-HH-01-25-004
Date of Examination:	19-January-2025	Next Inspection Due:	18-July-2025
Serial Number	Description of the examined equipment		Result
DZ-12-045	Substructure Front Column D.S Lifting Lugs		Accept
Connecting SN:	DZ23-5, DZ23-6, DZ23-7, DZ23-8	SWL Each Lug:	2.1 Ton

Visual and MPI were carried out for the above description and found free of surface defects at the time of inspection

Identification of any part found to have a defect and a description of the defect: None

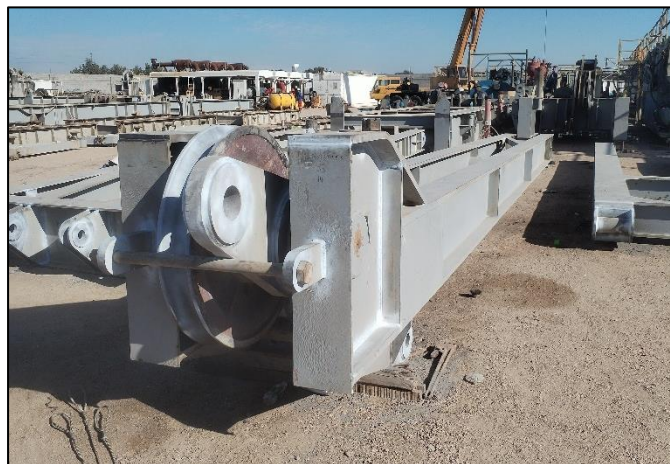
Client:	Hong Hua Oil & Gas Engineering Services Ltd	Certificate no:	QC-HH-01-25-004-18
Location:	HH Rig 008	Job Order No:	QC-HH-01-25-004
Date of Examination:	19-January-2025	Next Inspection Due:	18-July-2025
Serial Number	Description of the examined equipment		Result
DZ-12-045	Substructure Lifting Bracket O.D.S Lifting Lugs		Accept
Connecting SN:	DZ2-5, DZ2-6, DZ2-7, DZ2-8	SWL Each Lug:	3.3 Ton

Visual and MPI were carried out for the above description and found free of surface defects at the time of inspection

Identification of any part found to have a defect and a description of the defect: None

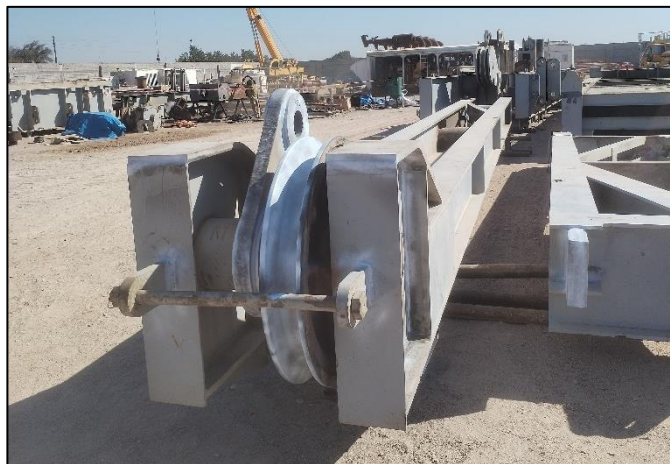
Client:	Hong Hua Oil & Gas Engineering Services Ltd	Certificate no:	QC-HH-01-25-004-19
Location:	HH Rig 008	Job Order No:	QC-HH-01-25-004
Date of Examination:	19-January-2025	Next Inspection Due:	18-July-2025
Serial Number	Description of the examined equipment		Result
DZ-12-045	Substructure Lifting Bracket D.S Lifting Lugs		Accept
Connecting SN:	DZ2-1, DZ2-2, DZ2-3, DZ2-4	SWL Each Lug:	3.3 Ton

Visual and MPI were carried out for the above description and found free of surface defects at the time of inspection

Identification of any part found to have a defect and a description of the defect: None

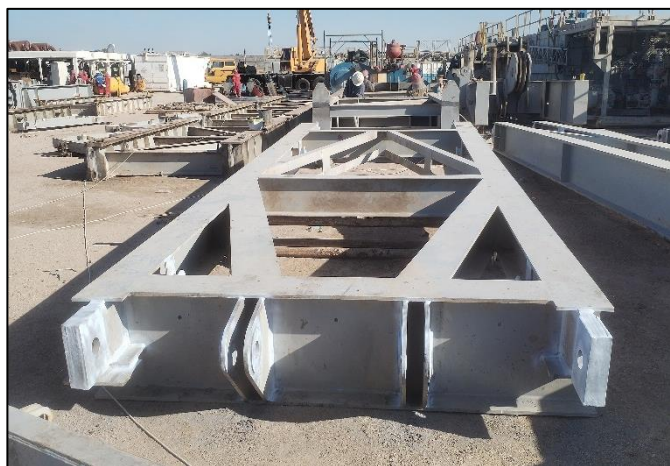
Client:	Hong Hua Oil& Gas Engineering Services Ltd	Certificate no:	QC-HH-01-25-004-20
Location:	HH Rig 008	Job Order No:	QC-HH-01-25-004
Date of Examination:	19-January-2025	Next Inspection Due:	18-July-2025
Serial Number	Description of the examined equipment		Result
DZ-12-045	Substructure Vertical Bracket O.D.S Lifting Lugs		Accept
Connecting SN:	DZ1-5, DZ1-6, DZ1-7, DZ1-8	SWL Each Lug:	1.9 Ton

Visual and MPI were carried out for the above description and found free of surface defects at the time of inspection

Identification of any part found to have a defect and a description of the defect: None

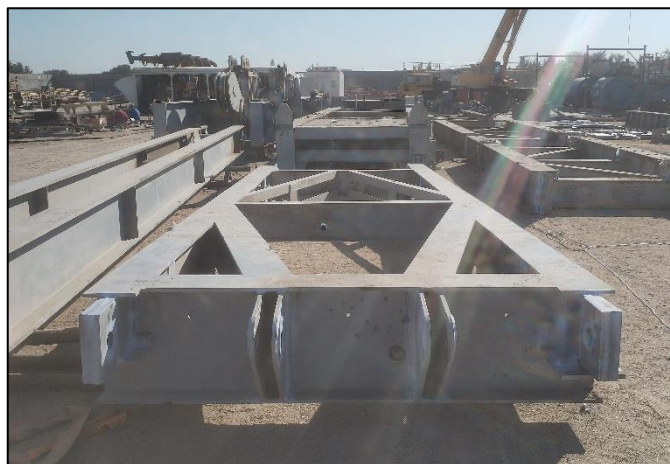
Client:	Hong Hua Oil& Gas Engineering Services Ltd	Certificate no:	QC-HH-01-25-004-21
Location:	HH Rig 008	Job Order No:	QC-HH-01-25-004
Date of Examination:	19-January-2025	Next Inspection Due:	18-July-2025
Serial Number	Description of the examined equipment		Result
DZ-12-045	Substructure Vertical Bracket D.S Lifting Lugs		Accept
Connecting SN:	DZ1-1, DZ1-2, DZ1-3, DZ1-4	SWL Each Lug:	1.9 Ton

Visual and MPI were carried out for the above description and found free of surface defects at the time of inspection

Identification of any part found to have a defect and a description of the defect: None

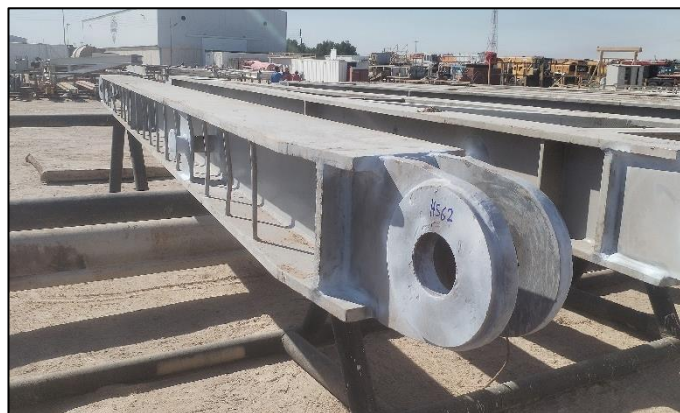
Client:	Hong Hua Oil & Gas Engineering Services Ltd	Certificate no:	QC-HH-01-25-004-22
Location:	HH Rig 008	Job Order No:	QC-HH-01-25-004
Date of Examination:	19-January-2025	Next Inspection Due:	18-July-2025
Serial Number	Description of the examined equipment		Result
DZ-12-045	Substructure Inclined Support O.D.S Lifting Lugs		Accept
Connecting SN:	DZ6-1, DZ6-2, DZ6-3, DZ6-4	SWL Each Lug:	1 Ton

Visual and MPI were carried out for the above description and found free of surface defects at the time of inspection

Identification of any part found to have a defect and a description of the defect: None

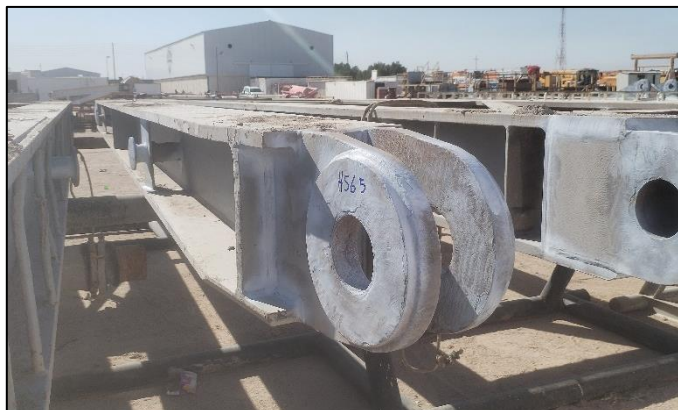
Client:	Hong Hua Oil & Gas Engineering Services Ltd	Certificate no:	QC-HH-01-25-004-23
Location:	HH Rig 008	Job Order No:	QC-HH-01-25-004
Date of Examination:	19-January-2025	Next Inspection Due:	18-July-2025
Serial Number	Description of the examined equipment		Result
DZ-12-045	Substructure Inclined Support D.S Lifting Lugs		Accept
Connecting SN:	DZ6-5, DZ6-6, DZ6-7, DZ6-8	SWL Each Lug:	1 Ton

Visual and MPI were carried out for the above description and found free of surface defects at the time of inspection

Identification of any part found to have a defect and a description of the defect: None

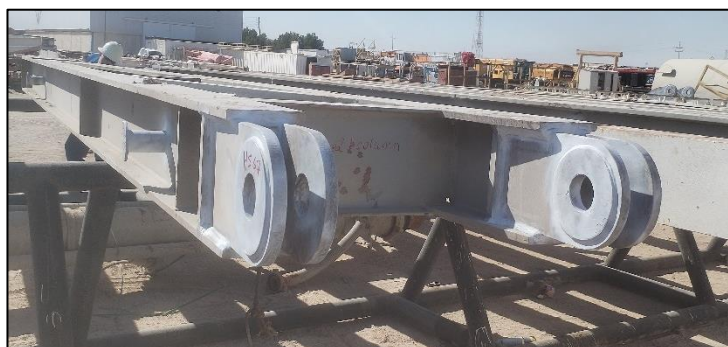
Client:	Hong Hua Oil & Gas Engineering Services Ltd	Certificate no:	QC-HH-01-25-004-24
Location:	HH Rig 008	Job Order No:	QC-HH-01-25-004
Date of Examination:	19-January-2025	Next Inspection Due:	18-July-2025
Serial Number	Description of the examined equipment		Result
DZ-12-045	Substructure Inclined Support O.D.S Lifting Lugs		Accept
Connecting SN:	DZ7-23 DZ8-3, DZ9-3, DZ10-3	SWL Each Lug:	1.3 Ton

Visual and MPI were carried out for the above description and found free of surface defects at the time of inspection

Identification of any part found to have a defect and a description of the defect: None

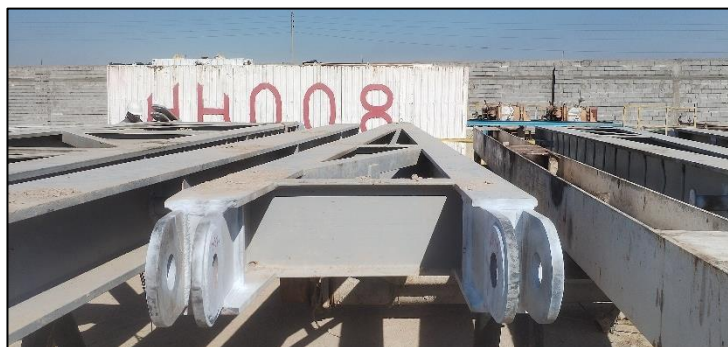
Client:	Hong Hua Oil & Gas Engineering Services Ltd	Certificate no:	QC-HH-01-25-004-25
Location:	HH Rig 008	Job Order No:	QC-HH-01-25-004
Date of Examination:	19-January-2025	Next Inspection Due:	18-July-2025
Serial Number	Description of the examined equipment		Result
DZ-12-045	Substructure Inclined Support D.S Lifting Lugs		Accept
Connecting SN:	DZ7-2, DZ8-2, DZ9-2, DZ10-2	SWL Each Lug:	1.3 Ton

Visual and MPI were carried out for the above description and found free of surface defects at the time of inspection

Identification of any part found to have a defect and a description of the defect: None

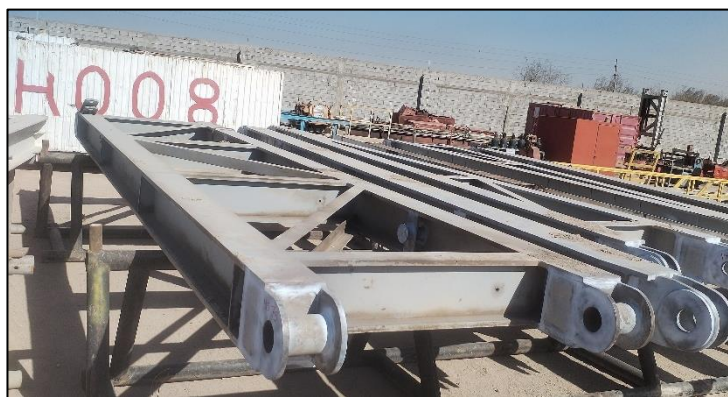
Client:	Hong Hua Oil & Gas Engineering Services Ltd	Certificate no:	QC-HH-01-25-004-26
Location:	HH Rig 008	Job Order No:	QC-HH-01-25-004
Date of Examination:	19-January-2025	Next Inspection Due:	18-July-2025
Serial Number	Description of the examined equipment		Result
DZ-12-045	Substructure Column Rear O.D.S Lifting Lugs		Accept
Connecting SN:	DZ4-5, DZ4-6, DZ4-7, DZ4-8	SWL Each Lug:	2 Ton

Visual and MPI were carried out for the above description and found free of surface defects at the time of inspection

Identification of any part found to have a defect and a description of the defect: None

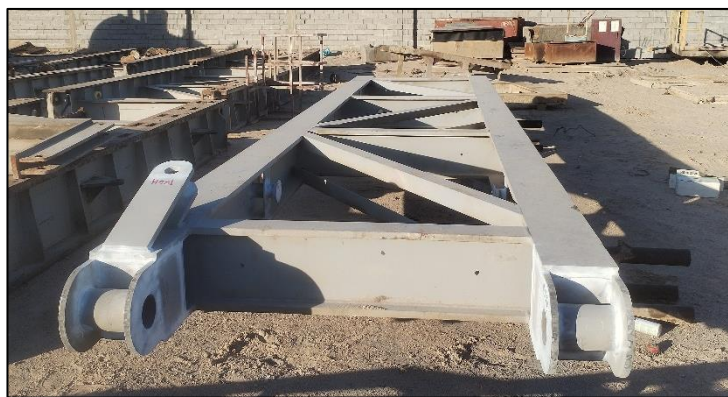
Client:	Hong Hua Oil & Gas Engineering Services Ltd	Certificate no:	QC-HH-01-25-004-27
Location:	HH Rig 008	Job Order No:	QC-HH-01-25-004
Date of Examination:	19-January-2025	Next Inspection Due:	18-July-2025
Serial Number	Description of the examined equipment		Result
DZ-12-045	Substructure Column Rear D.S Lifting Lugs		Accept
Connecting SN:	DZ4-5, DZ4-6, DZ4-7, DZ4-8	SWL Each Lug:	2 Ton

Visual and MPI were carried out for the above description and found free of surface defects at the time of inspection

Identification of any part found to have a defect and a description of the defect: None

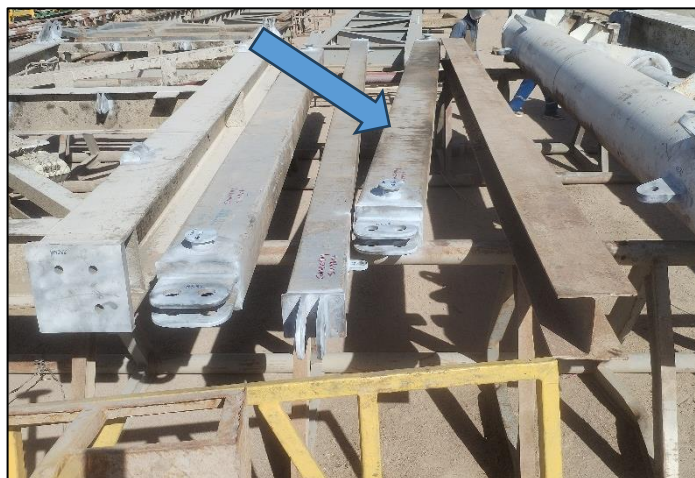
Client:	Hong Hua Oil& Gas Engineering Services Ltd	Certificate no:	QC-HH-01-25-004-28
Location:	HH Rig 008	Job Order No:	QC-HH-01-25-004
Date of Examination:	19-January-2025	Next Inspection Due:	18-July-2025
Serial Number	Description of the examined equipment		Result
DZ-12-045	Substructure Connecting Support Lifting Lugs		Accept
Connecting SN:	DZ43-1, DZ43-2	SWL Each Lug:	5.8 KN

Visual and MPI were carried out for the above description and found free of surface defects at the time of inspection

Identification of any part found to have a defect and a description of the defect: None

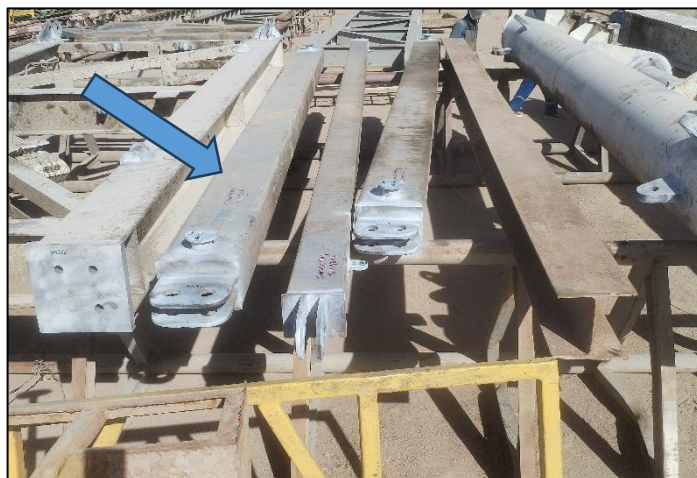
Client:	Hong Hua Oil & Gas Engineering Services Ltd	Certificate no:	QC-HH-01-25-004-29
Location:	HH Rig 008	Job Order No:	QC-HH-01-25-004
Date of Examination:	19-January-2025	Next Inspection Due:	18-July-2025
Serial Number	Description of the examined equipment		Result
DZ-12-045	Substructure Connecting Support Lifting Lugs		Accept
Connecting SN:	DZ43-5, DZ43-4	SWL Each Lug:	5.8 KN

Visual and MPI were carried out for the above description and found free of surface defects at the time of inspection

Identification of any part found to have a defect and a description of the defect: None

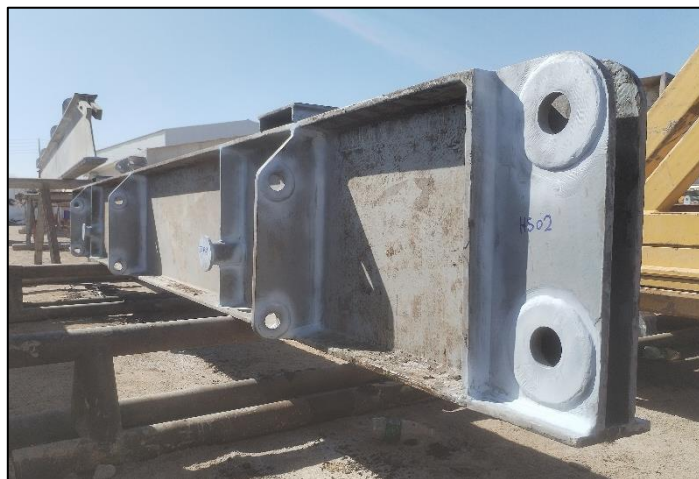
Serial Number	Description of the examined equipment	Result
DZ-12-045	Substructure D.W Rear Beam Lifting Lugs	Accept
Connecting SN:	DZ39-1, DZ39-2, DZ39-3, DZ39-4	SWL Each Lug: 1 Ton

Visual and MPI were carried out for the above description and found free of surface defects at the time of inspection

Identification of any part found to have a defect and a description of the defect: None

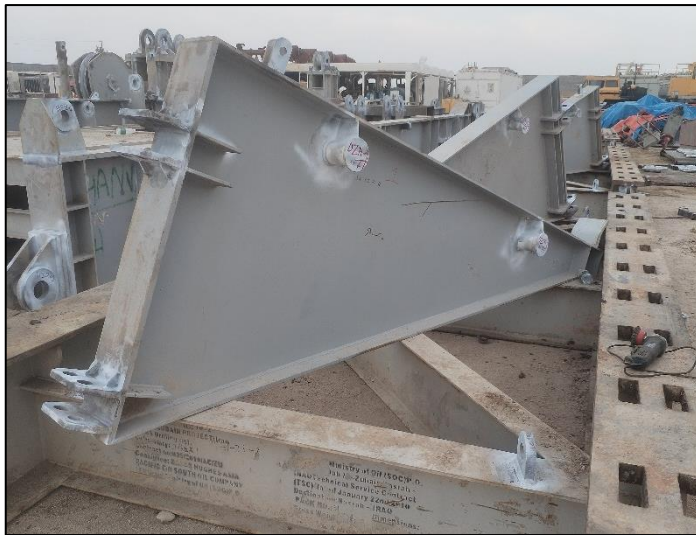
Client:	Hong Hua Oil & Gas Engineering Services Ltd	Certificate no:	QC-HH-01-25-004-31
Location:	HH Rig 008	Job Order No:	QC-HH-01-25-004
Date of Examination:	19-January-2025	Next Inspection Due:	18-July-2025
Serial Number	Description of the examined equipment		Result
DZ-12-045	Substructure Dog House Beam Lifting Lugs		Accept
Connecting SN:	DZ14-1, DZ14-2, DZ14-3, DZ14-4	SWL Each Lug:	0.7 Ton

Visual and MPI were carried out for the above description and found free of surface defects at the time of inspection

Identification of any part found to have a defect and a description of the defect: None

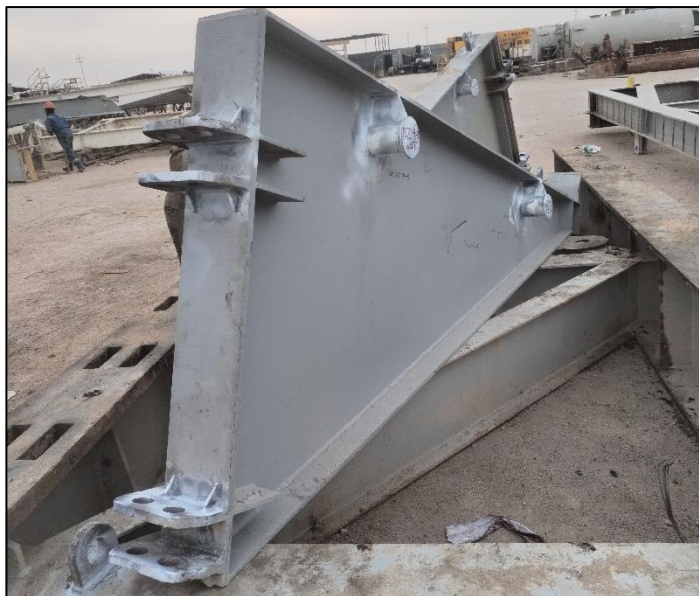
Serial Number	Description of the examined equipment	Result
DZ-12-045	Substructure Dog House Beam Lifting Lugs	Accept
Connecting SN:	DZ14-5, DZ14-6, DZ14-7, DZ14-8	SWL Each Lug: 0.7 Ton

Visual and MPI were carried out for the above description and found free of surface defects at the time of inspection

Identification of any part found to have a defect and a description of the defect: None

Particulars of any repair, renewal, or alteration required to remedy the defect identified above: None

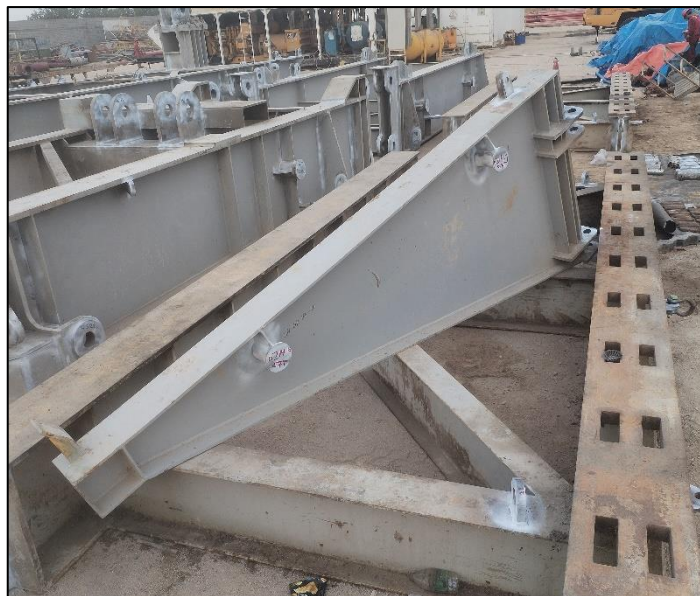
Client:	Hong Hua Oil& Gas Engineering Services Ltd	Certificate no:	QC-HH-01-25-004-33
Location:	HH Rig 008	Job Order No:	QC-HH-01-25-004
Date of Examination:	19-January-2025	Next Inspection Due:	18-July-2025
Serial Number	Description of the examined equipment		Result
DZ-12-045	Substructure Dog House Beam Lifting Lugs		Accept
Connecting SN:	DZ14-9, DZ14-10, DZ14-11, DZ14-12	SWL Each Lug:	0.7 Ton

Visual and MPI were carried out for the above description and found free of surface defects at the time of inspection

Identification of any part found to have a defect and a description of the defect: None

Particulars of any repair, renewal, or alteration required to remedy the defect identified above: None

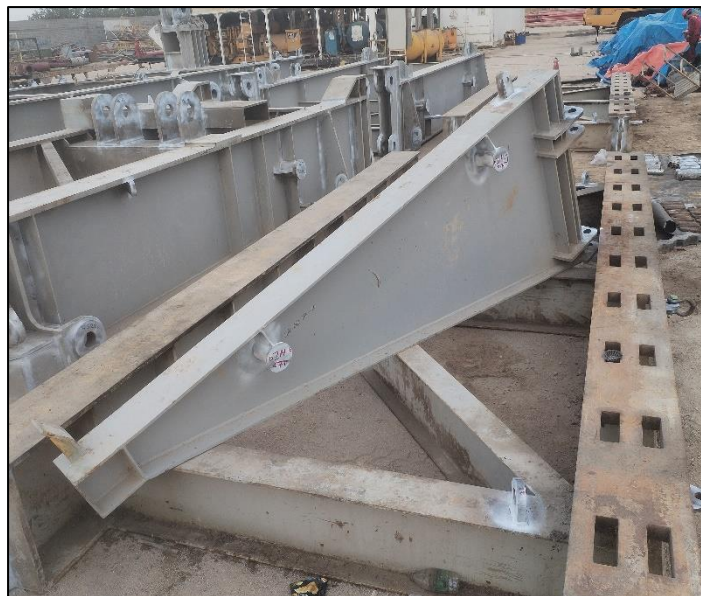
Serial Number	Description of the examined equipment	Result
DZ-12-045	Substructure Dog House Beam Lifting Lugs	Accept
Connecting SN:	DZ28-9, DZ28-10, DZ28-11, DZ28-12	SWL Each Lug: 0.7 Ton

Visual and MPI were carried out for the above description and found free of surface defects at the time of inspection
Identification of any part found to have a defect and a description of the defect: None
Particulars of any repair, renewal, or alteration required to remedy the defect identified above: None
All MPI was performed as per the instructions of OEM, and the measurements were done by OEM.

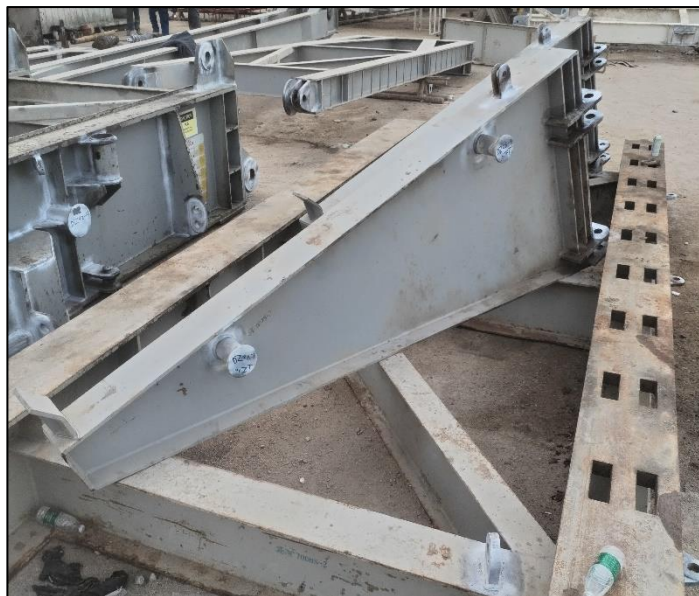
Client:	Hong Hua Oil& Gas Engineering Services Ltd	Certificate no:	QC-HH-01-25-004-35
Location:	HH Rig 008	Job Order No:	QC-HH-01-25-004
Date of Examination:	19-January-2025	Next Inspection Due:	18-July-2025
Serial Number	Description of the examined equipment		Result
DZ-12-045	Substructure Dog House Beam Lifting Lugs		Accept
Connecting SN:	DZ28-5, DZ28-6, DZ28-7, DZ28-8	SWL Each Lug:	0.7 Ton

Visual and MPI were carried out for the above description and found free of surface defects at the time of inspection

Identification of any part found to have a defect and a description of the defect: None

Particulars of any repair, renewal, or alteration required to remedy the defect identified above: None

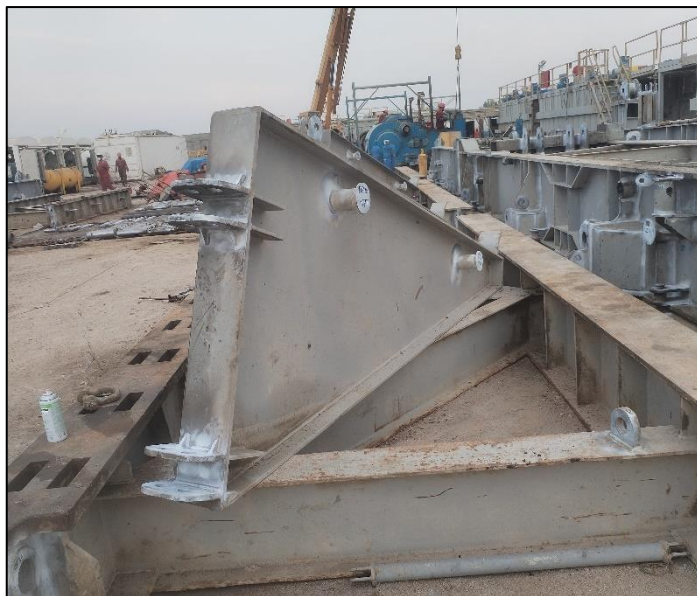
Client:	Hong Hua Oil& Gas Engineering Services Ltd	Certificate no:	QC-HH-01-25-004-36
Location:	HH Rig 008	Job Order No:	QC-HH-01-25-004
Date of Examination:	19-January-2025	Next Inspection Due:	18-July-2025
Serial Number	Description of the examined equipment		Result
DZ-12-045	Substructure Dog House Beam Lifting Lugs		Accept
Connecting SN:	DZ28-1, DZ28-2, DZ28-3, DZ28-4	SWL Each Lug:	0.7 Ton

Visual and MPI were carried out for the above description and found free of surface defects at the time of inspection

Identification of any part found to have a defect and a description of the defect: None

Particulars of any repair, renewal, or alteration required to remedy the defect identified above: None

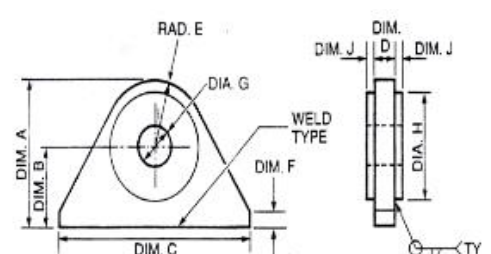
Serial Number:	QTY	Description	SWL Each Pad Eye:	Date of last Thorough examination
S21 S22	02	Fabricated Pad Eyes Substructure Connecting Support Pad Eye Dimension Thickness: 22 MM Pin Hole: 26 MM Length: 60 MM Height: 85 MM	2 Ton	N/A

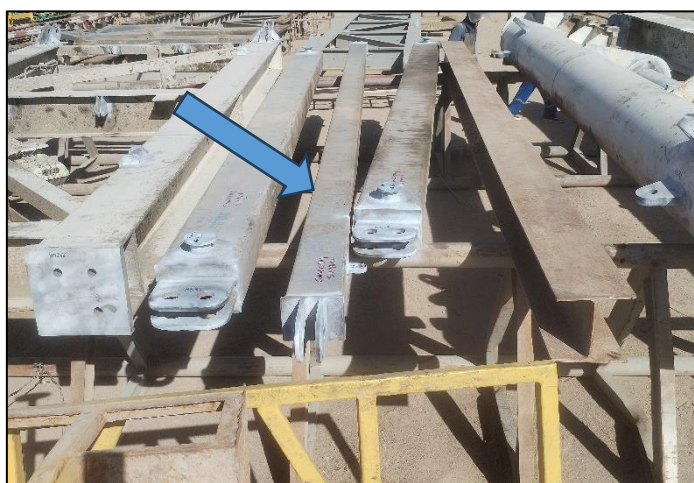
Client:	Hong Hua Oil& Gas Engineering Services Ltd	Certificate no:	QC-HH-01-25-004-38
Location:	HH Rig 008	Job Order No:	QC-HH-01-25-004
Date of Examination:	19-January-2025	Next Inspection Due:	18-July-2025
Serial Number	Description of the examined equipment		Result
DZ-12-045	Fabricated Pad Eyes Substructure Connecting Support		Accept
Connecting SN:	S21, S22	SWL Each Pad Eyes:	2 Ton

Visual and MPI were carried out for the above description and found free of surface defects at the time of inspection
Identification of any part found to have a defect and a description of the defect: None
Particulars of any repair, renewal, or alteration required to remedy the defect identified above: None
All MPI was performed as per the instructions of OEM, and the measurements were done by OEM.

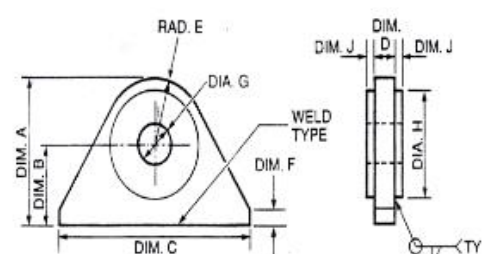
Serial Number:	QTY	Description	SWL Each Pad Eye:	Date of last Thorough examination
33-1 33-2	02	Fabricated Pad Eyes Substructure Front Cross Beam Pad Eye Dimension Thickness: 22 MM Pin Hole: 26 MM Length: 60 MM Height: 85 MM	2 Ton	N/A

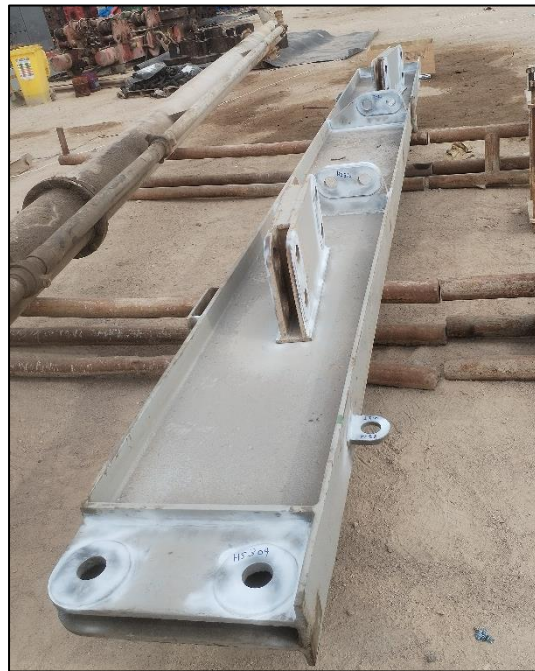
Client:	Hong Hua Oil& Gas Engineering Services Ltd	Certificate no:	QC-HH-01-25-004-40
Location:	HH Rig 008	Job Order No:	QC-HH-01-25-004
Date of Examination:	19-January-2025	Next Inspection Due:	18-July-2025
Serial Number	Description of the examined equipment		Result
DZ-12-045	Fabricated Pad Eyes Substructure Front Cross Beam		Accept
Connecting SN:	33-1, 33-2	SWL Each Pad Eyes:	2 Ton

Visual and MPI were carried out for the above description and found free of surface defects at the time of inspection
Identification of any part found to have a defect and a description of the defect: None
Particulars of any repair, renewal, or alteration required to remedy the defect identified above: None
All MPI was performed as per the instructions of OEM, and the measurements were done by OEM.

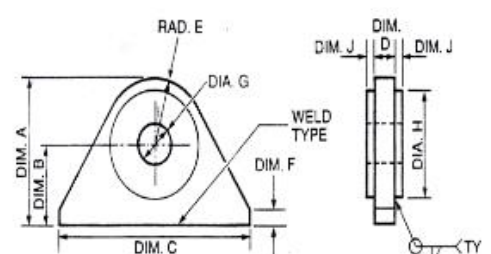
Serial Number:	QTY	Description	SWL Each Pad Eye:	Date of last Thorough examination
HS330 HS331 HS332 HS333	04	Fall Arrestor Pad Eyes Substructure Set Back Beam Pad Eye Dimension Thickness: 18 MM Pin Hole: 26 MM Length: 102 MM Height: 132 MM	25 KN	N/A

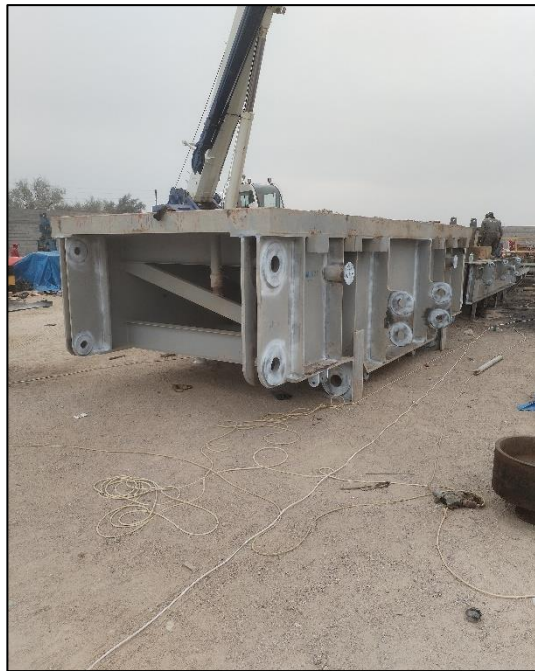
Serial Number	Description of the examined equipment	Result
DZ-12-045	Fall Arrestor Pad Eyes Substructure Set Back Beam	Accept
Connecting SN:	HS330, HS331, HS332, HS333	SWL Each Pad Eyes: 25 KN

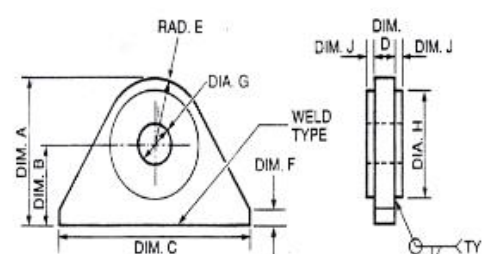
Serial Number:	QTY	Description	SWL Each Pad Eye:	Date of last Thorough examination
HS342 HS343 HS344 HS345	04	Fall Arrestor Pad Eyes Substructure Rotary Table Motor Beam Pad Eye Dimension Thickness: 18 MM Pin Hole: 26 MM Length: 102 MM Height: 132 MM	25 KN	N/A

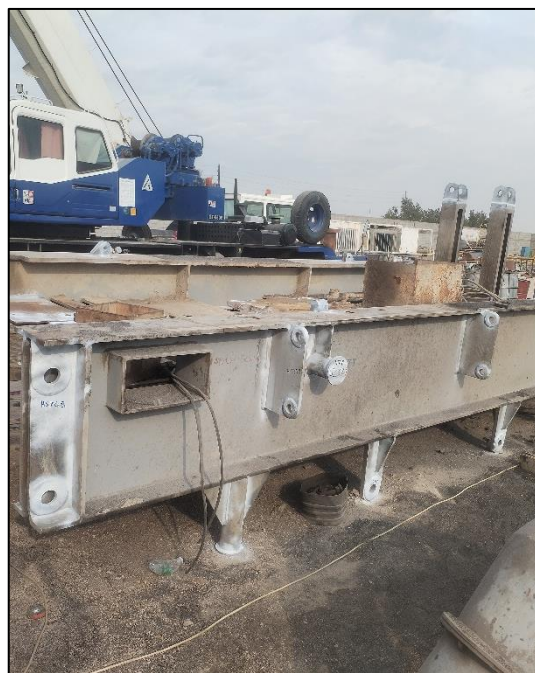
Serial Number	Description of the examined equipment	Result
DZ-12-045	Fall Arrestor Pad Eyes Substructure Rotary Table Motor Beam	Accept
Connecting SN:	HS342, HS343, HS344, HS345	SWL Each Pad Eyes: 25 KN
