Visual & Magnetic Particles Examination Report

Client:	Hong Hua Oil& Gas Engineering Services Ltd	Certificate no:	QC-HH-02-25-051/01
Location:	HH Rig 008	Job Order No:	QC-HH-02-25-051
Date of Examination:	07-Feb-2025	Next Inspection Due:	06-Aug-2025
Serial Number	Description of the examined equipment		Result
H001	LIFTING CROSS		Accept
LIFTING POINTS/N:	1H323	LIFTING POINTDIA: Pin hole: 50 mm / Thickness: 16 mm	SWL 1.5 TON

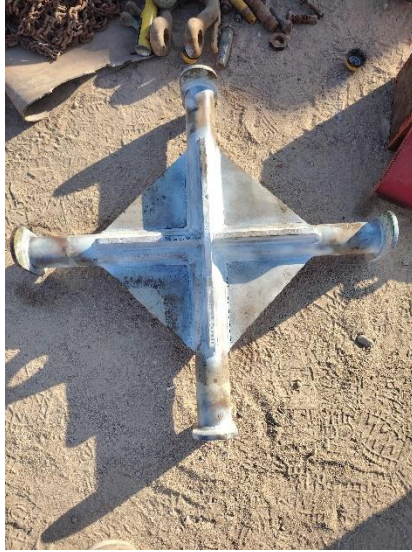
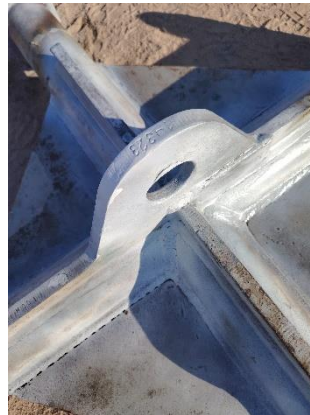
Visual and MPI were carried out for the above description and found free of surface defects at the time of inspection

Identification of any part found to have a defect and a description of the defect: None

Particulars of any repair, renewal, or alteration required to remedy the defect identified above: None

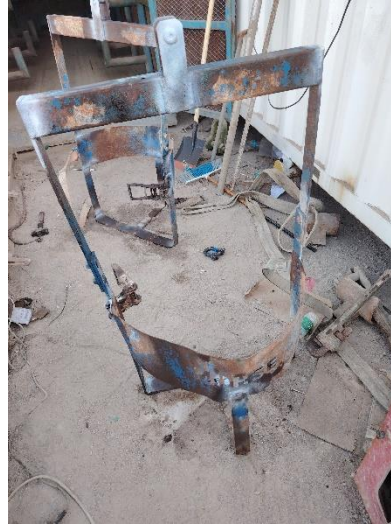
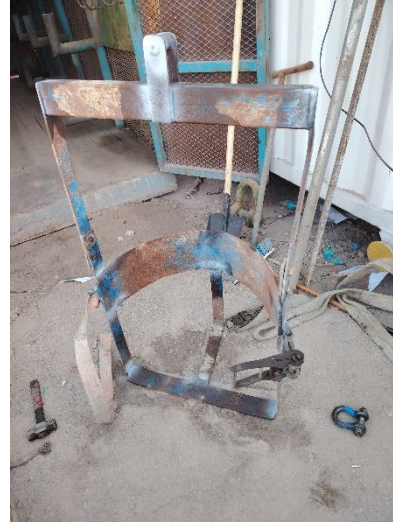
Client:	Hong Hua Oil& Gas Engineering Services Ltd	Certificate no:	QC-HH-02-25-051/02
Location:	HH Rig 008	Job Order No:	QC-HH-02-25-051
Date of Examination:	07-Feb-2025	Next Inspection Due:	06-Aug-2025
Serial Number	Description of the examined equipment	Result	
HH8-S41	DRUM LIFTER (Welding Area)	Accept	
SWL	453.6 KG

Visual and MPI were carried out for the above description and found free of surface defects at the time of inspection

Identification of any part found to have a defect and a description of the defect: None

Particulars of any repair, renewal, or alteration required to remedy the defect identified above: None

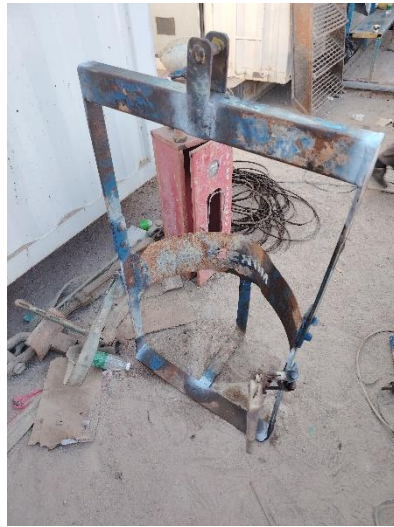
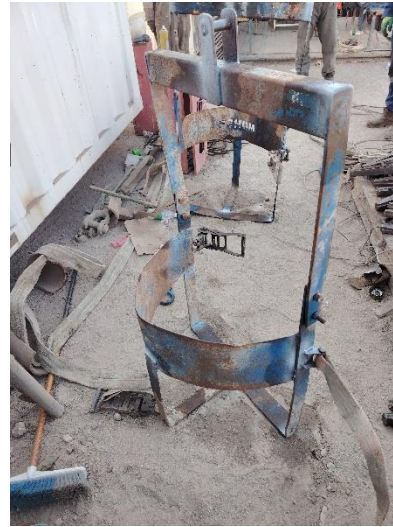
Client:	Hong Hua Oil& Gas Engineering Services Ltd	Certificate no:	QC-HH-02-25-051/03
Location:	HH Rig 008	Job Order No:	QC-HH-02-25-051
Date of Examination:	07-Feb-2025	Next Inspection Due:	06-Aug-2025
Serial Number	Description of the examined equipment	Result	
HH8-S40	DRUM LIFTER (Welding Area)	Accept	
SWL:	453.6 KG

Visual and MPI were carried out for the above description and found free of surface defects at the time of inspection

Identification of any part found to have a defect and a description of the defect: None

Particulars of any repair, renewal, or alteration required to remedy the defect identified above: None

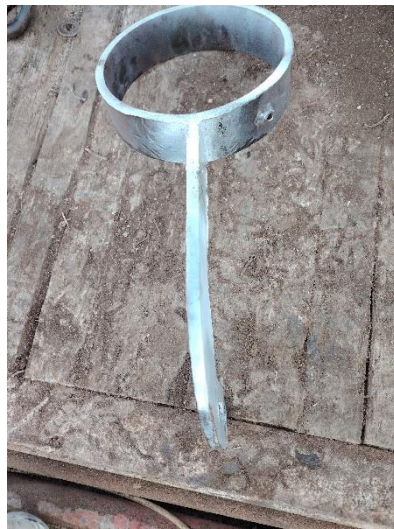
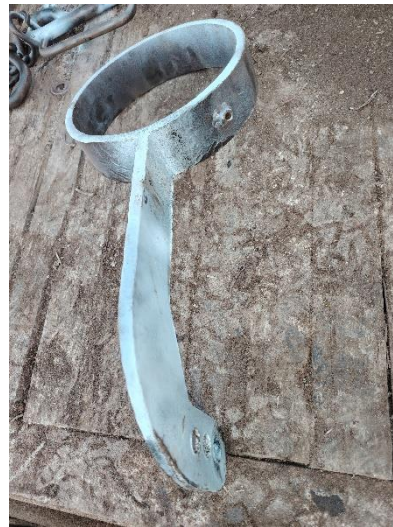
Client:	Hong Hua Oil& Gas Engineering Services Ltd	Certificate no:	QC-HH-02-25-051/04
Location:	HH Rig 008	Job Order No:	QC-HH-02-25-051
Date of Examination:	07-Feb-2025	Next Inspection Due:	06-Aug-2025
Serial Number	Description of the examined equipment	Result	
HH008-100	MUD PUMP LINER PULLER	Accept

Visual and MPI were carried out for the above description and found free of surface defects at the time of inspection

Identification of any part found to have a defect and a description of the defect: None

Particulars of any repair, renewal, or alteration required to remedy the defect identified above: None

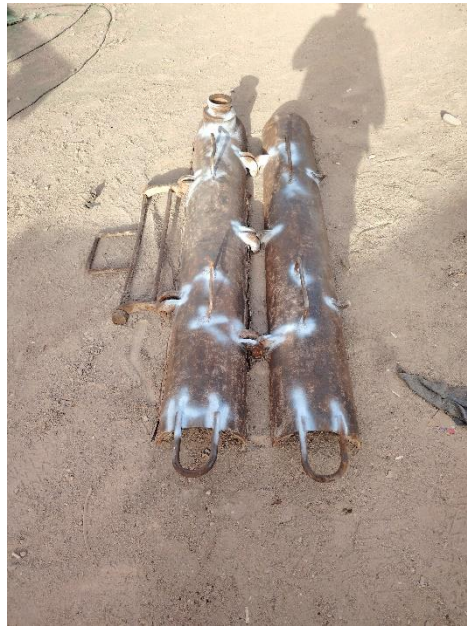
Serial Number	Description of the examined equipment	Result
HH008-100	MUD SAVER (welding area)	Accept

Visual and MPI were carried out for the above description and found free of surface defects at the time of inspection

Identification of any part found to have a defect and a description of the defect: None

Particulars of any repair, renewal, or alteration required to remedy the defect identified above: None
