Certificate of Thorough Examination & NDT of Lifting Equipment

Client Name:	Daqing Drilling Company	Location:	Rig (DQ 1202)	Job Number:	QC-B-03-25-0091
Date of Examination:	15-03-2025	Date of Report:	15-03-2025	Certificate No:	QC-B-03-25-0091-01-01
Serial Number:	QTY	Description		SWL	Date of last Thorough examination
DZ025 DZ026	02	Fabricated Pad Eyes SUBSTRUCTURE SUPPORT BEAM Pad Eye Dimension Thickness: 24 MM Pin Hole: 30 MM Length: 120 MM Height: 129 MM		30 KN	19-10-2024
				Last Proof Load Test:- N/A

Visual & Magnetic Particles Examination Report

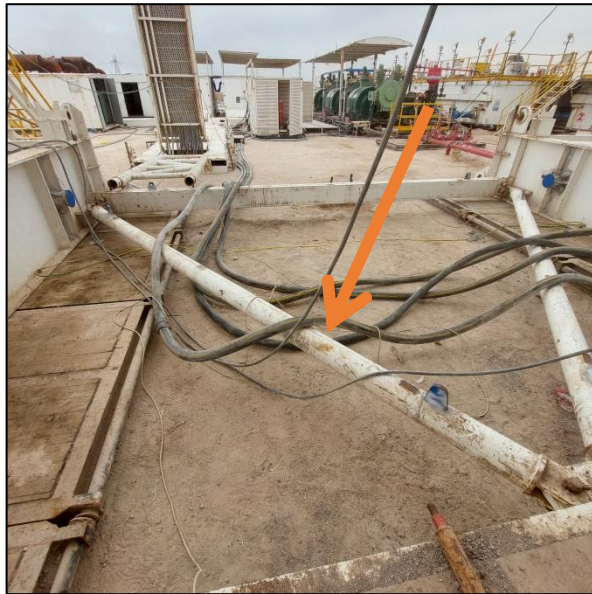
Client Name:	Daqing Drilling Company	Location:	Rig (DQ 1202)	Job Number:	QC-B-03-25-0091
Date of Examination:	15-03-2025	Date of Report:	15-03-2025	Certificate No:	QC-B-03-25-0091-01-01A
Unit Serial Number	Description of the examined equipment				Result
20019	SUBSTRUCTURE SUPPORT BEAM PAD EYES				Pass
PAD EYES SN:	DZ025 , DZ026

NDT procedure	
Visual and MPI carried out for the above description and found free of surface defects at the time of inspection	
Identification of any part found to have a defect and a description of the defect:	
None	
Particulars of any repair, renewal or alteration required to remedy the defect identified above:	
None

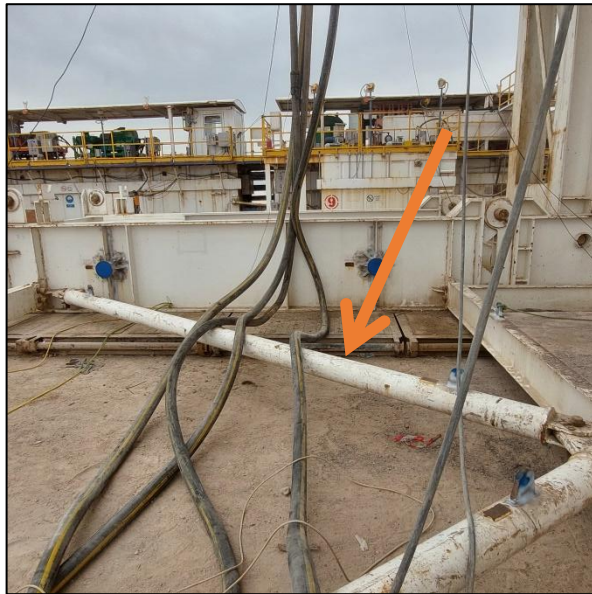
Client Name:	Daqing Drilling Company	Location:	Rig (DQ 1202)	Job Number:	QC-B-03-25-0091
Date of Examination:	15-03-2025	Date of Report:	15-03-2025	Certificate No:	QC-B-03-25-0091-01-02A
Unit Serial Number	Description of the examined equipment				Result
20019	SUBSTRUCTURE SUPPORT BEAM PAD EYES				Pass
PAD EYES SN:	DZ027 , DZ028

Visual and MPI carried out for the above description and found free of surface defects at the time of inspection

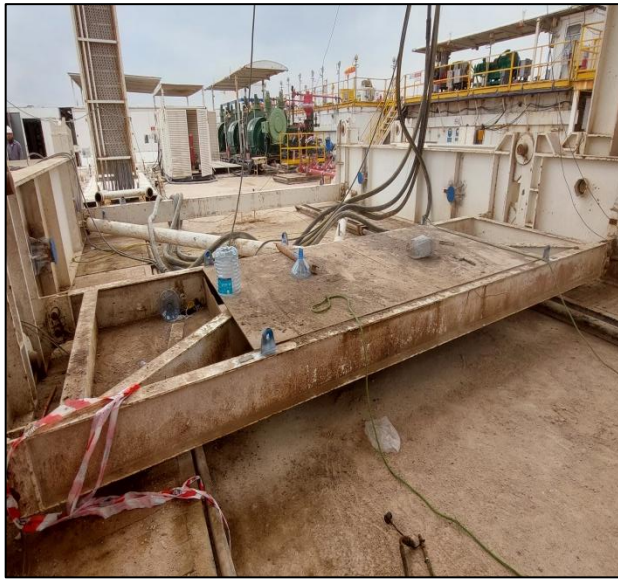
Client Name:	Daqing Drilling Company	Location:	Rig (DQ 1202)	Job Number:	QC-B-03-25-0091
Date of Examination:	15-03-2025	Date of Report:	15-03-2025	Certificate No:	QC-B-03-25-0091-01-03A
Unit Serial Number	Description of the examined equipment				Result
20019	SUBSTRUCTURE H- SUPPORT BEAM PAD EYES				Pass
PAD EYES SN:	DZ017 , DZ018 , DZ019 , DZ020

Visual and MPI carried out for the above description and found free of surface defects at the time of inspection

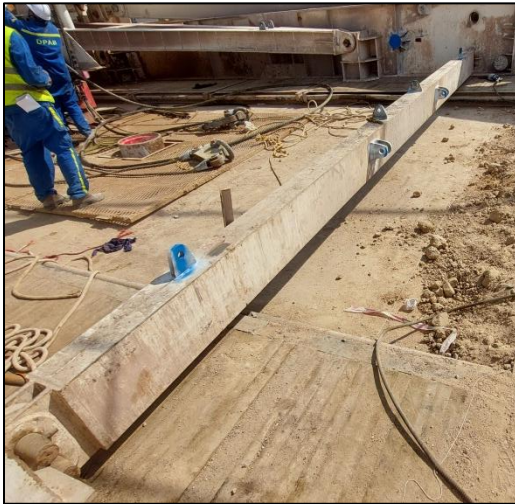
Client Name:	Daqing Drilling Company	Location:	Rig (DQ 1202)	Job Number:	QC-B-03-25-0091
Date of Examination:	15-03-2025	Date of Report:	15-03-2025	Certificate No:	QC-B-03-25-0091-01-04A
Unit Serial Number	Description of the examined equipment				Result
20019	SUBSTRUCTURE SUPPORT BEAM PAD EYES				Pass
PAD EYES SN:	DZ021 , DZ022

Visual and MPI carried out for the above description and found free of surface defects at the time of inspection

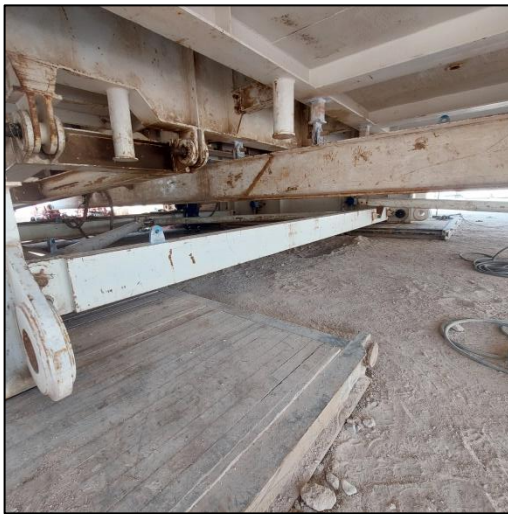
Client Name:	Daqing Drilling Company	Location:	Rig (DQ 1202)	Job Number:	QC-B-03-25-0091
Date of Examination:	15-03-2025	Date of Report:	15-03-2025	Certificate No:	QC-B-03-25-0091-01-05A
Unit Serial Number	Description of the examined equipment				Result
20019	SUBSTRUCTURE SUPPORT BEAM PAD EYES				Pass
PAD EYES SN:	DZ023 , DZ024

Visual and MPI carried out for the above description and found free of surface defects at the time of inspection

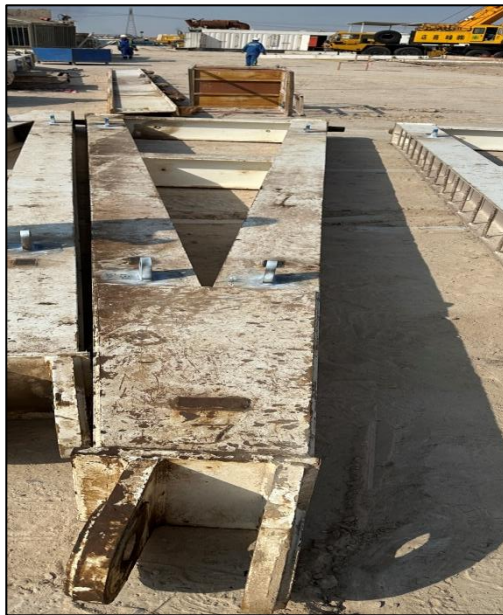
Client Name:	Daqing Drilling Company	Location:	Rig (DQ 1202)	Job Number:	QC-B-03-25-0091
Date of Examination:	15-03-2025	Date of Report:	15-03-2025	Certificate No:	QC-B-03-25-0091-01-06A
Unit Serial Number	Description of the examined equipment				Result
20019	SUBSTRUCTURE SUPPORT BEAM 7# PAD EYES				Pass
PAD EYES SN:	049 , 050 , 051 , 052

Visual and MPI carried out for the above description and found free of surface defects at the time of inspection

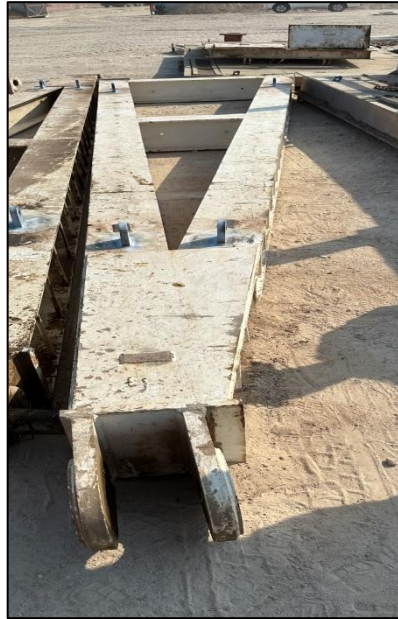
Client Name:	Daqing Drilling Company	Location:	Rig (DQ 1202)	Job Number:	QC-B-03-25-0091
Date of Examination:	15-03-2025	Date of Report:	15-03-2025	Certificate No:	QC-B-03-25-0091-01-07A
Unit Serial Number	Description of the examined equipment				Result
20019	SUBSTRUCTURE SUPPORT BEAM 4# PAD EYES				Pass
PAD EYES SN:	041 , 042 , 043 , 044

Visual and MPI carried out for the above description and found free of surface defects at the time of inspection

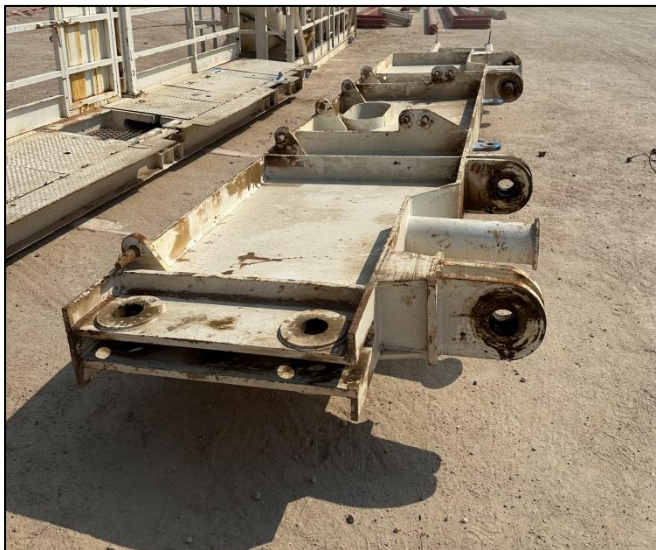
Client Name:	Daqing Drilling Company	Location:	Rig (DQ 1202)	Job Number:	QC-B-03-25-0091
Date of Examination:	15-03-2025	Date of Report:	15-03-2025	Certificate No:	QC-B-03-25-0091-01-08A
Unit Serial Number	Description of the examined equipment				Result
20019	SUB STRUCTURE SUPPORT BEAM PAD EYES				Pass
PAD EYES SN:	073 , 074

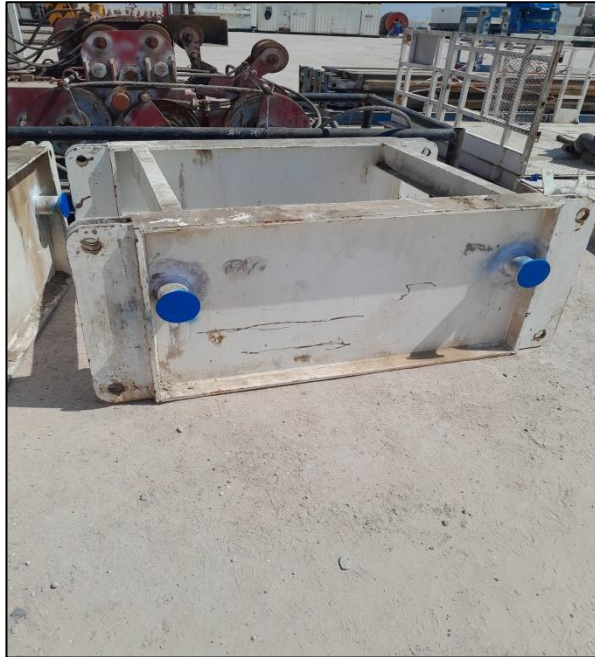
Client Name:	Daqing Drilling Company	Location:	Rig (DQ 1202)	Job Number:	QC-B-03-25-0091
Date of Examination:	15-03-2025	Date of Report:	15-03-2025	Certificate No:	QC-B-03-25-0091-01-09
Unit Serial Number	Description of the examined equipment				Result
20019	SUBSTRUCTURE BOX LIFTING LUGS				Pass
LUGS SN:	D9 , D10 , D11 , D12

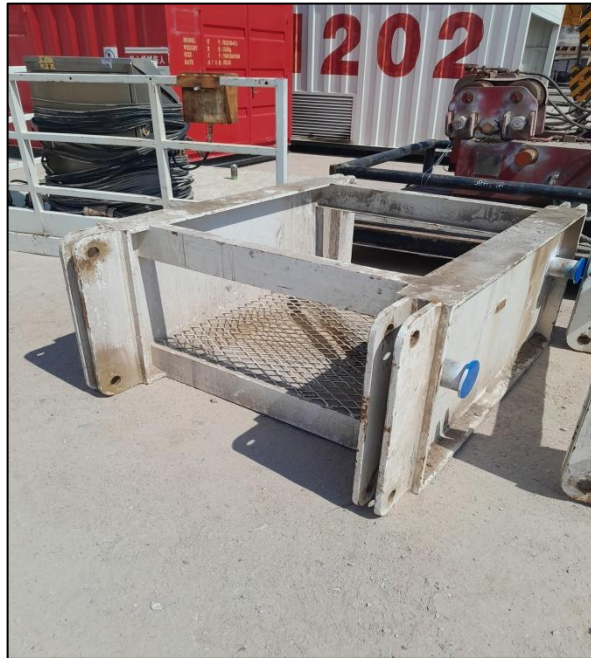
Client Name:	Daqing Drilling Company	Location:	Rig (DQ 1202)	Job Number:	QC-B-03-25-0091
Date of Examination:	15-03-2025	Date of Report:	15-03-2025	Certificate No:	QC-B-03-25-0091-01-10
Unit Serial Number	Description of the examined equipment				Result
20019	SUB STRUCTURE BOX LIFTING LUGS				Pass
LUGS SN:	D13 , D14 , D15 , D16

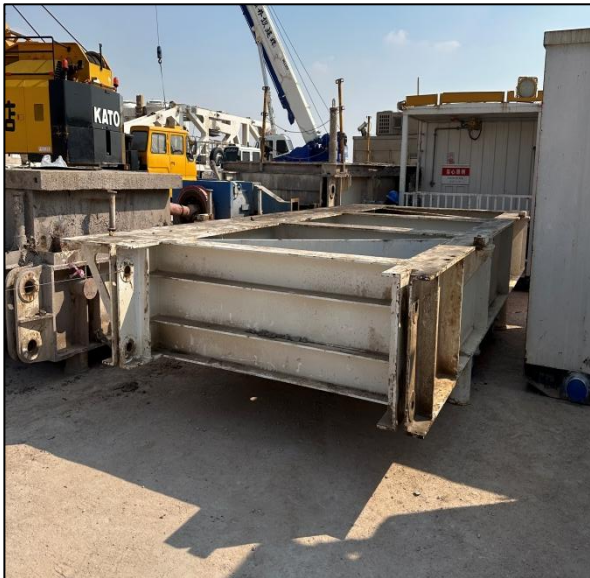
Client Name:	Daqing Drilling Company	Location:	Rig (DQ 1202)	Job Number:	QC-B-03-25-0091
Date of Examination:	15-03-2025	Date of Report:	15-03-2025	Certificate No:	QC-B-03-25-0091-01-11
Unit Serial Number	Description of the examined equipment				Result
20019	SUBSTRUCTURE DRAWWORKS BASE LIFTING LUGS				Pass
LUGS SN:	077 , 078 , 079 , 080	ECHE LUG SWL		70 KN

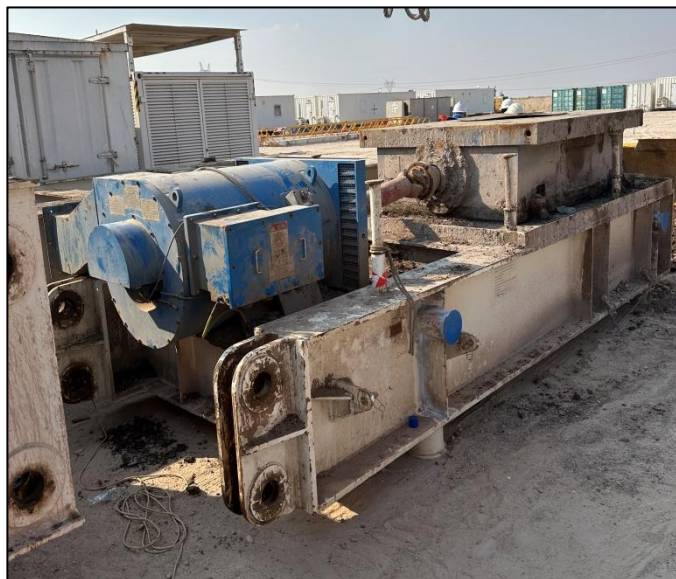
Client Name:	Daqing Drilling Company	Location:	Rig (DQ 1202)	Job Number:	QC-B-03-25-0091
Date of Examination:	15-03-2025	Date of Report:	15-03-2025	Certificate No:	QC-B-03-25-0091-01-12
Unit Serial Number	Description of the examined equipment				Result
20019	ROTARY TABLE LIFTING LUGS				Pass
LUGS SN:	069 , 070 , 071 , 072	ECHE LUG SWL		80 KN

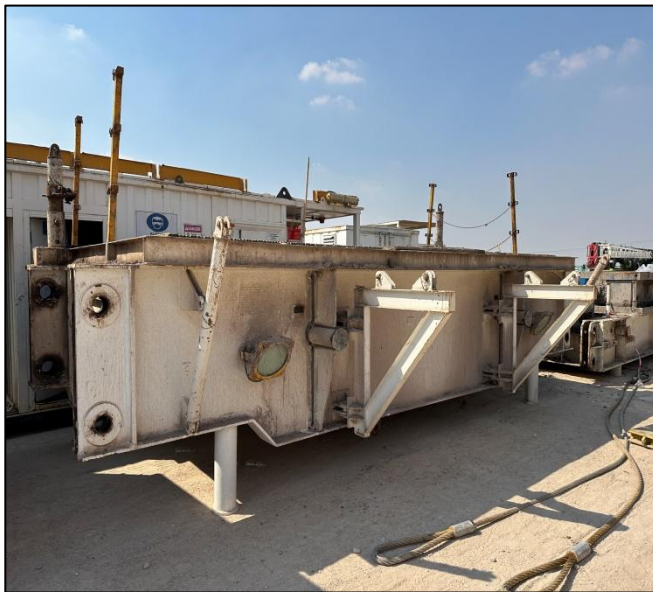
Client Name:	Daqing Drilling Company	Location:	Rig (DQ 1202)	Job Number:	QC-B-03-25-0091
Date of Examination:	15-03-2025	Date of Report:	15-03-2025	Certificate No:	QC-B-03-25-0091-01-13
Unit Serial Number	Description of the examined equipment				Result
20019	SUBSTRUCTURE SIT BACK BOX LIFTING LUGS				Pass
LUGS SN:	065 , 066 , 067 , 068	ECHE LUG SWL		70 KN

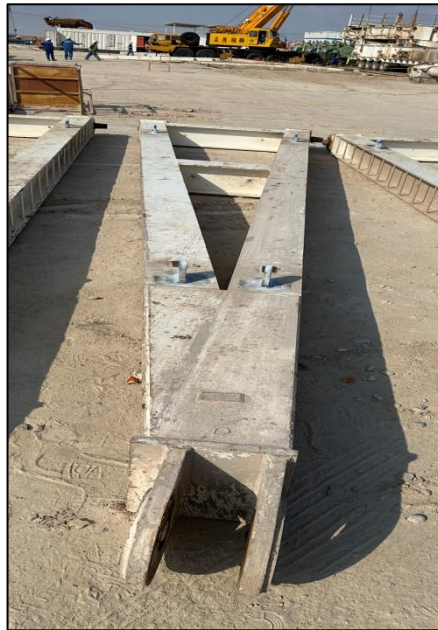
Client Name:	Daqing Drilling Company	Location:	Rig (DQ 1202)	Job Number:	QC-B-03-25-0091
Date of Examination:	15-03-2025	Date of Report:	15-03-2025	Certificate No:	QC-B-03-25-0091-01-14A
Unit Serial Number	Description of the examined equipment				Result
20019	SUBSTRUCTURE SUPPORT BEAM 6# PAD EYES				Pass
PAD EYES SN:	045 , 046 , 047 , 048

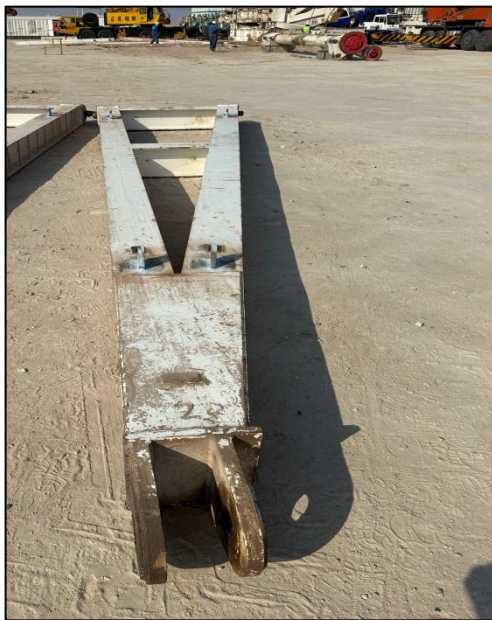
Client Name:	Daqing Drilling Company	Location:	Rig (DQ 1202)	Job Number:	QC-B-03-25-0091
Date of Examination:	15-03-2025	Date of Report:	15-03-2025	Certificate No:	QC-B-03-25-0091-01-15A
Unit Serial Number	Description of the examined equipment				Result
20019	SUBSTRUCTURE SUPPORT BEAM 2# PAD EYES				Pass
PAD EYES SN:	037 , 038 , 039 , 040

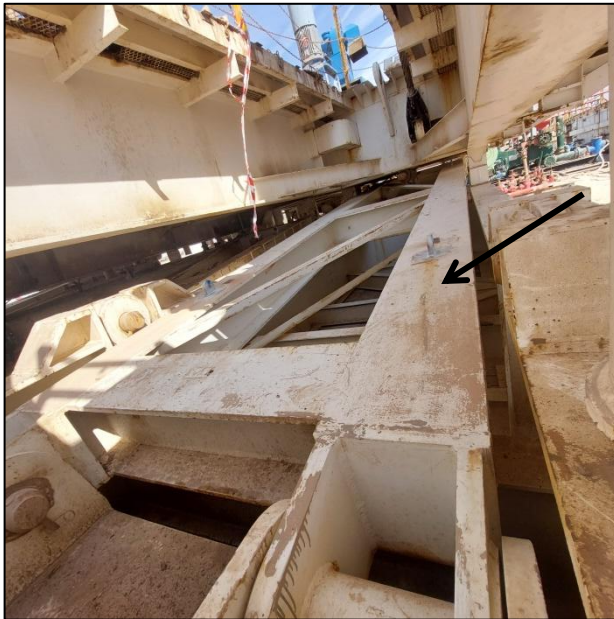
Client Name:	Daqing Drilling Company	Location:	Rig (DQ 1202)	Job Number:	QC-B-03-25-0091
Date of Examination:	15-03-2025	Date of Report:	15-03-2025	Certificate No:	QC-B-03-25-0091-01-16A
Unit Serial Number	Description of the examined equipment				Result
20019	SUBSTRUCTURE OFF DRILL SIDE SUPPORT BEAM PAD EYES				Pass
PAD EYES SN:	057 , 058 , 059 , 060

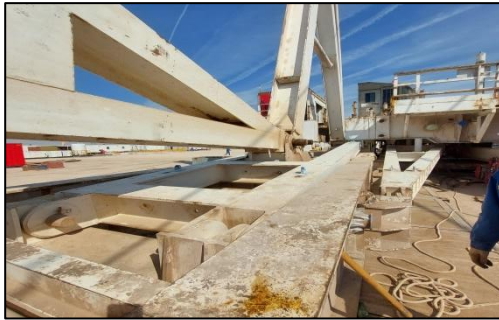
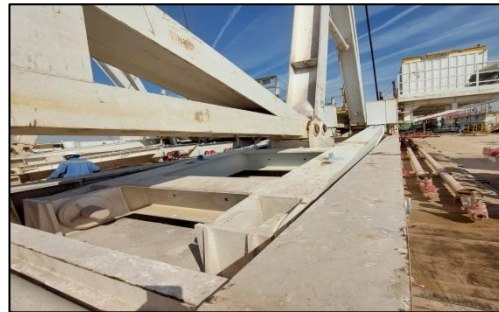
Client Name:	Daqing Drilling Company	Location:	Rig (DQ 1202)	Job Number:	QC-B-03-25-0091
Date of Examination:	15-03-2025	Date of Report:	15-03-2025	Certificate No:	QC-B-03-25-0091-01-20A
Unit Serial Number	Description of the examined equipment				Result
20019	SUBSTRUCTURE DRILL SIDE & OFF DRILL SIDE SUPPORT BEAM PAD EYES				Pass
PAD EYES SN:	S13 ,S14 , S21 , S22

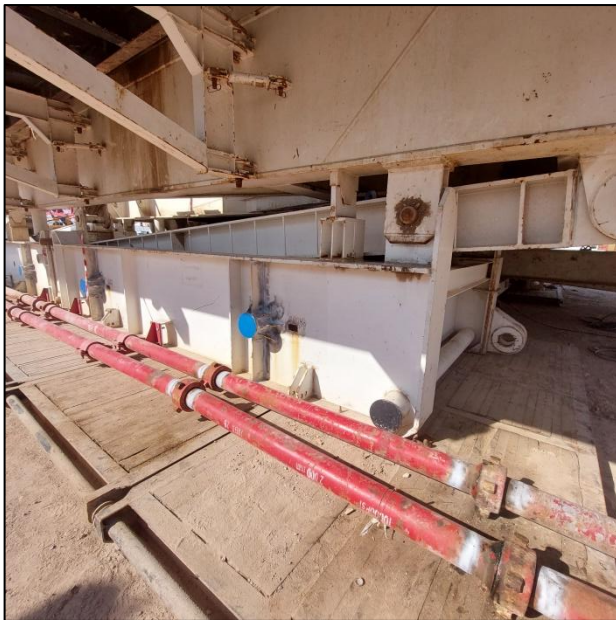
Client Name:	Daqing Drilling Company	Location:	Rig (DQ 1202)	Job Number:	QC-B-03-25-0091
Date of Examination:	15-03-2025	Date of Report:	15-03-2025	Certificate No:	QC-B-03-25-0091-01-21
Unit Serial Number	Description of the examined equipment				Result
20019	SUBSTRUCTURE LOWER OFF DRILL SIDE LIFTING LUGS				Pass
LUGS SN:	DZ013 , DZ014 , DZ015 , DZ016			ECHÉ LUG SWL	280 KN

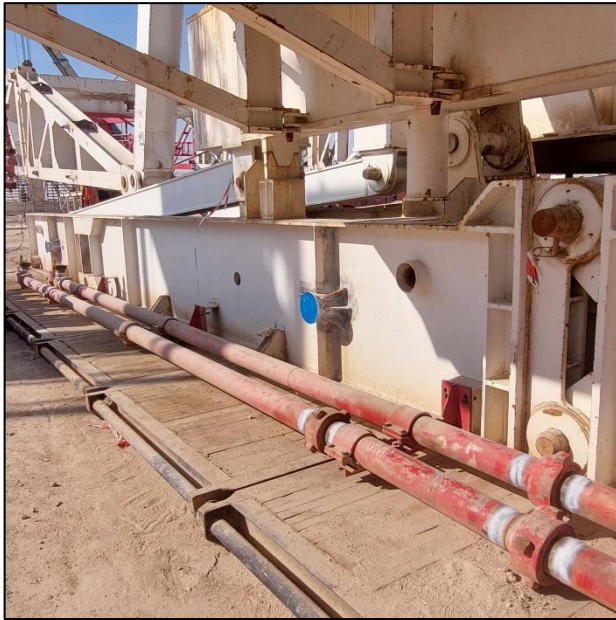
Client Name:	Daqing Drilling Company	Location:	Rig (DQ 1202)	Job Number:	QC-B-03-25-0091
Date of Examination:	15-03-2025	Date of Report:	15-03-2025	Certificate No:	QC-B-03-25-0091-01-22
Unit Serial Number	Description of the examined equipment				Result
20019	SUBSTRUCTURE LOWER OFF DRILL SIDE LIFTING LUGS				Pass
LUGS SN:	DZ005 , DZ006 , DZ007 , DZ008		ECHE LUG SWL		280 KN

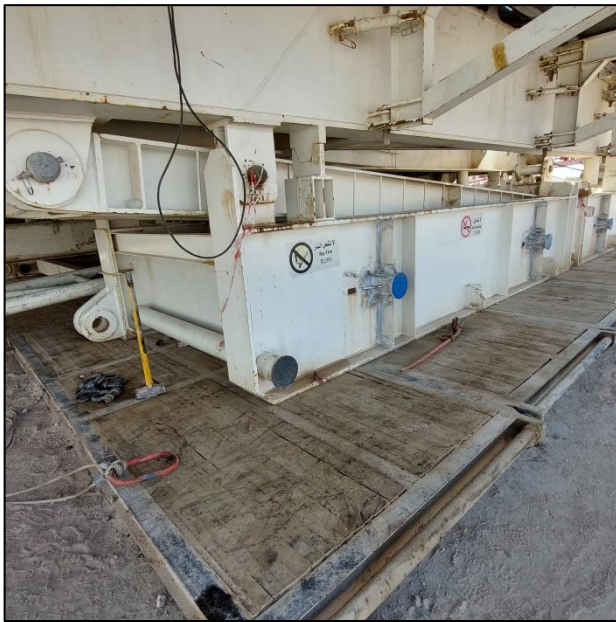
Client Name:	Daqing Drilling Company	Location:	Rig (DQ 1202)	Job Number:	QC-B-03-25-0091
Date of Examination:	15-03-2025	Date of Report:	15-03-2025	Certificate No:	QC-B-03-25-0091-01-24
Unit Serial Number	Description of the examined equipment				Result
20019	SUBSTRUCTURE LOWER DRILL SIDE LIFTING LUGS				Pass
LUGS SN:	DZ009 , DZ010 , DZ011 , DZ012			ECHÉ LUG SWL	280 KN

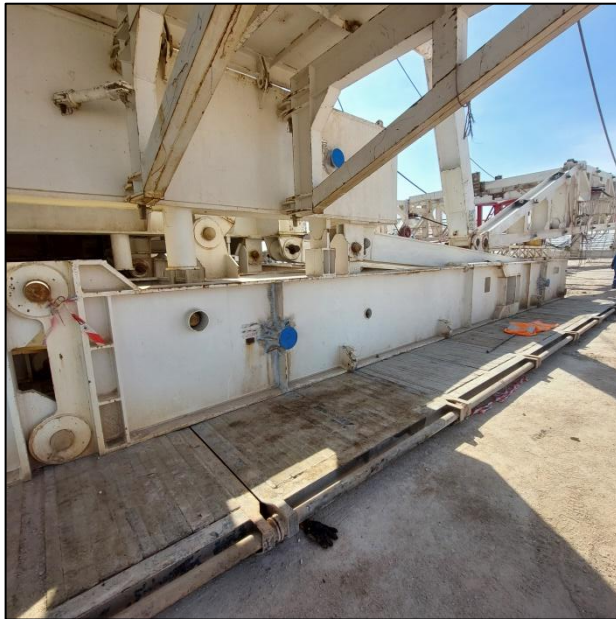
Client Name:	Daqing Drilling Company	Location:	Rig (DQ 1202)	Job Number:	QC-B-03-25-0091
Date of Examination:	15-03-2025	Date of Report:	15-03-2025	Certificate No:	QC-B-03-25-0091-01-25
Unit Serial Number	Description of the examined equipment				Result
20019	SUBSTRUCTURE LOWER DRILL SIDE LIFTING LUGS				Pass
LUGS SN:	DZ001 , DZ002 , DZ003 , DZ004			ECHE LUG SWL	280 KN

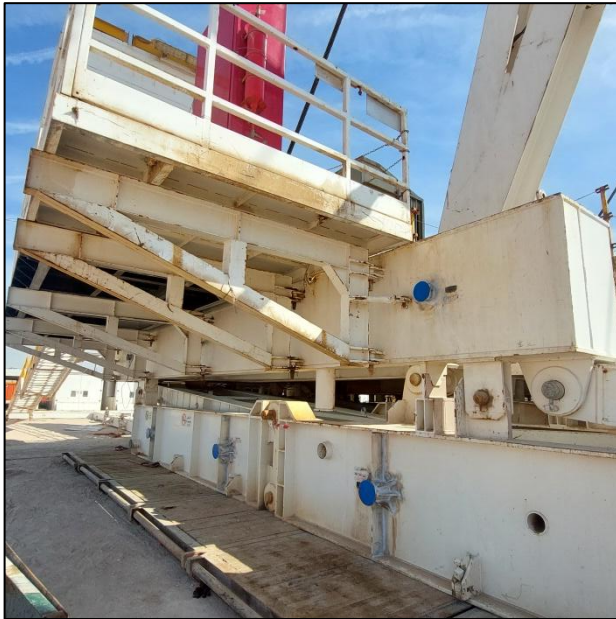
Client Name:	Daqing Drilling Company	Location:	Rig (DQ 1202)	Job Number:	QC-B-03-25-0091
Date of Examination:	15-03-2025	Date of Report:	15-03-2025	Certificate No:	QC-B-03-25-0091-01-26
Unit Serial Number	Description of the examined equipment				Result
20019	SUBSTRUCTURE UPPER DRILL SIDE LIFTING LUGS				Pass
LUGS SN:	061 , 062 , 063 , 064	ECHE LUG SWL		80 KN

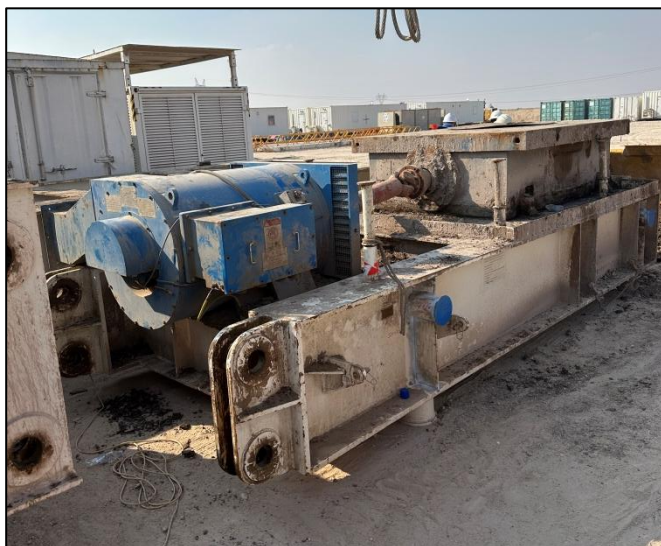
Client Name:	Daqing Drilling Company	Location:	Rig (DQ 1202)	Job Number:	QC-B-03-25-0091
Date of Examination:	15-03-2025	Date of Report:	15-03-2025	Certificate No:	QC-B-03-25-0091-01-27
Unit Serial Number	Description of the examined equipment				Result
20019	ROTARY TABLE SECONDARY RETENTION FALL ARRESTORE				Pass
LUGS SN:	C1 , C2 , C3, C4
