Certificate of Thorough Examination & NDT of Lifting Equipment

Client Name:	Daqing Drilling Company	Location:	Rig (DQ 1202)	Job Number:	QC-B-03-25-0090
Date of Examination:	13-03-2025	Date of Report:	13-03-2025	Certificate No:	QC-B-03-25-0090-04-70
Serial Number:	QTY	Description		SWL	Date of last Thorough examination
225C	01	Lifting Bracket Pad Eye MAST UPPER SECTION POWER TONG BRACKET		10 TON	20-10-2024
		Pad Eye Dimension Thickness: 30 MM Pin Hole: 38 MM Length: 150 MM Height: 150 MM Bracket Body Height: 350 MM Bracket Body Jaw Inside Width: 175 MM Bracket Body Pin Holes: 82 MM Bracket Pins: 79 MM		Last Proof Load Test:- 05-06-2023 BY GAMMA

Visual & Magnetic Particles Examination Report

Client Name:	Daqing Drilling Company	Location:	Rig (DQ 1202)	Job Number:	QC-B-03-25-0090
Date of Examination:	13-03-2025	Date of Report:	13-03-2025	Certificate No:	QC-B-03-25-0090-04-70A
Unit Serial Number	Description of the examined equipment				Result
225C	MAST UPPER SECTION POWER TONG BRACKET PAD EYE				Pass

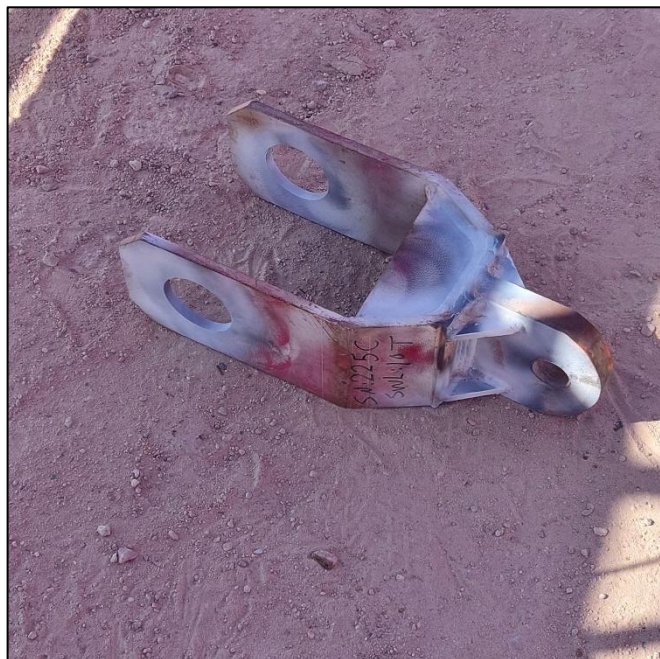
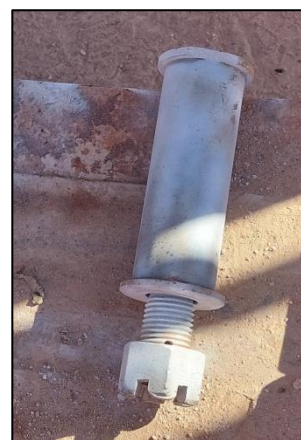
Visual and MPI carried out for the above description and found free of surface defects at the time of inspection

None

None

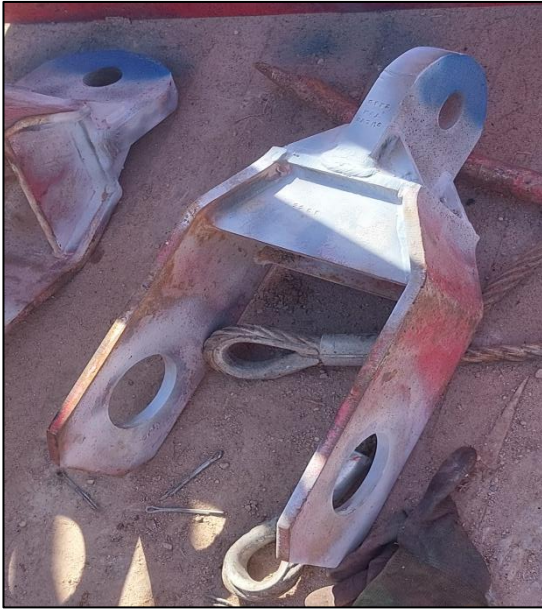
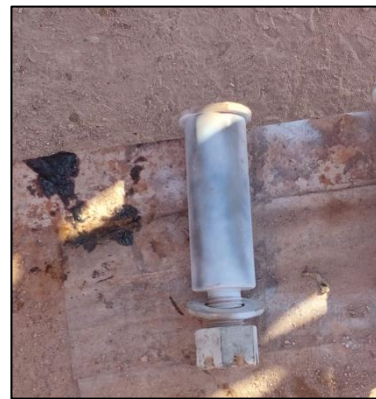
Client Name:	Daqing Drilling Company	Location:	Rig (DQ 1202)	Job Number:	QC-B-03-25-0090
Date of Examination:	13-03-2025	Date of Report:	13-03-2025	Certificate No:	QC-B-03-25-0090-04-71A
Unit Serial Number	Description of the examined equipment				Result
225A	MAST UPPER SECTION POWER TONG BRACKET PAD EYE				Pass

Visual and MPI carried out for the above description and found free of surface defects at the time of inspection

None

None

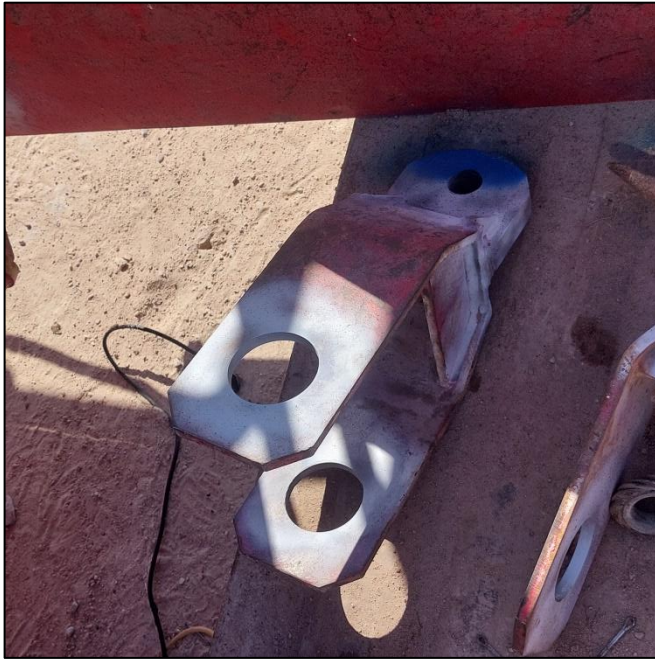
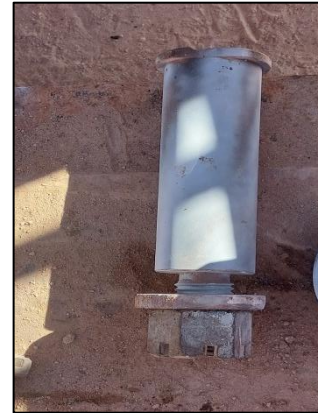
Client Name:	Daqing Drilling Company	Location:	Rig (DQ 1202)	Job Number:	QC-B-03-25-0090
Date of Examination:	13-03-2025	Date of Report:	13-03-2025	Certificate No:	QC-B-03-25-0090-04-72A
Unit Serial Number	Description of the examined equipment				Result
225B	MAST UPPER SECTION POWER TONG BRACKET PAD EYE				Pass

Visual and MPI carried out for the above description and found free of surface defects at the time of inspection

None

None
