## Visual & Dye Penetrant Examination Report

Client:	Black Gold Gulf	Certificate no:	QC-B-03-25-0148-01
Location:	TRS BGG Yard	Job Order No:	QC-B-03-25-0148
Date of Examination:	26-March-2025	Next Inspection Due:	25-Sep-2025

Serial Number	Description of the examined equipment	Result
231150	Flange 13 5/8" 10K 5X	Accept

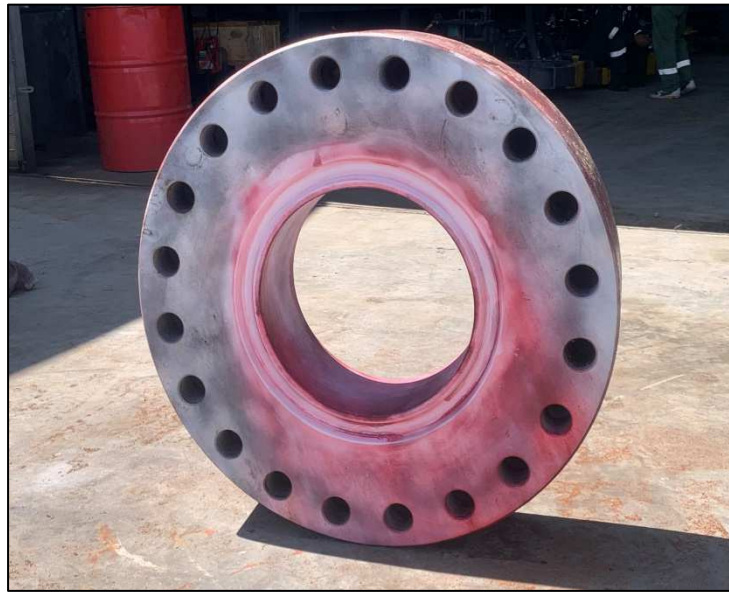
Visual and MPI were carried out for the above description and found free of surface defects at the time of inspection
Identification of any part found to have a defect and a description of the defect: None
Particulars of any repair, renewal, or alteration required to remedy the defect identified above: None
All MPI was performed per OEM's instructions, and OEM did the measurements.
