## Visual & Magnetic Particles Examination Report

Client:	Daqing Drilling Company	Certificate no:	QC-B-04-25-0167-25
Location:	DQ Rig 037	Job Order No:	QC-B-04-25-0167
Date of Examination:	12-Apr-2025	Next Inspection Due:	11-Oct-2025

Serial Number	Description of the examined equipment	Result
WT001	Top Spare Water Tank Lifting Lugs	Accept
Lifting Lugs S/N:	W1 , W2 , W3 , W4

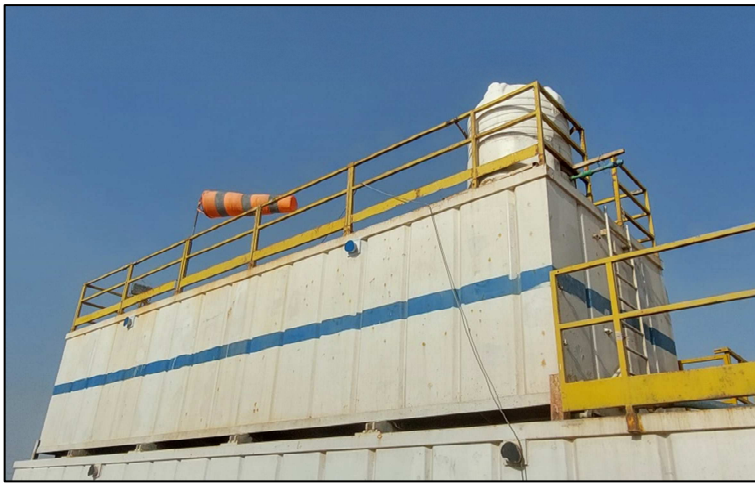
NDT procedure
Visual and MPI were carried out for the above description and found free of surface defects at the time of inspection
Identification of any part found to have a defect and a description of the defect: None
Particulars of any repair, renewal, or alteration required to remedy the defect identified above: None
All MPI Performed as Per Instructions of OEM:

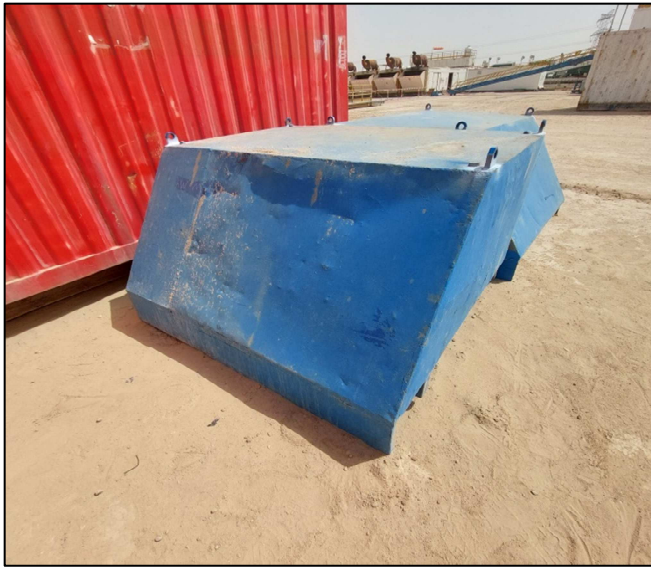
Serial Number	Description of the examined equipment	Result
DW-M02	Draw Work Cover Lifting Point	Accept
Lifting Point S/N:	5 , 6 , 7 , 8

NDT procedure
Visual and MPI were carried out for the above description and found free of surface defects at the time of inspection
Identification of any part found to have a defect and a description of the defect: None
Particulars of any repair, renewal, or alteration required to remedy the defect identified above: None
All MPI Performed as Per Instructions of OEM:

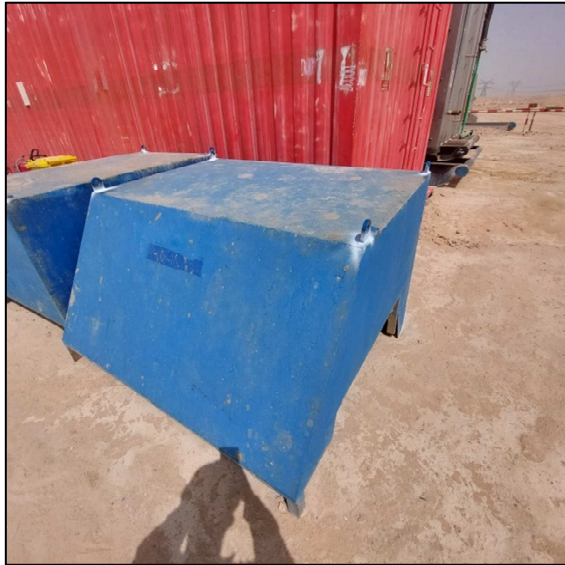
Serial Number	Description of the examined equipment	Result
DW-M01	Draw Work Cover Lifting Point	Accept
Lifting Point S/N:	1 , 2 , 3 , 4

NDT procedure
Visual and MPI were carried out for the above description and found free of surface defects at the time of inspection
Identification of any part found to have a defect and a description of the defect: None
Particulars of any repair, renewal, or alteration required to remedy the defect identified above: None
All MPI Performed as Per Instructions of OEM:
