Visual & Magnetic Particles Examination Report

Client:	Daqing Drilling Company	Certificate no:	QC-B-06-25-0335-02-01
Location:	DQ Rig 1202	Job Order No:	QC-B-06-25-0335
Date of Examination:	03-6-2025	Next Inspection Due:	02-12-2025

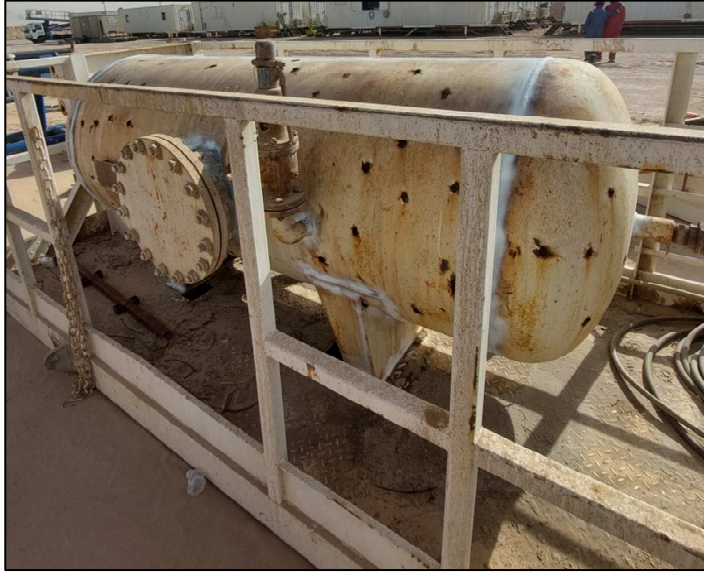
Serial Number	Description of the examined equipment	Result
217010C39202000027	Air Tank Under Rig Floor Welding Area	Accept

Visual and MPI were carried out for the above description and found free of surface defects at the time of inspection

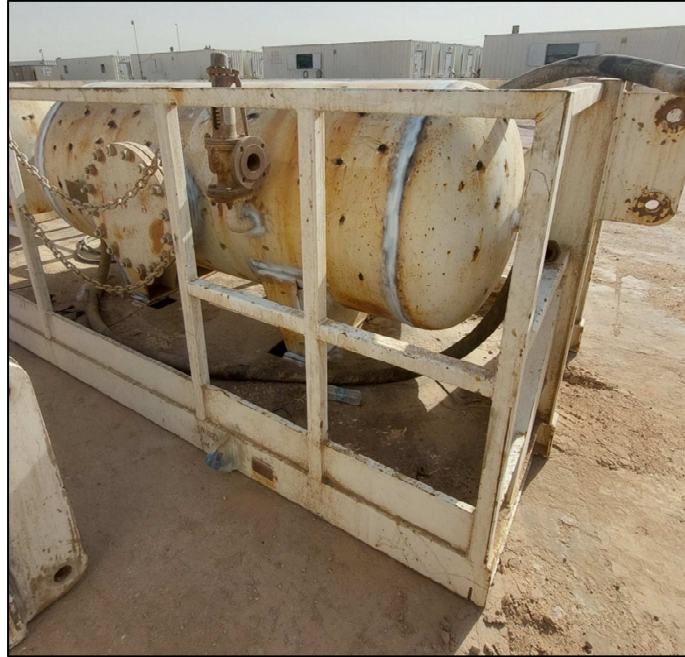
Serial Number	Description of the examined equipment	Result
217010C39202000029	Air Tank Under Rig Floor Welding Area	Accept

Visual and MPI were carried out for the above description and found free of surface defects at the time of inspection
Identification of any part found to have a defect and a description of the defect: None
Particulars of any repair, renewal, or alteration required to remedy the defect identified above: None
All MPI Performed as Per Instructions of OEM:

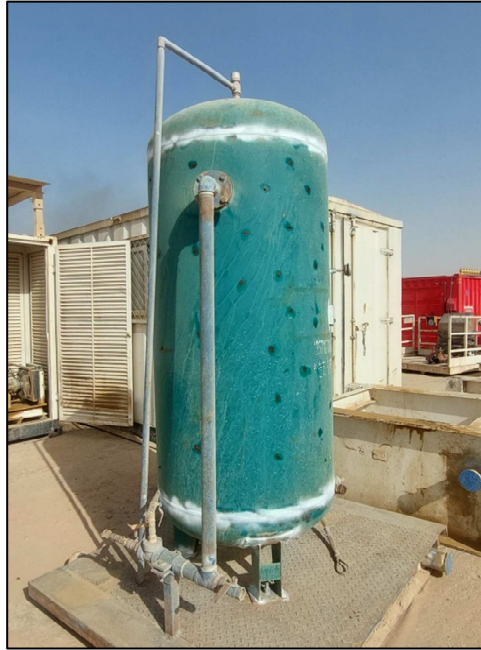
Serial Number	Description of the examined equipment	Result
02-1612007	Air Tank Welding Area	Accept

Visual and MPI were carried out for the above description and found free of surface defects at the time of inspection
Identification of any part found to have a defect and a description of the defect: None
Particulars of any repair, renewal, or alteration required to remedy the defect identified above: None
All MPI Performed as Per Instructions of OEM:

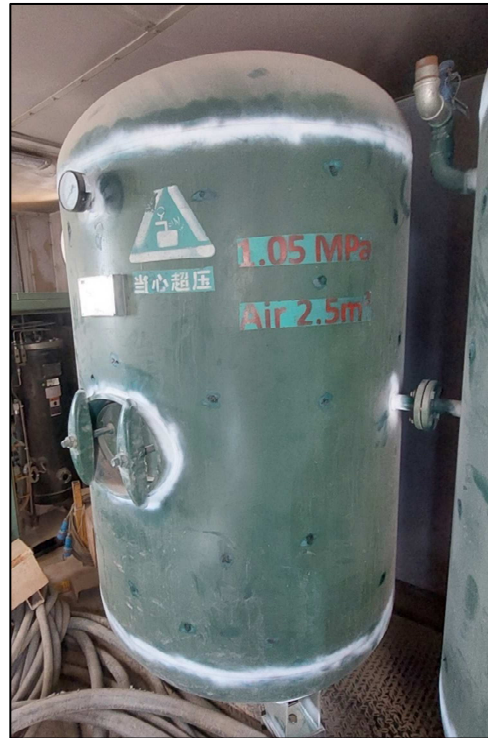
Serial Number	Description of the examined equipment	Result
R20-4759	Gas Tank Welding Area	Accept

Visual and MPI were carried out for the above description and found free of surface defects at the time of inspection

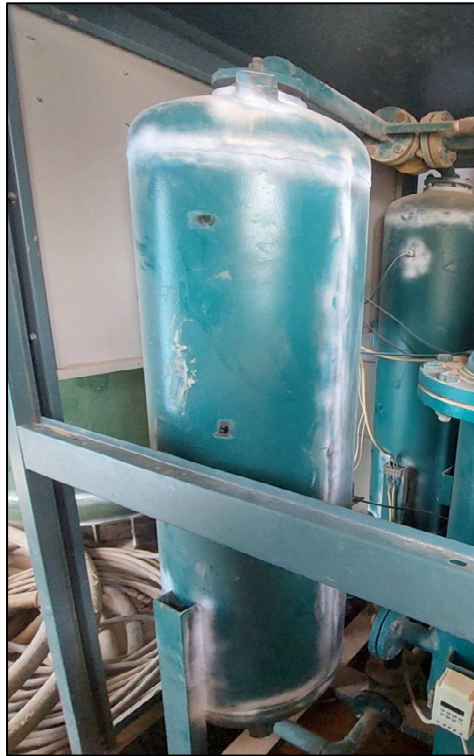
Serial Number	Description of the examined equipment	Result
C19-2400	Gas Tank Welding Area	Accept

Visual and MPI were carried out for the above description and found free of surface defects at the time of inspection

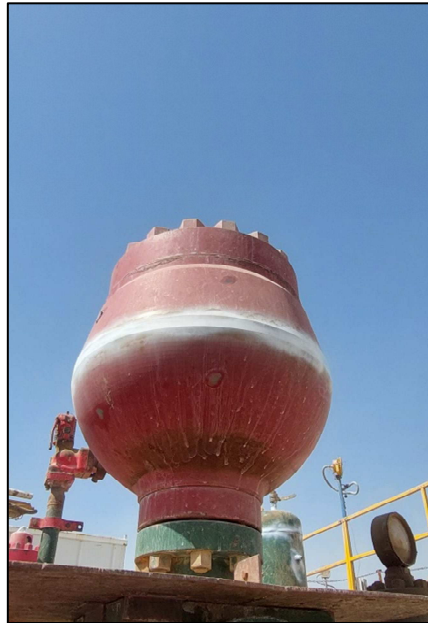
Serial Number	Description of the examined equipment	Result
BYD202009015	PULSATION DAMPENER Welding Area	Accept

Visual and MPI were carried out for the above description and found free of surface defects at the time of inspection

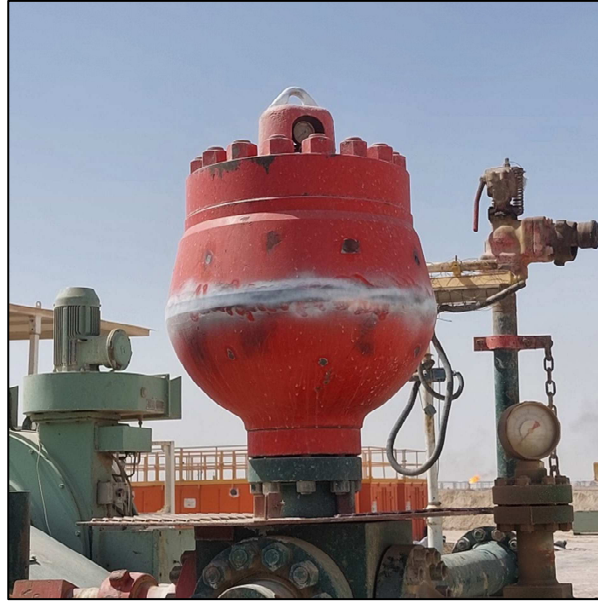
Serial Number	Description of the examined equipment	Result
BYD202009020	PULSATION DAMPENER Welding Area	Accept

Visual and MPI were carried out for the above description and found free of surface defects at the time of inspection

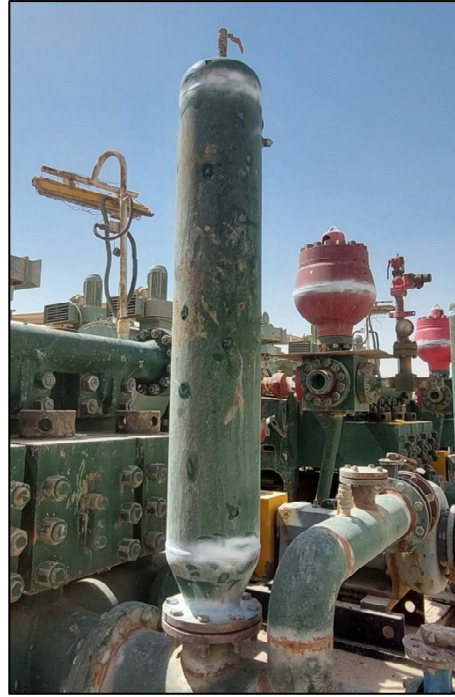
Serial Number	Description of the examined equipment	Result
BY20-112HL-L	Low Pressure Dampener For Mud Pump 1 Welding Area	Accept

Visual and MPI were carried out for the above description and found free of surface defects at the time of inspection

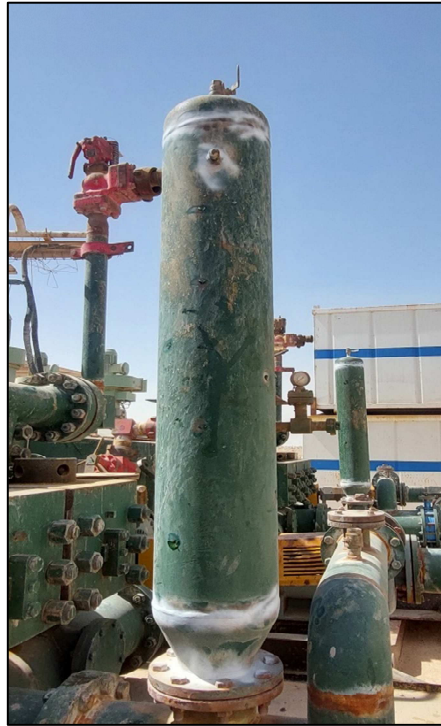
Serial Number	Description of the examined equipment	Result
BY20-113HL-L	Low Pressure Dampener For Mud Pump 2 Welding Area	Accept

Visual and MPI were carried out for the above description and found free of surface defects at the time of inspection
Identification of any part found to have a defect and a description of the defect: None
Particulars of any repair, renewal, or alteration required to remedy the defect identified above: None
All MPI Performed as Per Instructions of OEM:

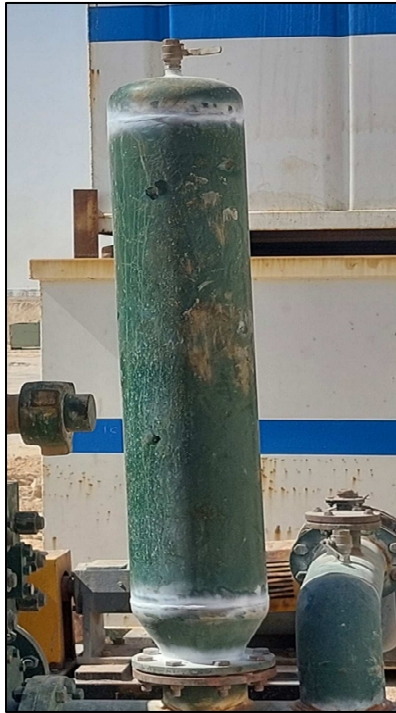
Serial Number	Description of the examined equipment	Result
BY20-114HL-L	Low Pressure Dampener For Mud Pump 3 Welding Area	Accept

Visual and MPI were carried out for the above description and found free of surface defects at the time of inspection
