**AI TAKAMUL COMPANY FOR ENGINEERING TESTS
AND PROFESSIONAL SAFETY LIMITED**
Basra, North Rumaila, Quality Control Yard - Iraq

CERTIFICATION OF VISUAL, THOROUGH EXAMINATION & MAGNETIC PARTICLE INSPECTION

Client:	HALLIBURTON (HPS)	Report No:	QC/24/HALL-HPS-JULY-0098/48 A	
Location:	WQI-583	Job Number:	QC-24/HALL-HPS-0098	
Date:	July 13, 2025	Next Inspection Date:	January 12, 2026	
Type Of Inspection:	VISUAL , THOROUGH EXAMINATION & MAGNETIC PARTICLE INSPECTION		Specification:	ASTM E709 -21 LATEST EDITION

CERTIFICATE OF QUALIFICATION VISUAL INSPECTION AND LEAK TESTING

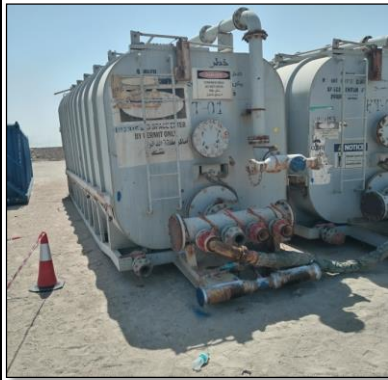
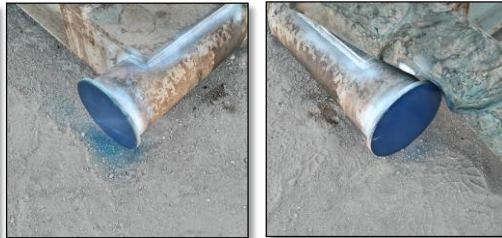
UNIT DESCRIPTION:	FRAC TANK LIFTING LUGS
UNIT S/N:	11873154
UNIT DIM:	11.50 M (L) X 2.50 M (W) X 3.55 M (H)
INSPECTION RESULT :	
VISUAL , THOROUGH EXAMINATION	unit fully inspected and found free from deforms, cracks, corrosion & mechanical damage
MAGNETIC PARTICLE INSPECTION	Welds & forgn areas inspected and found free from cracks and other defects
FINAL RESULTS	unit found satisfactory and free of defects at the time of inspection
COMMENT:	Magnetic Particle Inspection With A/C Hand Yoke , Black & White Contrast

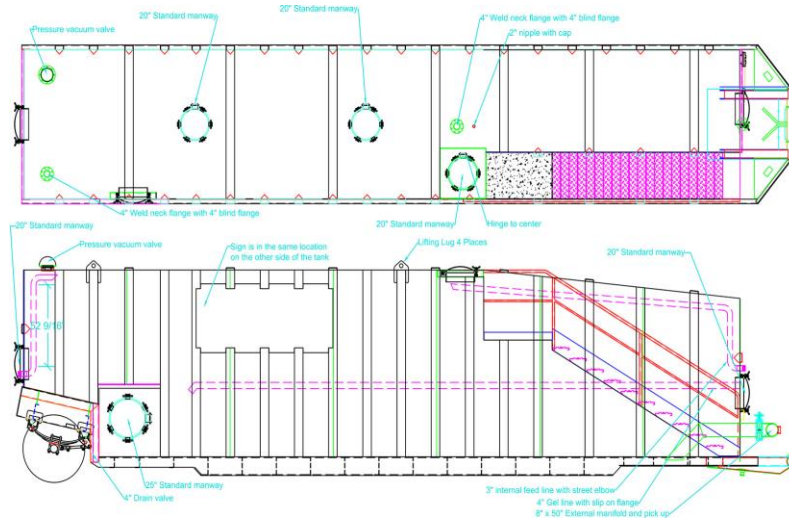
PICTURES

VISUAL TESTING:	Visual Testing of Frac Tank did not found Deforms Mechanical Damage, Cracks and Corrosion. At time of Inspection.
LEAK TESTING:	Leak Testing of Frac Tank did not found any leakage during the holding time. At time of Inspection.

VISUAL TESTING-The above mentioned Frac Tank was found "Satisfactory" Fit for intended used.

LEAK TESTING- The above mentioned Frac Tank was found "Satisfactory" Fit for intended used.
