## Visual & Magnetic Particles Examination Report

Client:	Hong Hua Oil& Gas Engineering Services Ltd	Certificate no:	QC-B-06-25-0363-01
Location:	Rig: HH08 / RU-674	Job Order No:	QC-B-06-25-0363
Date of Examination:	13-06-2025	Next Inspection Due:	12-12-2025
Serial Number	Description of the examined equipment	Result	
V1 & V2	Catwalk Ramp to V-Door Connection Points	Accept

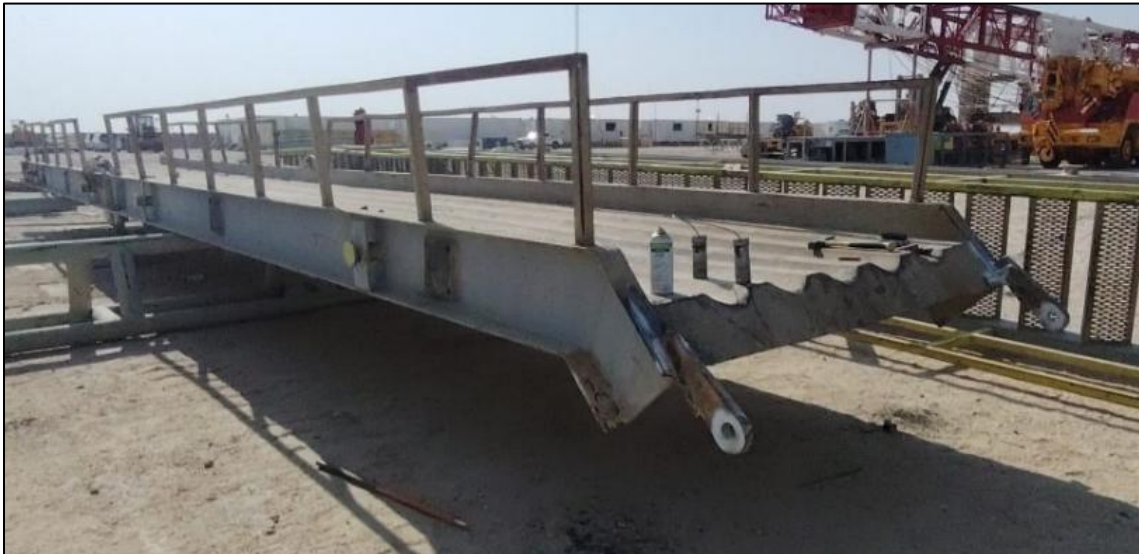
Visual and MPI were carried out for the above description and found free of surface defects at the time of inspection

Identification of any part found to have a defect and a description of the defect: None

None
