Visual & Magnetic Particles Examination Report

Client Name:	Hong Hua Oil & Gas Engineering Services Ltd	Location:	Rig HH-008	Job Number:	QC-B-06-25-0363
Date of Examination:	13-06-2025	Date of Report:	16-06-2025	Certificate No:	QC-B-06-25-0363-10

Serial Number	Description of the examined equipment	Result
HZ06	Mast Rising Sheave	Pass
Location:	A-Frame - Driller Side

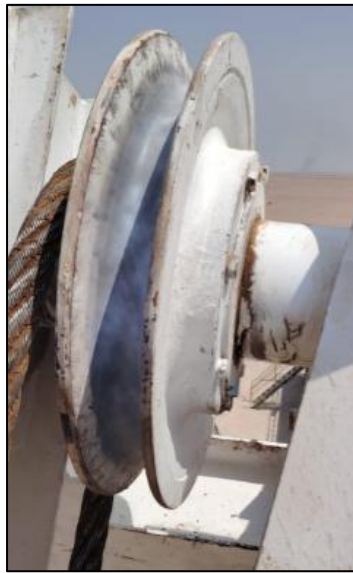
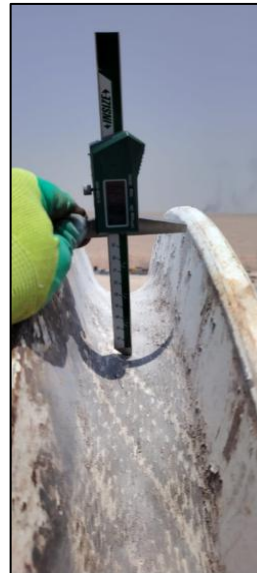
Sheave No	Nominal Wire Rope Dim:	Actual depth	Max Allowable Groove Depth=1.75D	Min Allowable Groove Depth=1.33D	Remarks/Results
HZ06	72mm	100.7 mm	126mm	95.76mm	Accepted

Visual and MPI carried out for the above description and found free of surface defects at the time of inspection

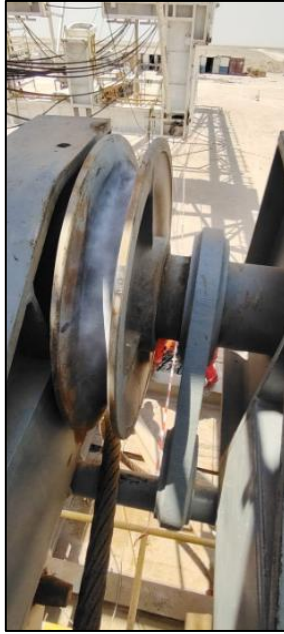
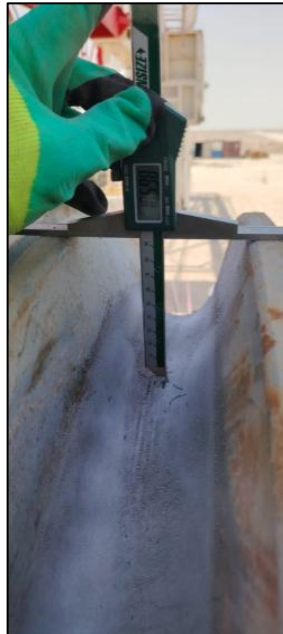
Serial Number	Description of the examined equipment	Result
HZ13	Mast Rising Sheave	Pass
Location:	Substructure - Driller Side

Sheave No	Nominal Wire Rope Dim:	Actual depth	Max Allowable Groove Depth=1.75D	Min Allowable Groove Depth=1.33D	Remarks/Results
HZ13	72mm	100.2 mm	126mm	95.76mm	Accepted

Visual and MPI carried out for the above description and found free of surface defects at the time of inspection

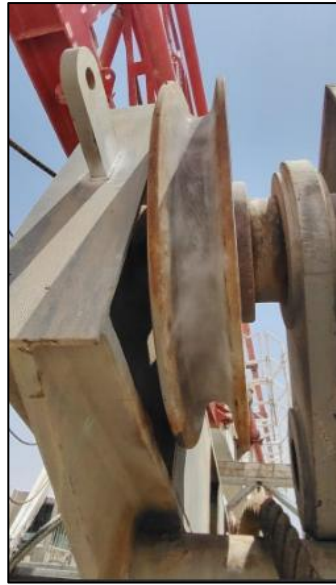
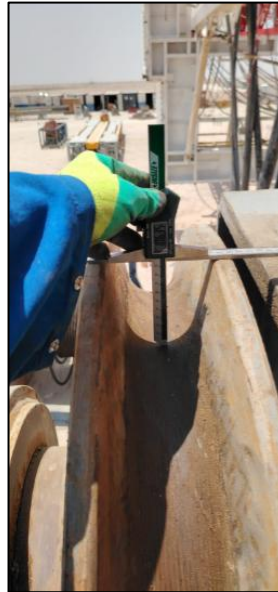
Serial Number	Description of the examined equipment	Result
HZ08	Mast Rising Sheave	Pass
Location:	Substructure - Off-Driller Side

Sheave No	Nominal Wire Rope Dim:	Actual depth	Max Allowable Groove Depth=1.75D	Min Allowable Groove Depth=1.33D	Remarks/Results
HZ08	72mm	100.2 mm	126mm	95.76mm	Accepted

Visual and MPI carried out for the above description and found free of surface defects at the time of inspection

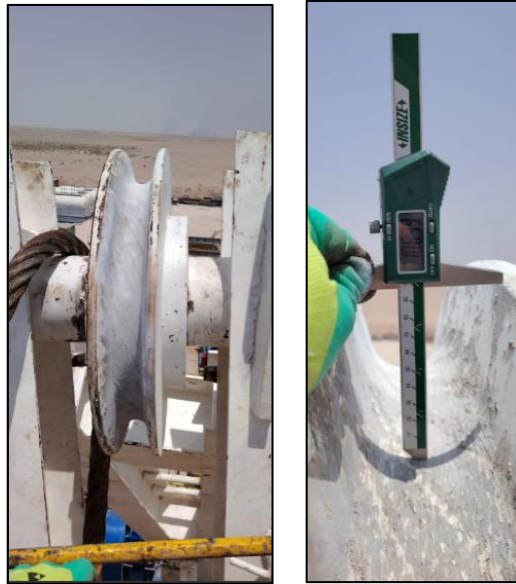
Serial Number	Description of the examined equipment	Result
HZ05	Mast Rising Sheave	Pass
Location:	A-Frame / Off-Driller Side

Sheave No	Nominal Wire Rope Dim:	Actual depth	Max Allowable Groove Depth=1.75D	Min Allowable Groove Depth=1.33D	Remarks/Results
HZ05	72mm	100.1 mm	126mm	95.76mm	Accepted

Visual and MPI carried out for the above description and found free of surface defects at the time of inspection

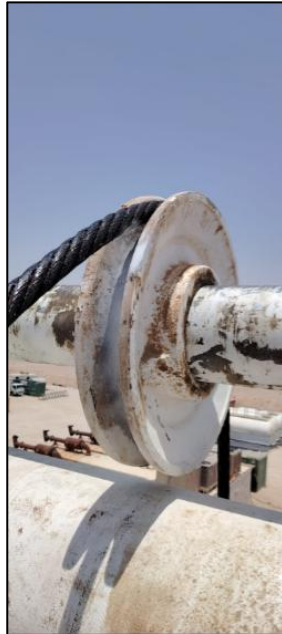
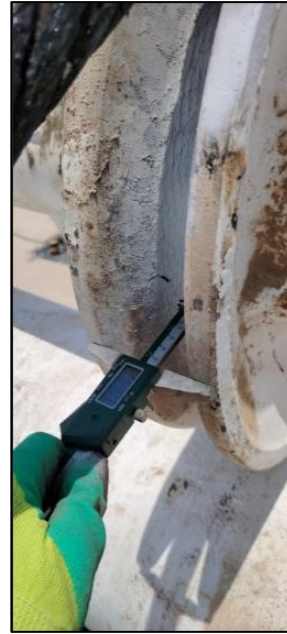
Serial Number	Description of the examined equipment	Result
HZ07	Mast Rising Sheave	Pass
Location:	A-Frame / Middle Side

Sheave No	Nominal Wire Rope Dim:	Actual depth	Max Allowable Groove Depth=1.75D	Min Allowable Groove Depth=1.33D	Remarks/Results
HZ07	38 mm	62.1 mm	66.5 mm	50.54 mm	Accepted

Visual and MPI carried out for the above description and found free of surface defects at the time of inspection

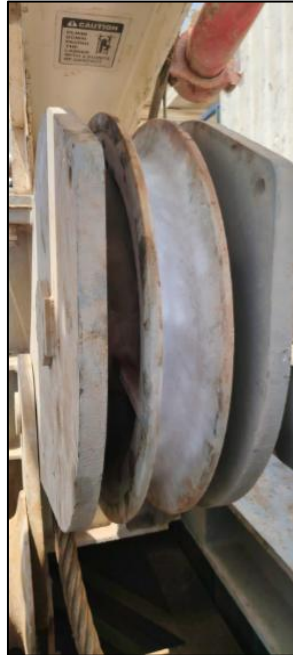
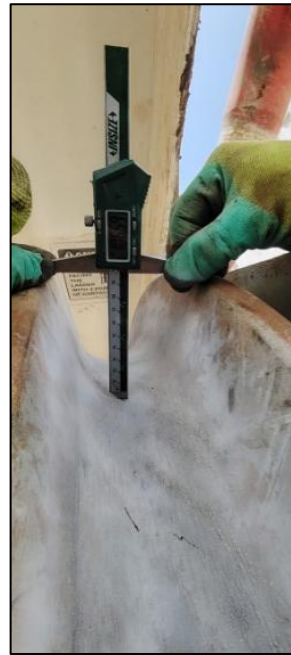
Serial Number	Description of the examined equipment	Result
HZ11	Mast Rising Sheave	Pass
Location:	Substructure / Off-Driller Side

Sheave No	Nominal Wire Rope Dim:	Actual depth	Max Allowable Groove Depth = 1.75D	Min Allowable Groove Depth=1.33D	Remarks/Results
HZ11	72mm	100.2 mm	126mm	95.76mm	Accepted

Visual and MPI carried out for the above description and found free of surface defects at the time of inspection

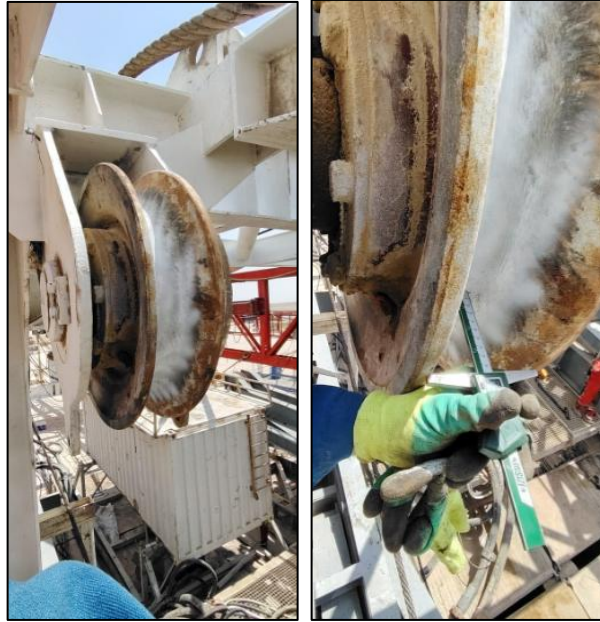
Serial Number	Description of the examined equipment	Result
HZ03	Mast Rising Sheave	Pass
Location:	Mast / Off-Driller Side

Sheave No	Nominal Wire Rope Dim:	Actual depth	Max Allowable Groove Depth = 1.75D	Min Allowable Groove Depth=1.33D	Remarks/Results
HZ03	72mm	100.1 mm	126mm	95.76mm	Accepted

Visual and MPI carried out for the above description and found free of surface defects at the time of inspection

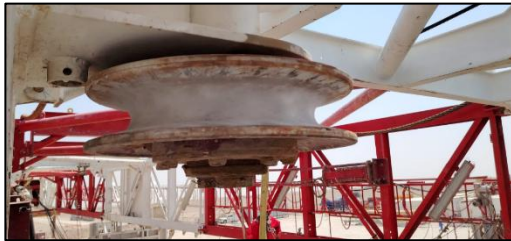
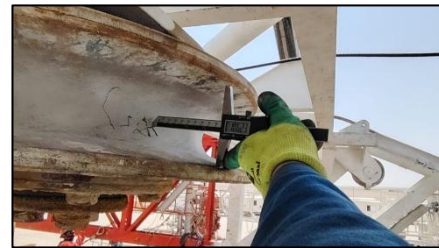
Serial Number	Description of the examined equipment	Result
HZ04	Mast Rising Sheave	Pass
Location:	Mast / Off-Driller Side

Sheave No	Nominal Wire Rope Dim:	Actual depth	Max Allowable Groove Depth=1.75D	Min Allowable Groove Depth=1.33D	Remarks/Results
HZ04	72mm	100.1 mm	126mm	95.76mm	Accepted

Visual and MPI carried out for the above description and found free of surface defects at the time of inspection

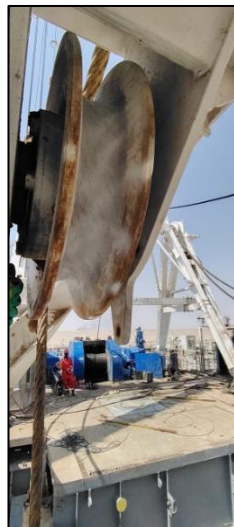
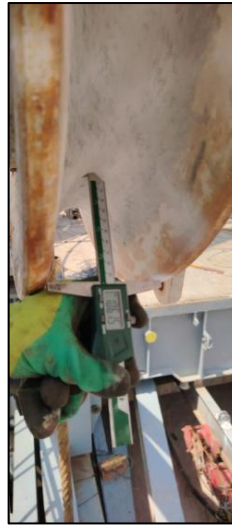
Serial Number	Description of the examined equipment	Result
HZ01	Mast Rising Sheave	Pass
Location:	Mast / Driller Side

Sheave No	Nominal Wire Rope Dim:	Actual depth	Max Allowable Groove Depth=1.75D	Min Allowable Groove Depth=1.33D	Remarks/Results
HZ01	72mm	100.1 mm	126mm	95.76mm	Accepted

Visual and MPI carried out for the above description and found free of surface defects at the time of inspection

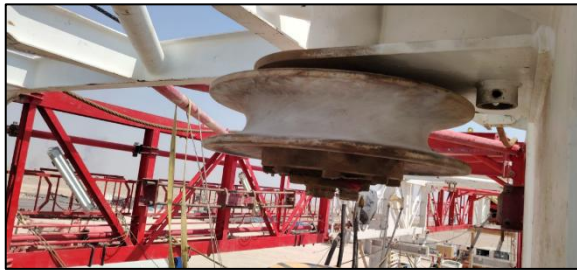
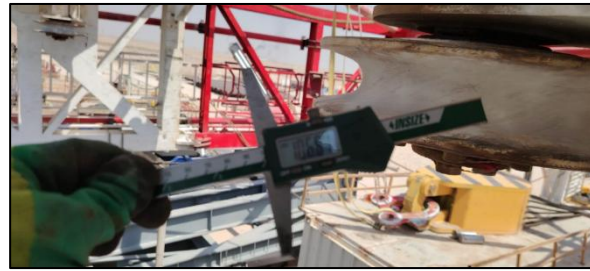
Serial Number	Description of the examined equipment	Result
HZ02	Mast Rising Sheave	Pass
Location:	Mast / Driller Side

Sheave No	Nominal Wire Rope Dim:	Actual depth	Max Allowable Groove Depth=1.75D	Min Allowable Groove Depth=1.33D	Remarks/Results
HZ02	72mm	100.1 mm	126mm	95.76mm	Accepted

Visual and MPI carried out for the above description and found free of surface defects at the time of inspection

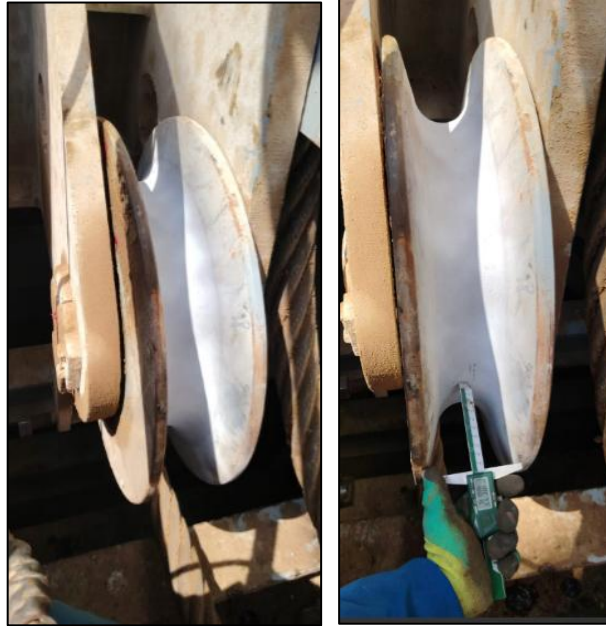
Serial Number	Description of the examined equipment	Result
HZ12	Mast Rising Sheave	Pass
Location:	Substructure / Off-Driller Side

Sheave No	Nominal Wire Rope Dim:	Actual depth	Max Allowable Groove Depth=1.75D	Min Allowable Groove Depth=1.33D	Remarks/Results
HZ12	72mm	100.1 mm	126mm	95.76mm	Accepted

Visual and MPI carried out for the above description and found free of surface defects at the time of inspection

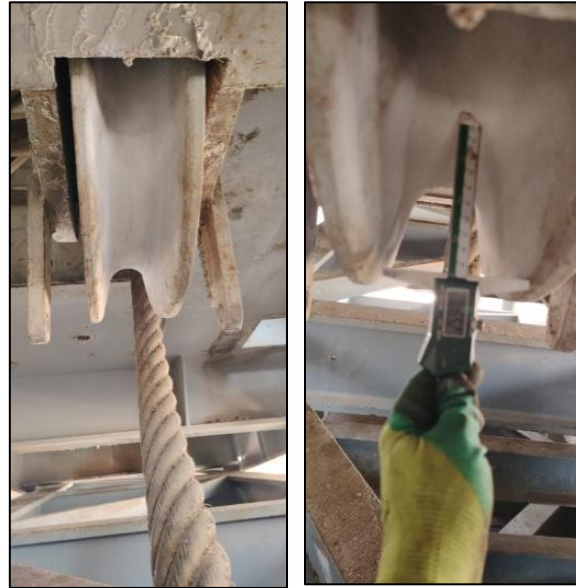
Serial Number	Description of the examined equipment	Result
HZ10	Mast Rising Sheave	Pass
Location:	Substructure / Off-Driller Side

Sheave No	Nominal Wire Rope Dim:	Actual depth	Max Allowable Groove Depth=1.75D	Min Allowable Groove Depth=1.33D	Remarks/Results
HZ10	72mm	100.1 mm	126mm	95.76mm	Accepted

Visual and MPI carried out for the above description and found free of surface defects at the time of inspection

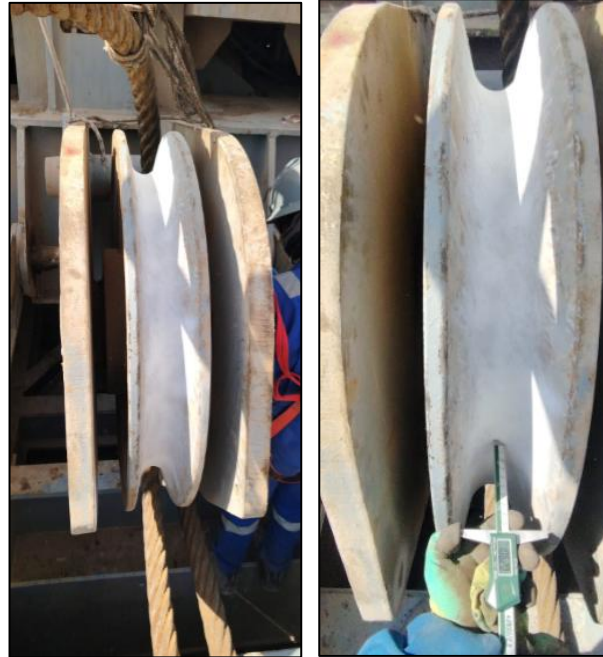
Serial Number	Description of the examined equipment	Result
HZ16	Mast Rising Sheave	Pass
Location:	Substructure / Driller Side

Sheave No	Nominal Wire Rope Dim:	Actual depth	Max Allowable Groove Depth=1.75D	Min Allowable Groove Depth=1.33D	Remarks/Results
HZ16	72mm	100.1 mm	126mm	95.76mm	Accepted

NDT procedure	
Visual and MPI carried out for the above description and found free of surface defects at the time of inspection	
Identification of any part found to have a defect and a description of the defect:	
None	
Particulars of any repair, renewal or alteration required to remedy the defect identified above:	
None

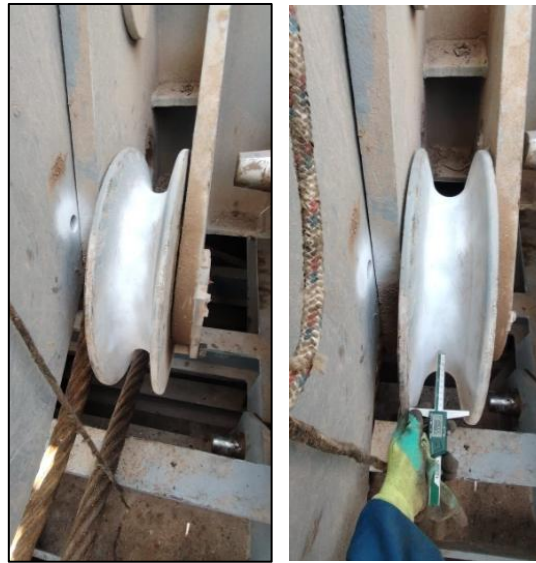
Serial Number	Description of the examined equipment	Result
HZ17	Mast Rising Sheave	Pass
Location:	Substructure / Driller Side

Sheave No	Nominal Wire Rope Dim:	Actual depth	Max Allowable Groove Depth=1.75D	Min Allowable Groove Depth=1.33D	Remarks/Results
HZ17	72mm	100.1 mm	126mm	95.76mm	Accepted

Visual and MPI carried out for the above description and found free of surface defects at the time of inspection

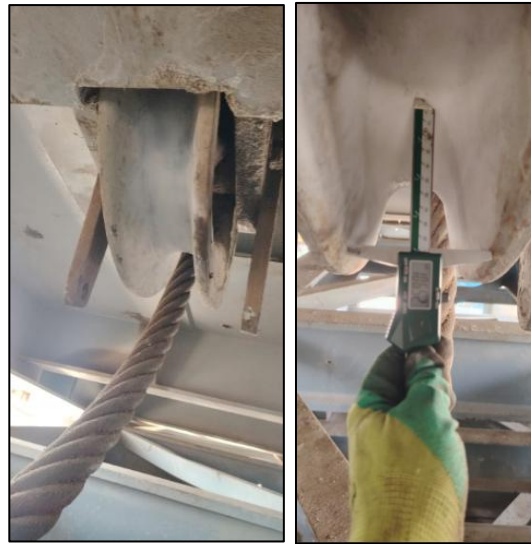
Serial Number	Description of the examined equipment	Result
HZ15	Mast Rising Sheave	Pass
Location:	Substructure / Driller Side

Sheave No	Nominal Wire Rope Dim:	Actual depth	Max Allowable Groove Depth=1.75D	Min Allowable Groove Depth=1.33D	Remarks/Results
HZ15	72mm	100.1 mm	126mm	95.76mm	Accepted

Visual and MPI carried out for the above description and found free of surface defects at the time of inspection
